TREBLA
INDUSTRIAL RESOURCES, INC.

Final Report AIR HANDLER UNIT Refurbishments

AHU 1

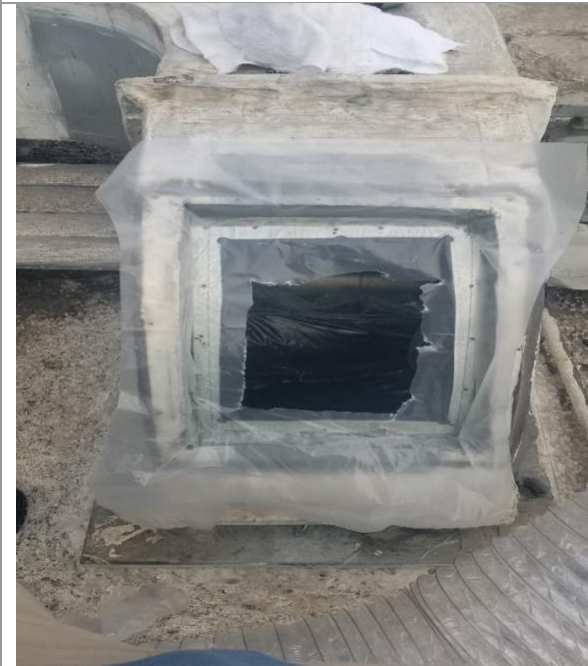
Access created on vertical duct and sealed prior to start of project

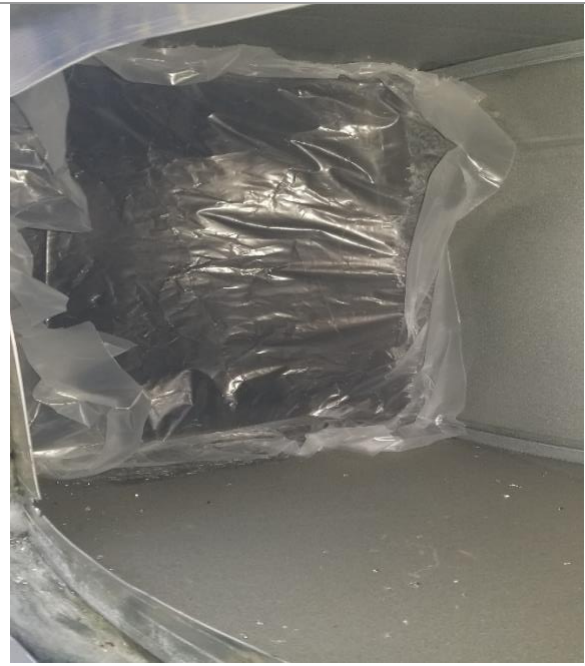
Vertical duct (interior) sealed prior to start of project - Infectious Control

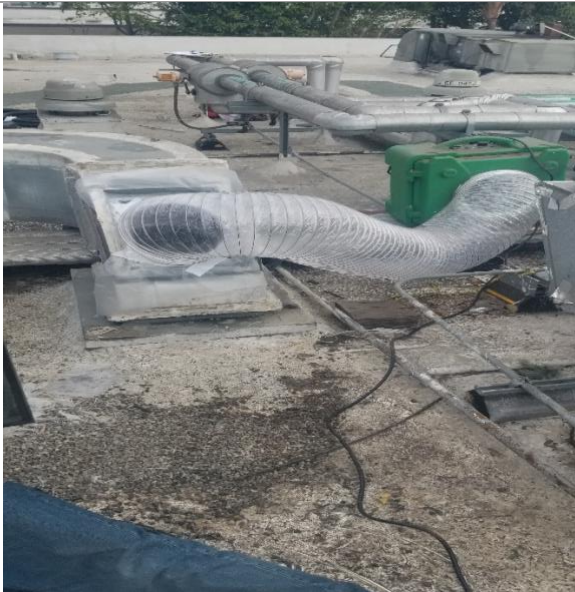
Negative air implemented – Infectious Control

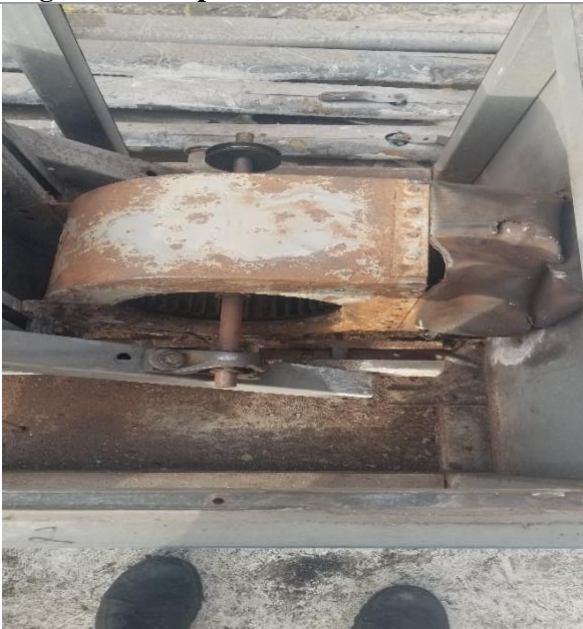
Before
Fan area with significant corrosion, rust and deterioration (Flex connector compromised)

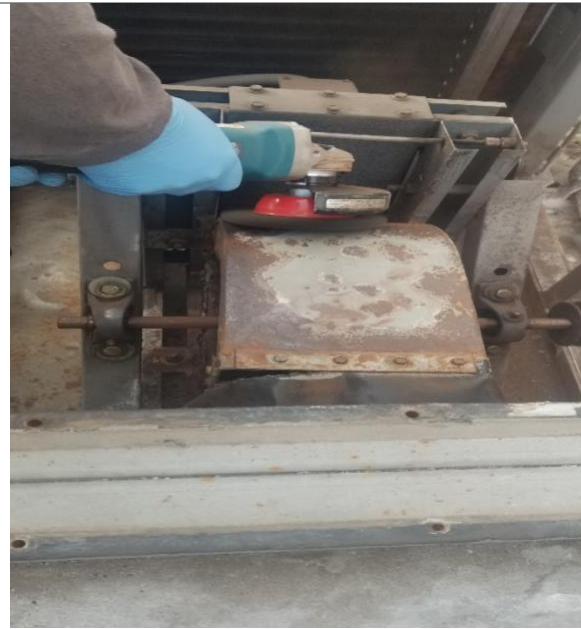
In Progress
Wire fabric brush (Prep for repair and epoxy)

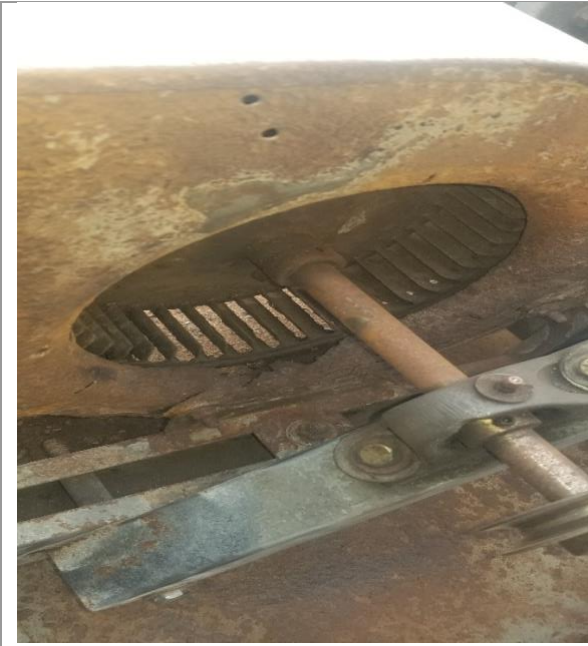
In Progress
Fan wired brushed

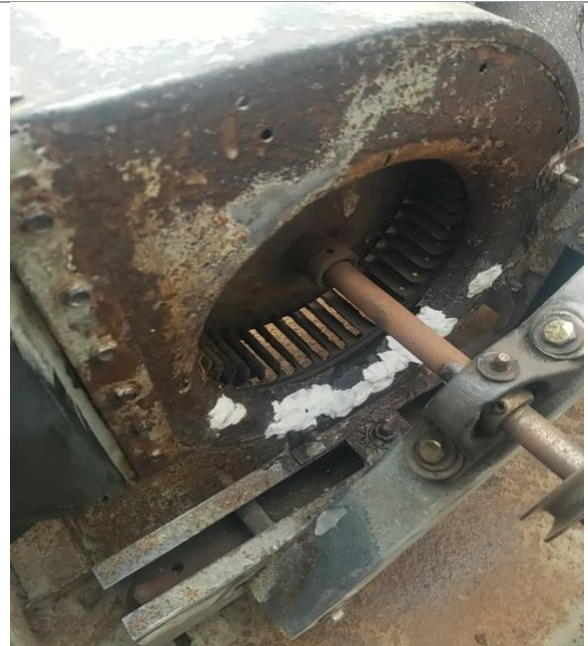
In Progress
Metal treated with converter; metal cracks
welded with underwater epoxy seal

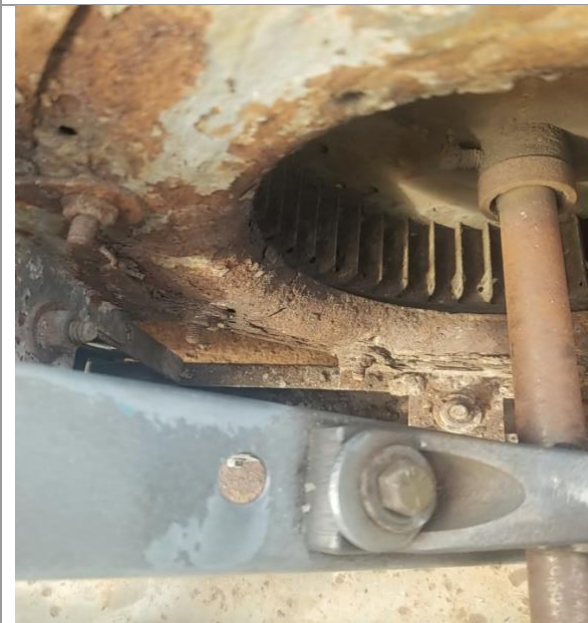
Before
Fan area with significant corrosion, rust and
deterioration

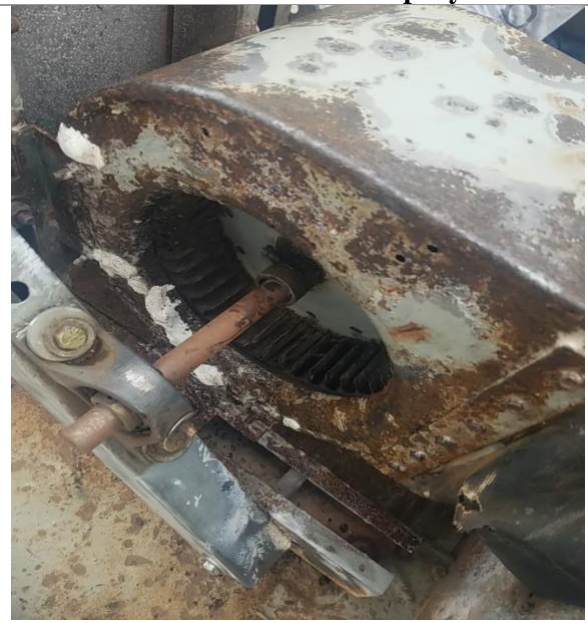
In progress
Metal treated with converter; metal cracks
welded with underwater epoxy seal

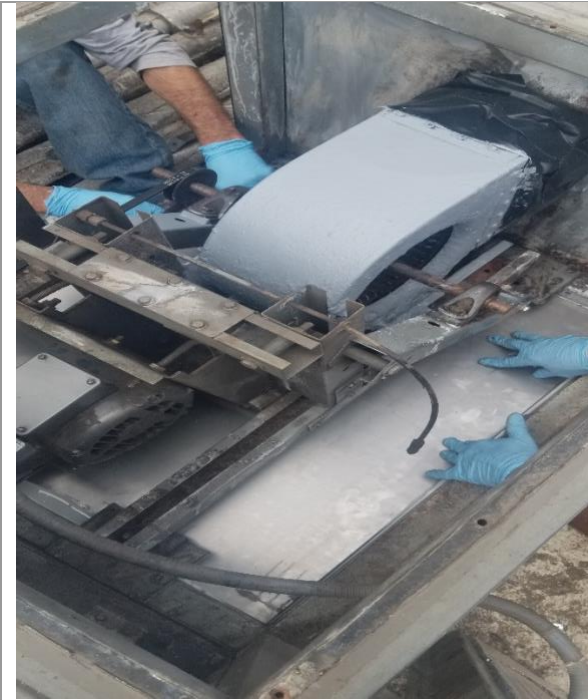
In Progress
Silver Bullet Primer used before painting,
New sheet metal introduced to base of duct

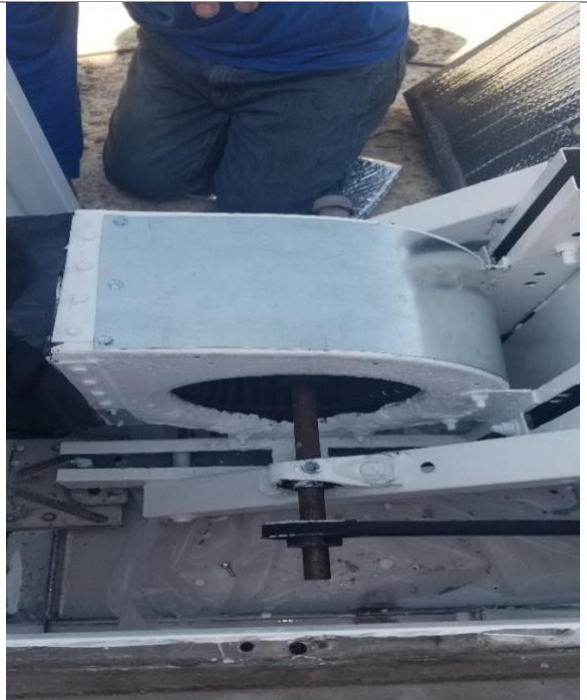
In Progress
Fan painted with Silver Bullet Epoxy after
repairs. Additionally, team
overlapped/wrapped sheet metal from top to
bottom to seal breach (hole) at the bottom of
fan

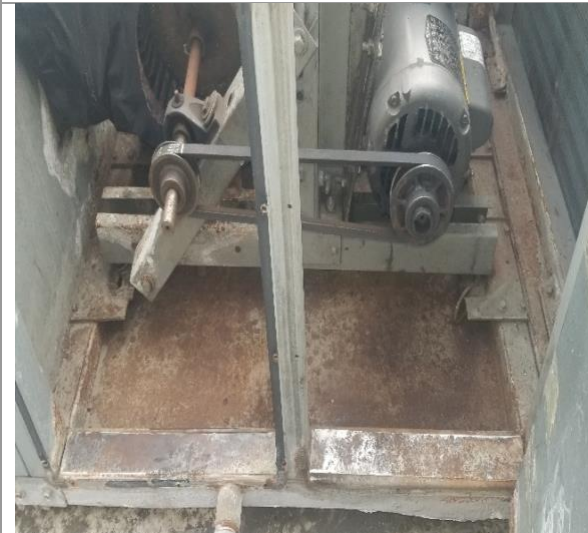
Before
Fan area with extreme corrosion

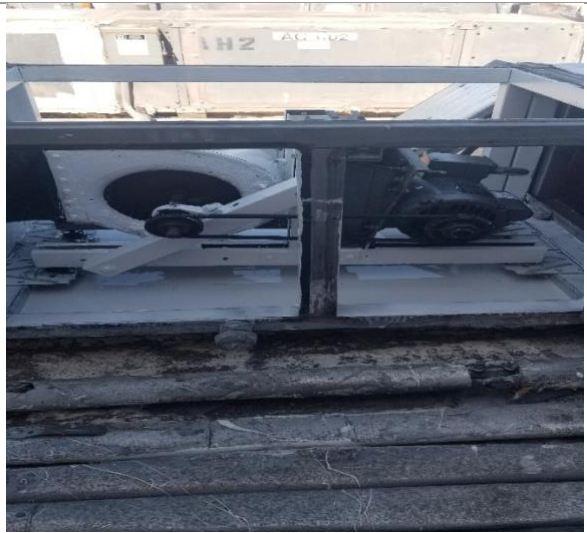
After
Fan painted with second layer of Silver Bullet
and after sheet metal repair.

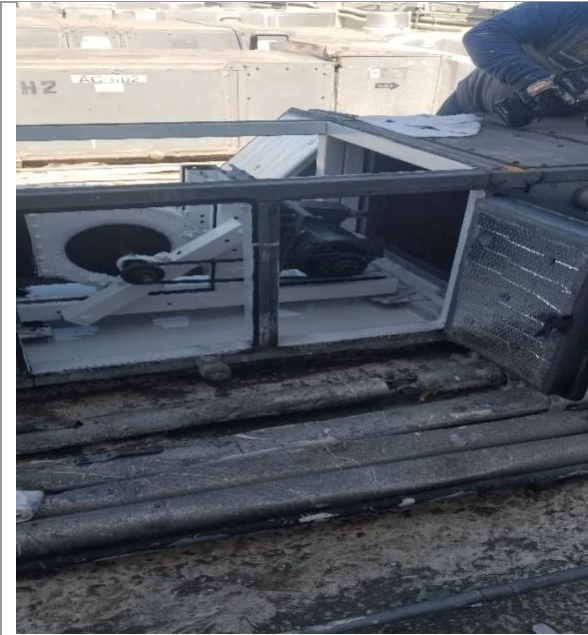
After
Fan compartment area with Silver Bullet
Epoxy and PC260 (Note all panels with
Astro Shield)

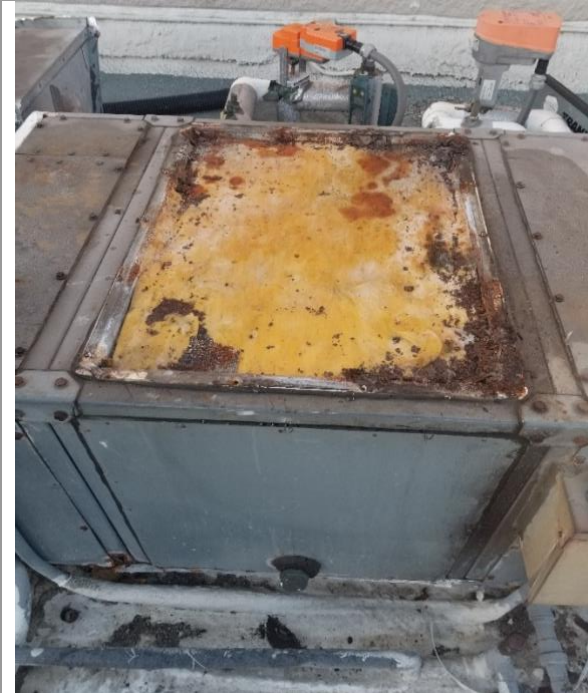
Before
Insulation compromised

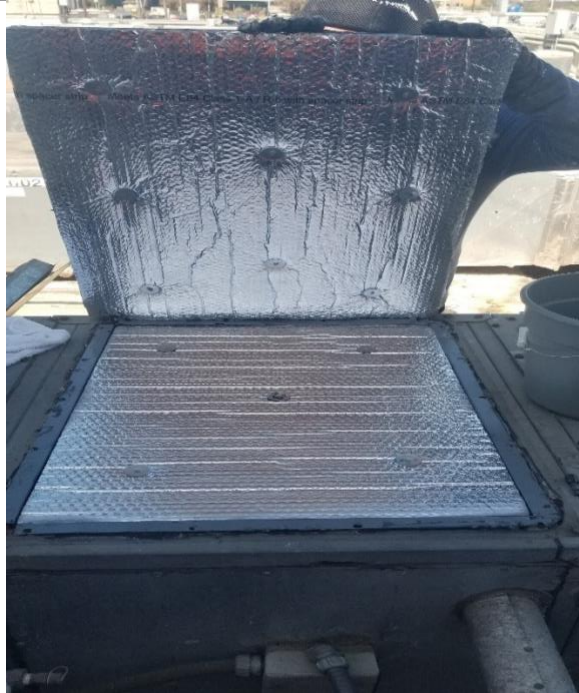
After
All insulation replaced with multiple layers of
Astro Shield

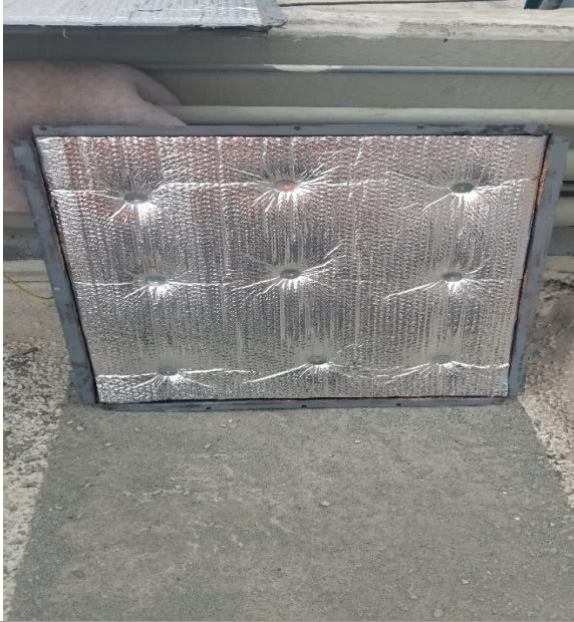
**After
All Astro Shield pinned**

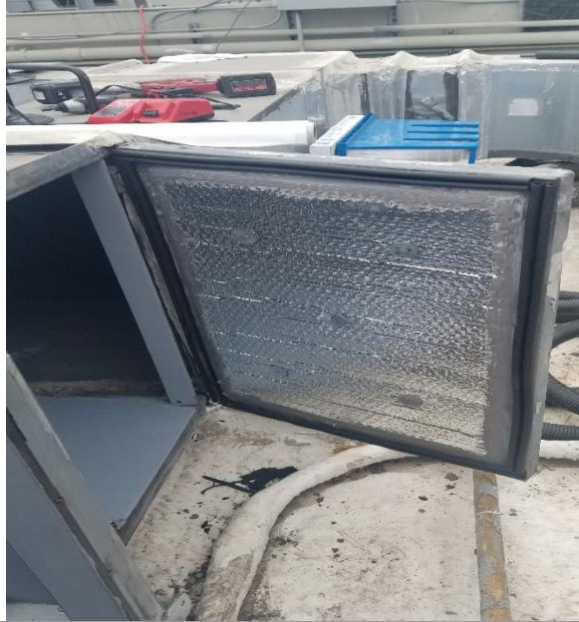
**After
Astro Shield added to access doors.
DP1010/DP1030 added to seams to ensure
complete encapsulation. New gaskets added
to access doors to improve loss of CFM
within unit
(primer before adding paint to interior)**

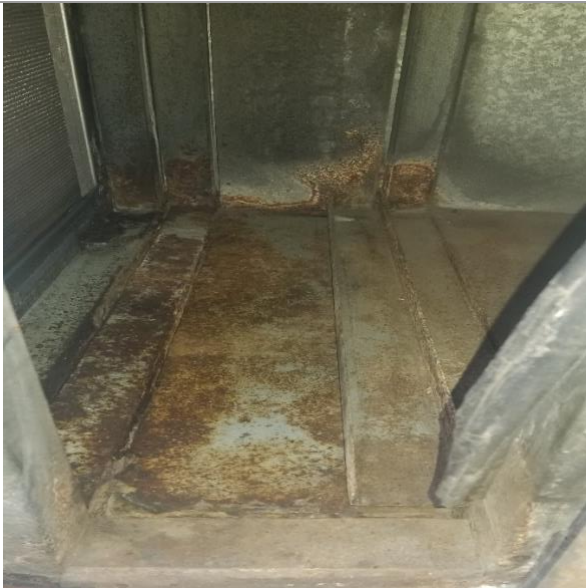
**Before
Outside air filter area**

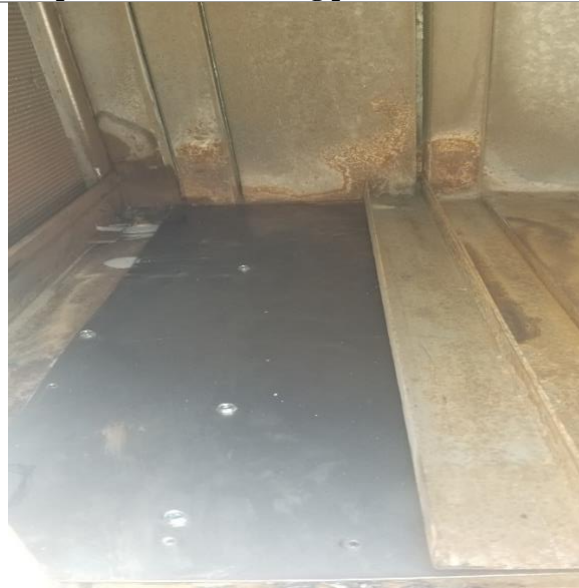
**In Progress
Area wired brushed and new sheet metal**

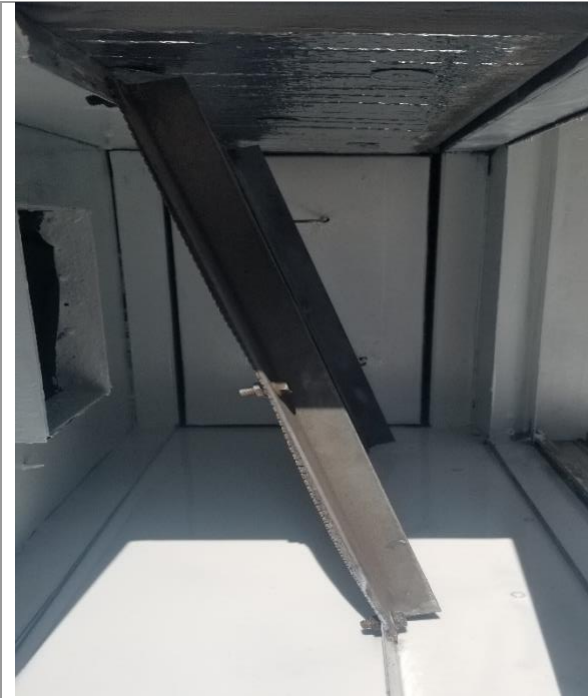
After
Supply area with Silver Bullet and PC 260
(Astro Shield on roof of unit)

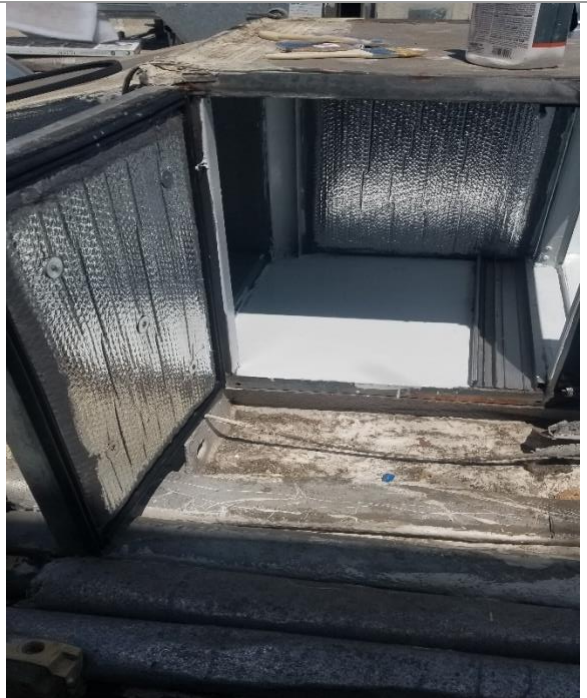
After
Supply filter area with silver bullet, wall
panel and access with Astro Shield

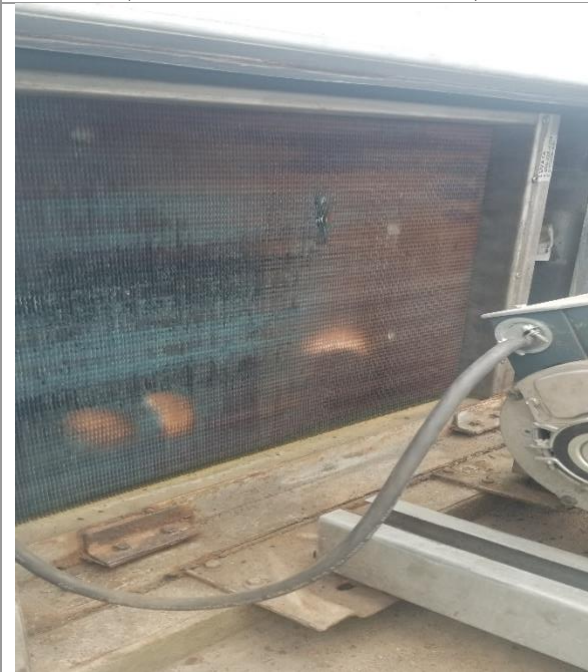
Before
All coils in similar condition

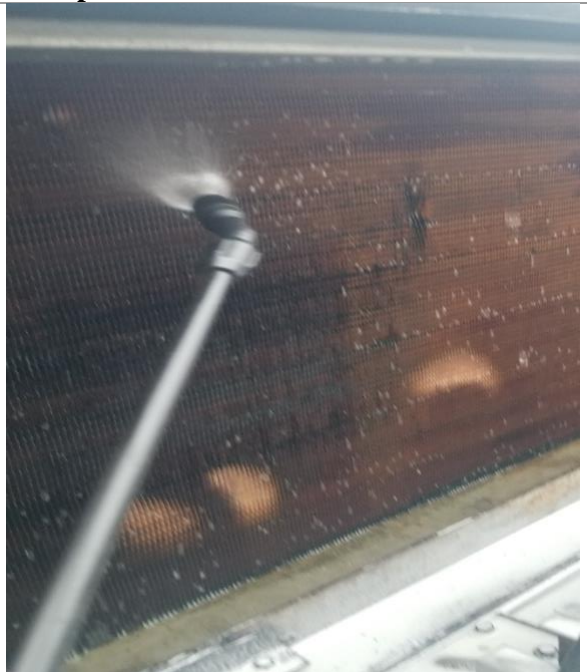
After
Evap used to clean sensitive equipment

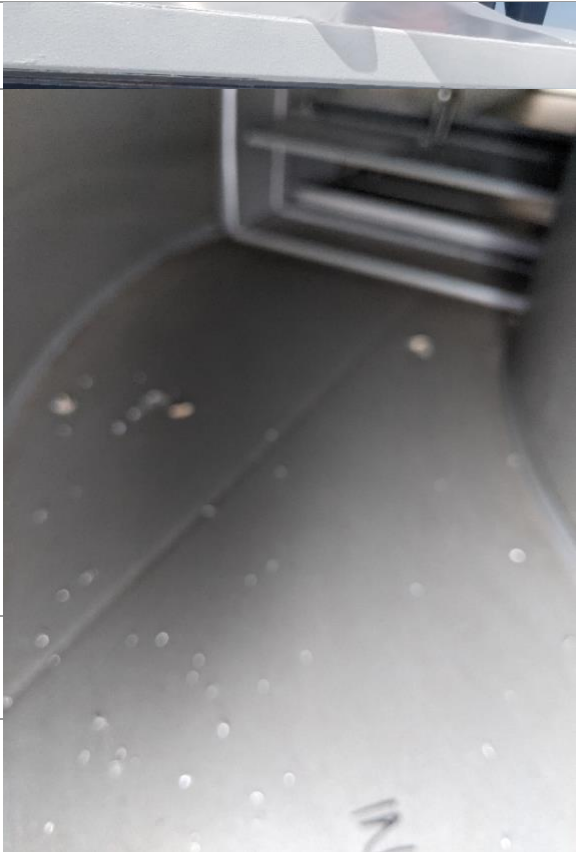
Before
Small duct run with some debris

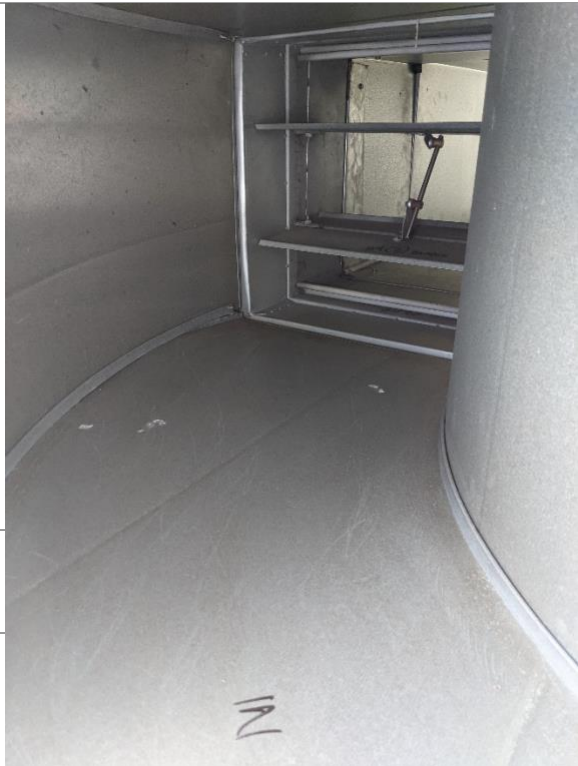
After
Debris cleaned. White specks are stains of some sort, possibly mastic
