**TREBLA**  
INDUSTRIAL RESOURCES, INC.

# DUCT CLEANING FINAL REPORT

## First Floor

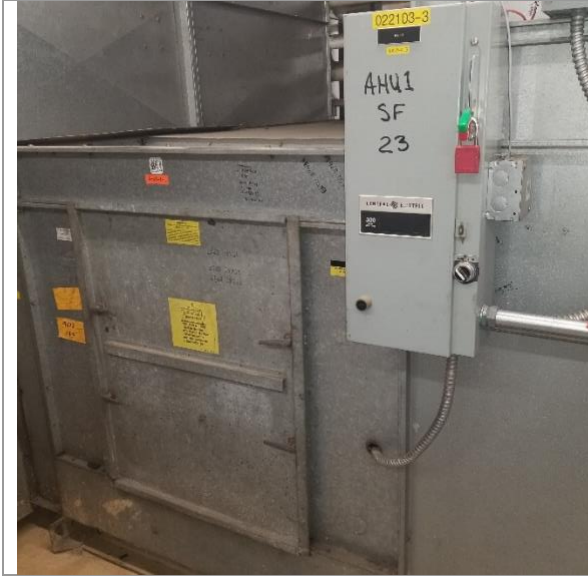
1<sup>st</sup> Floor AHU #1

Unit scrubbed and steamed cleaned. Process also eliminates organic growth

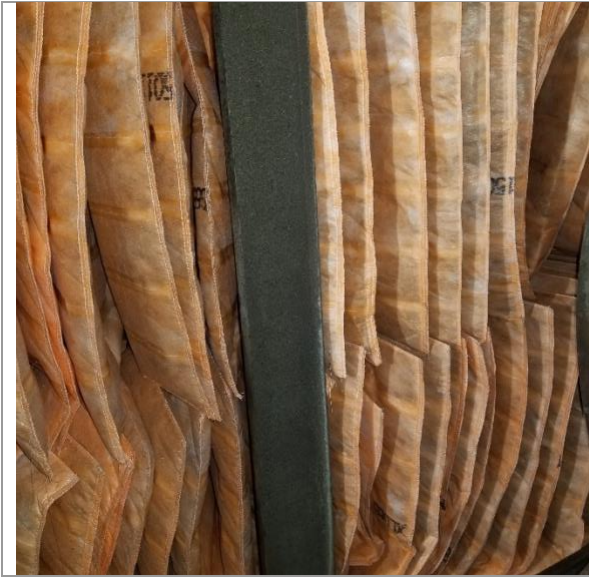
--Before--

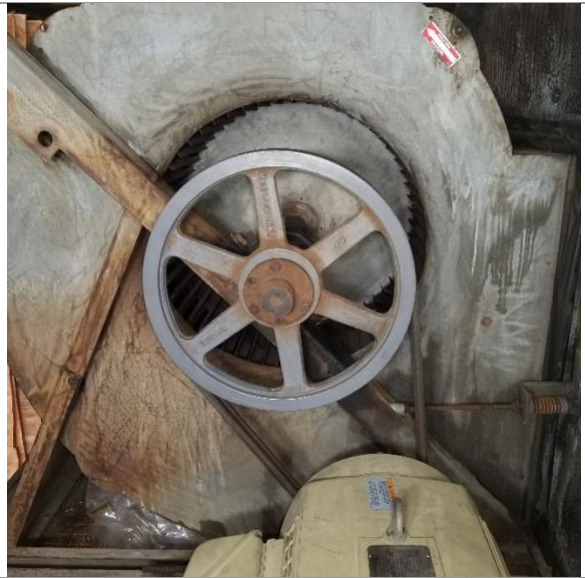
Unit cleaned

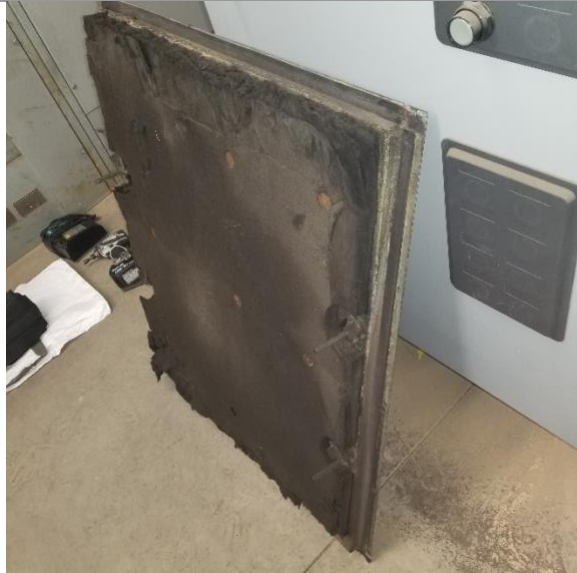
--Before--  
Deteriorating insulation is part of cause for  
debris

1. Origin of black debris was from unit insulation deterioration. AstroShield was added to interior of unit to resolve this issue.
2. Flex ducts in common meeting area and conference room were switched out for new ducts. These old flex ducts with fabric interior are notorious for retaining and spreading old debris, please review pics on report. It is recommended they be changed. Approximately 60 of these flex ducts are located on the first floor and none on second floor.
3. We will have a team return approximately a month from today to remove media filter from registers.

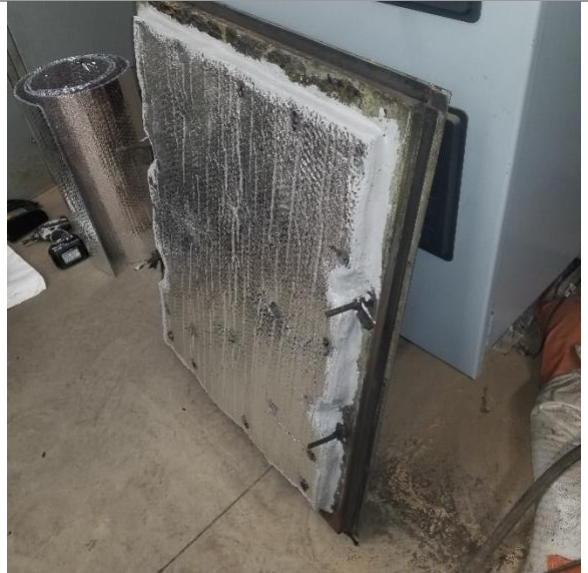
---After---  
AstroShield repair to resolve debris issue from  
doors

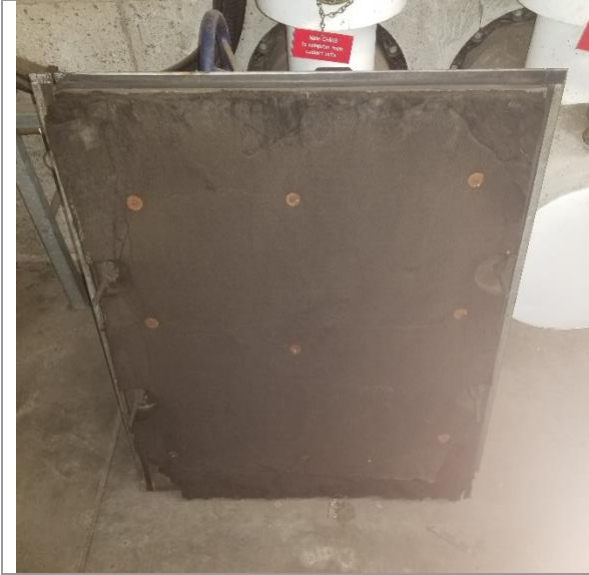
--Before--  
Deteriorating insulation is part of cause for  
debris

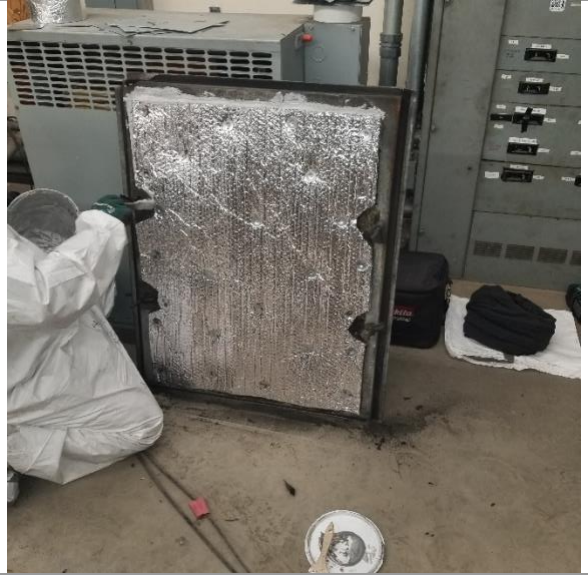
---After---  
AstroShield repair to resolve debris issue from  
doors

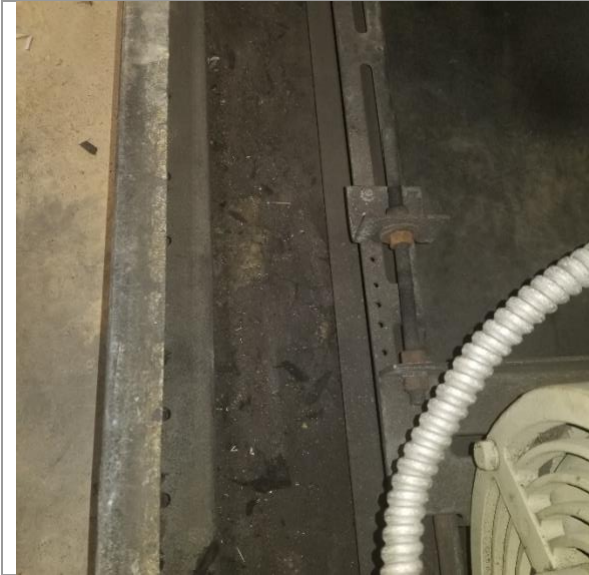
--Before--  
Deteriorating insulation is part of cause for  
debris

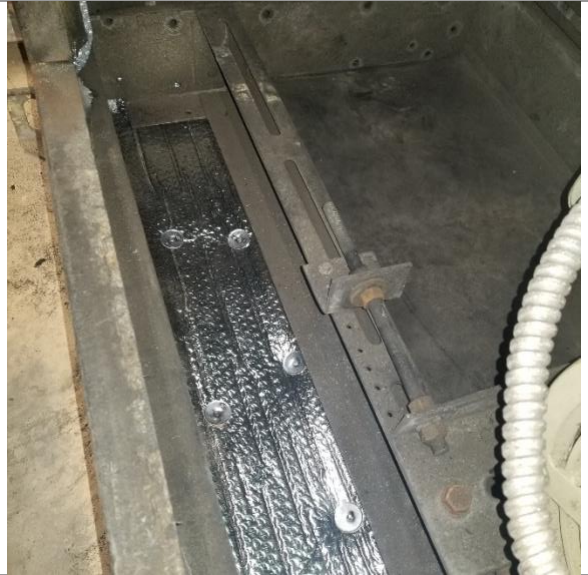
---After---  
AstroShield repair to resolve debris issue from  
unit

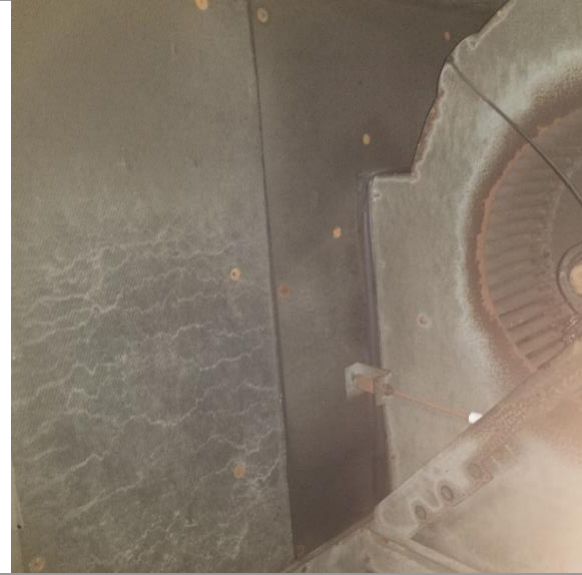
--Before--  
Deteriorating insulation is part of cause for  
debris

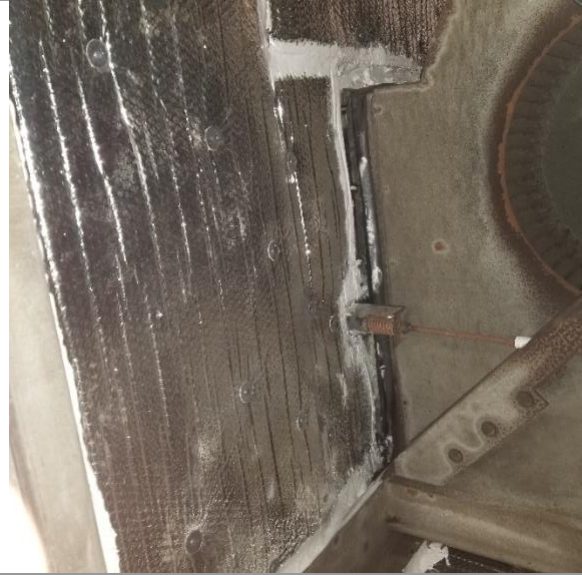
---After---  
AstroShield repair to resolve debris issue from  
unit

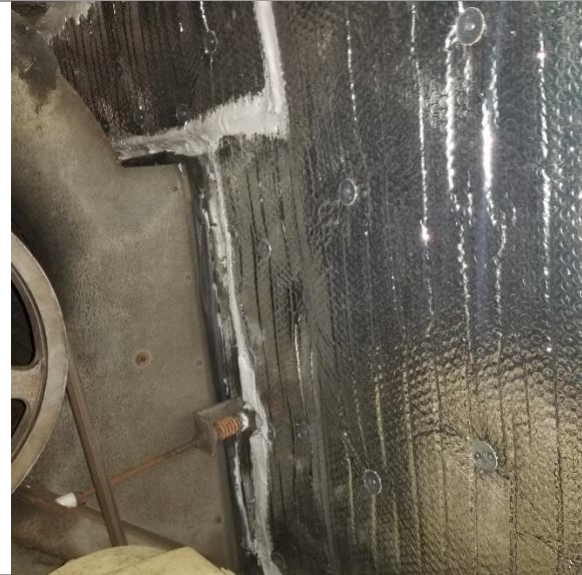
---After---  
AstroShield repair to resolve debris issue from  
unit

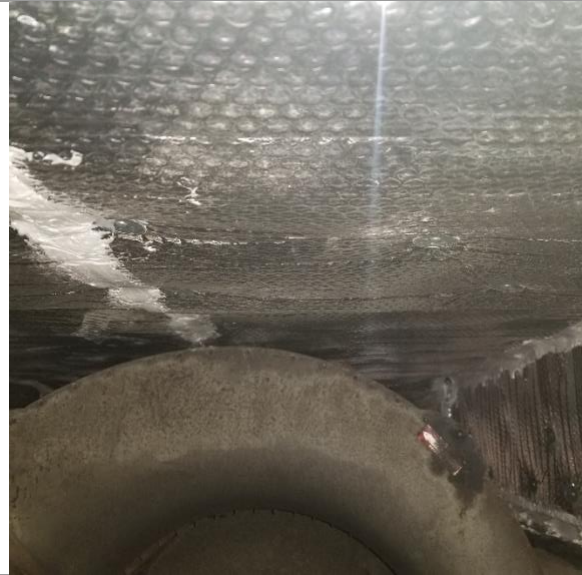
---After---  
AstroShield repair to resolve debris issue from  
unit

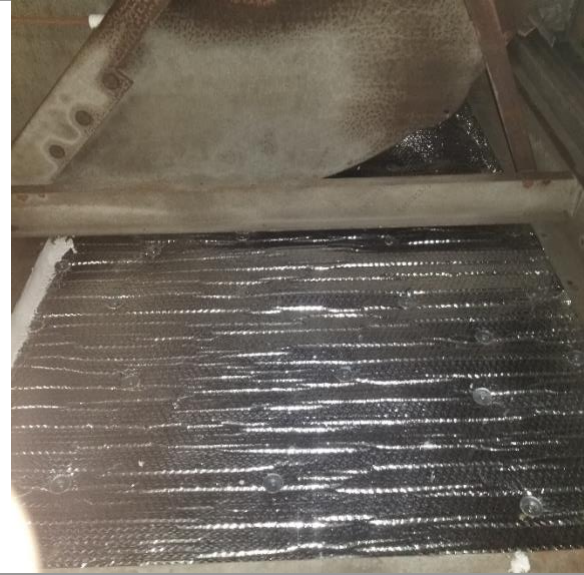
---After---  
AstroShield repair to resolve debris issue from  
unit

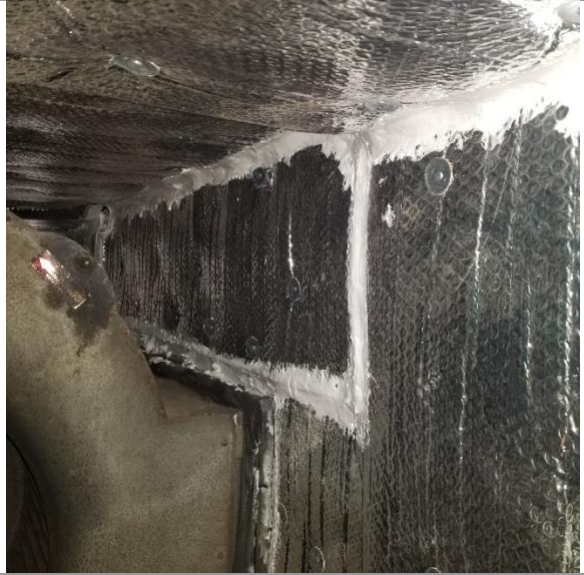
---After---  
AstroShield repair to resolve debris issue from  
unit

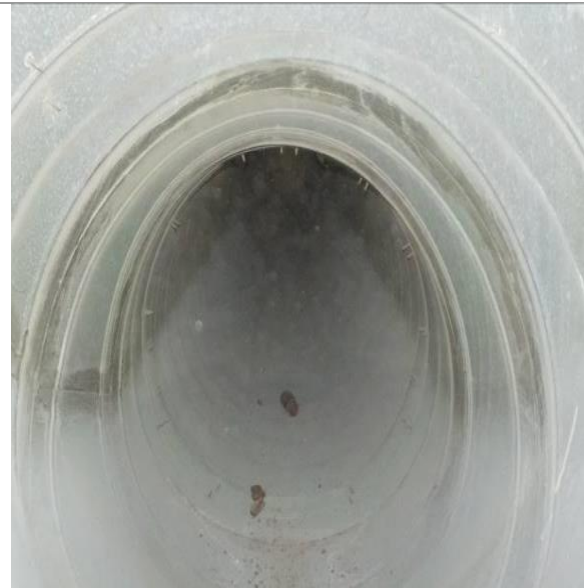
--Before--  
Sample of Mechanical Area Ducts

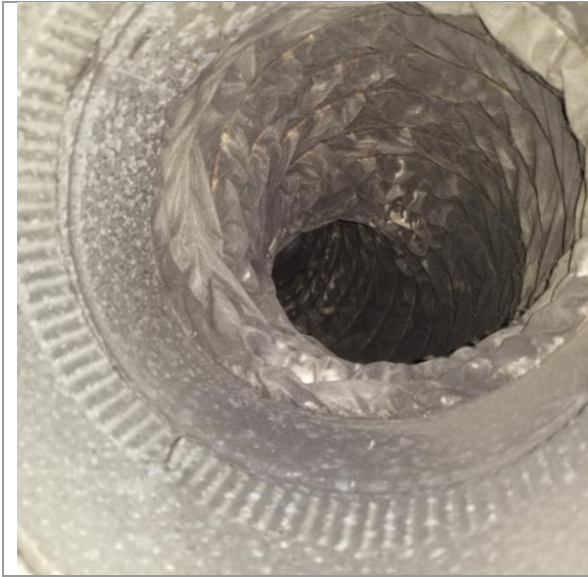
Flex duct deterioration, interior fabric a host for debris

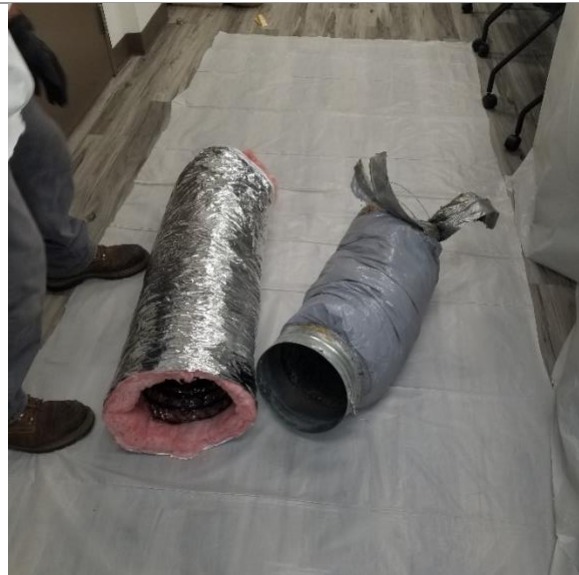
Flex duct replacement (old duct and new duct), meeting room

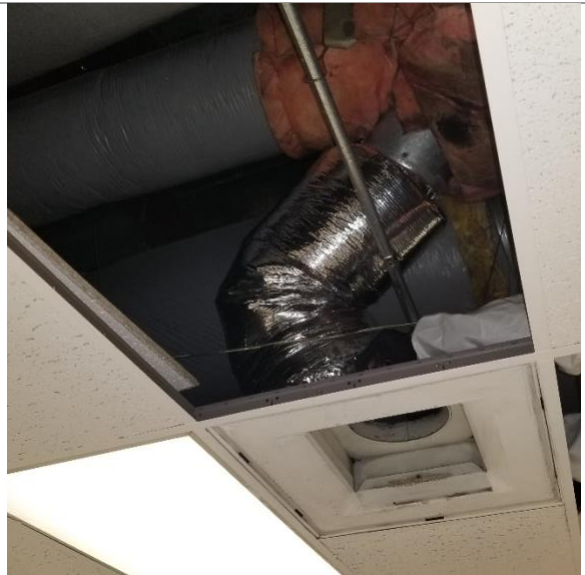
Flex duct replaced (new duct put in)

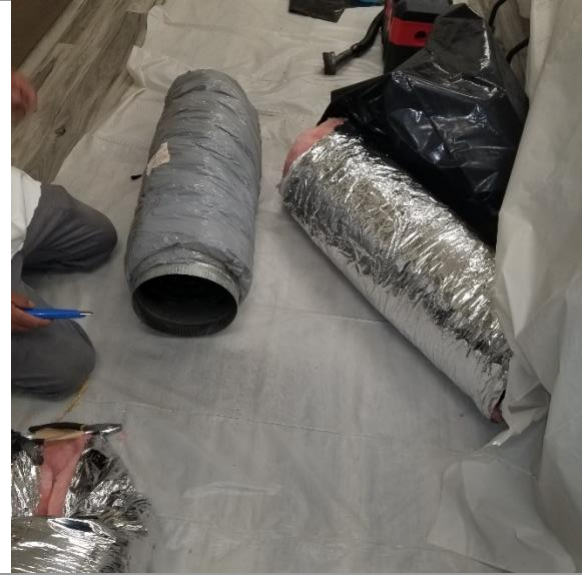
Flex duct replacement (old duct and new duct)

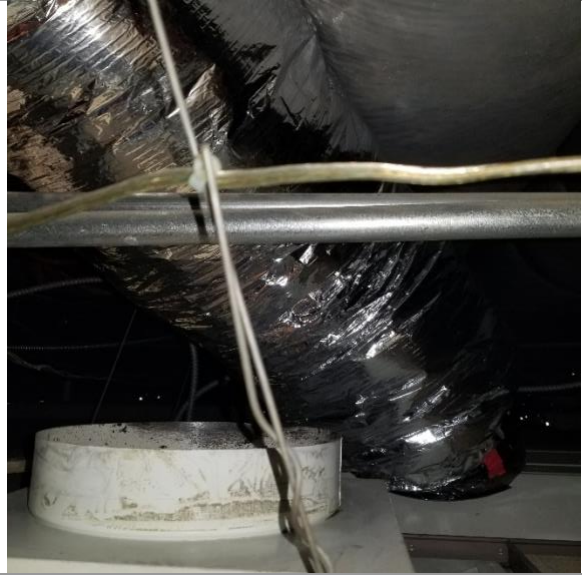
Flex duct replaced (new duct put in)

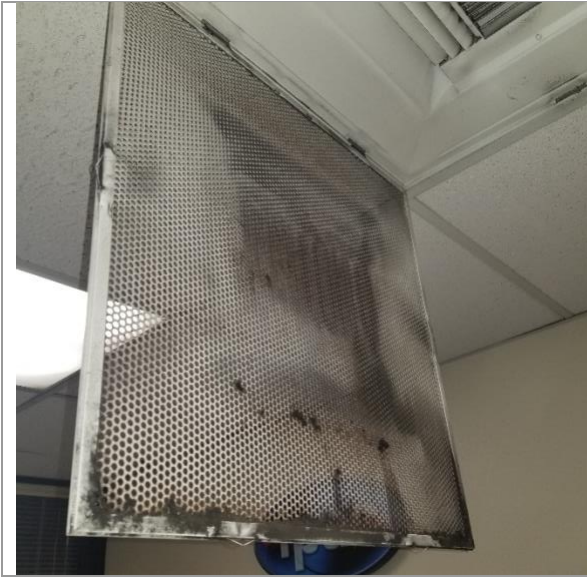
--Before--  
Screens dirty

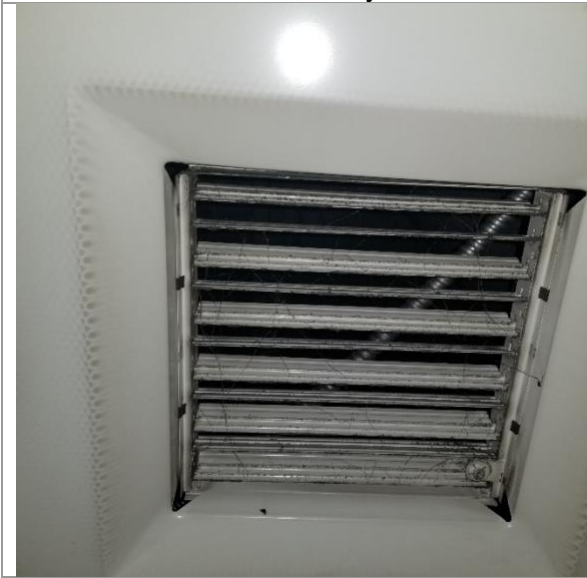
--Before--  
Debris on registers

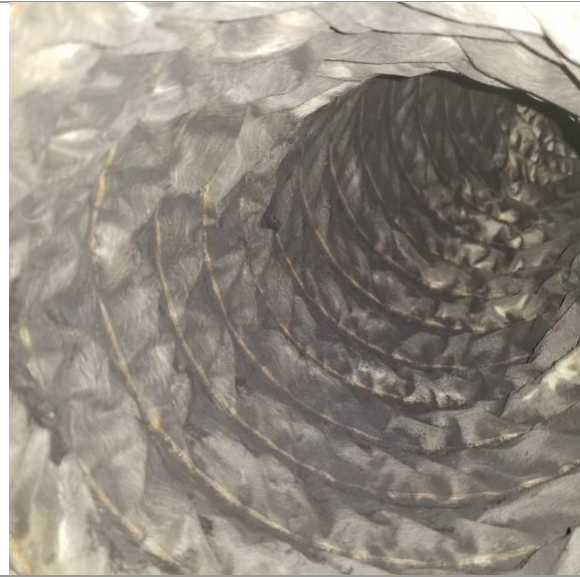
--After--  
Difficult to remove debris from these interior fabric flex ducts. Should consider they be replaced. Mostly found in 1<sup>st</sup> floor offices

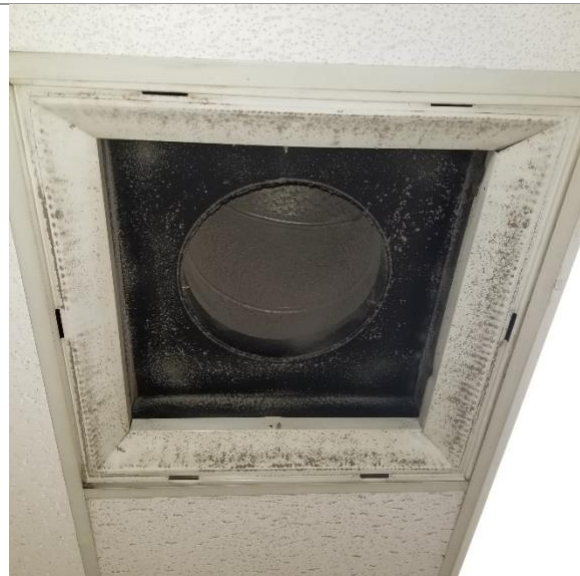
--Before--  
Debris on register housing

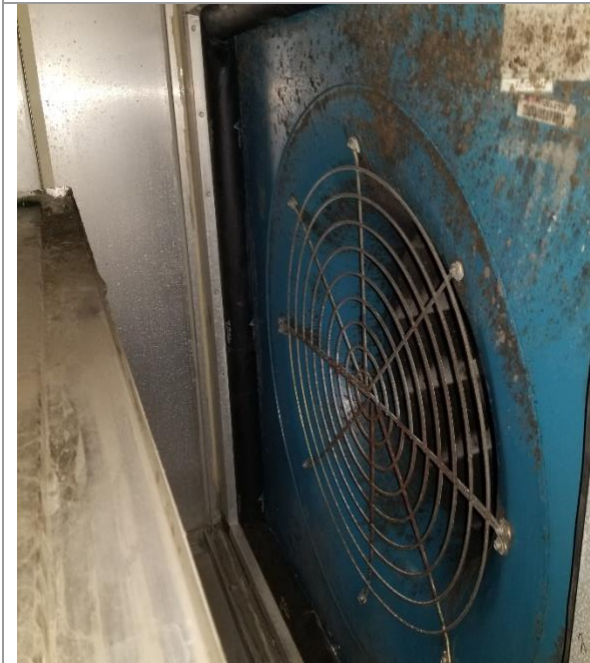
--Before--  
Fan with debris and organic growth

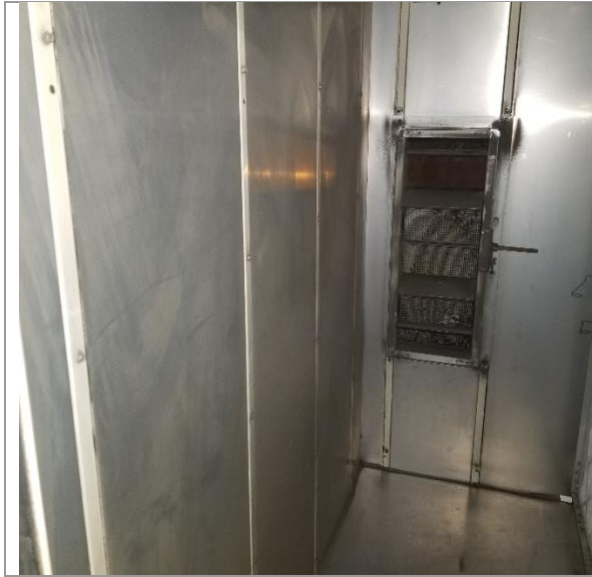
--Before--  
Interior of fan compartment with debris

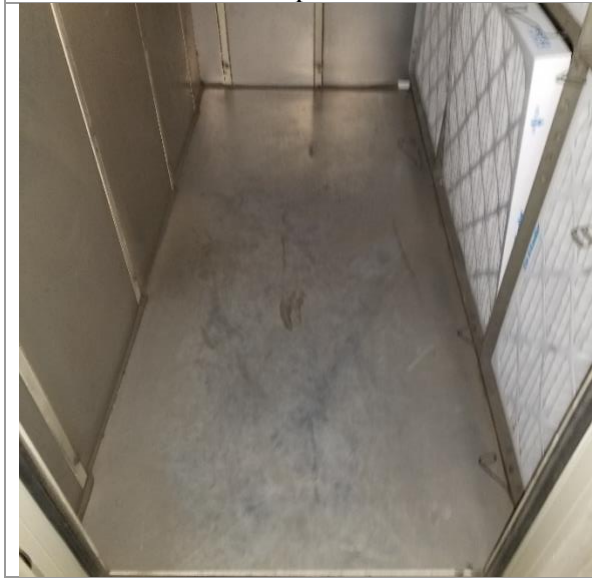
--Before--  
Interior of fan compartment with debris

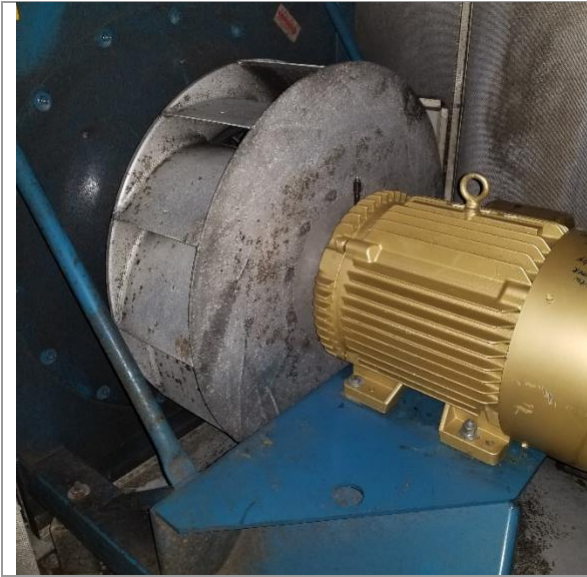
--Before--  
Fan with debris and organic growth

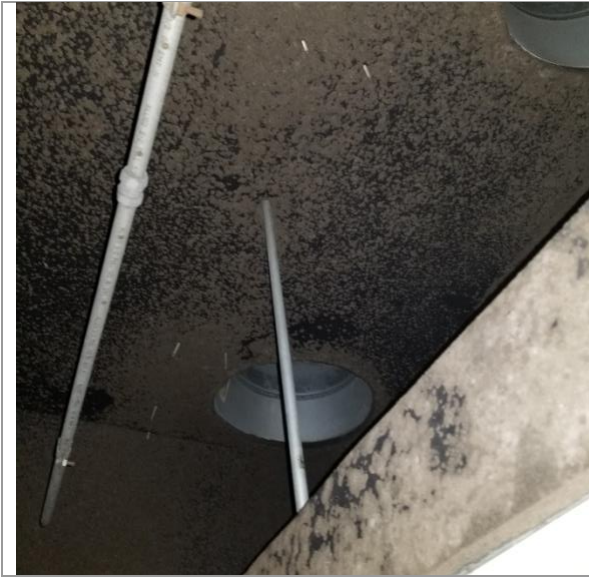
--Before--  
Plenum area with debris and organic growth

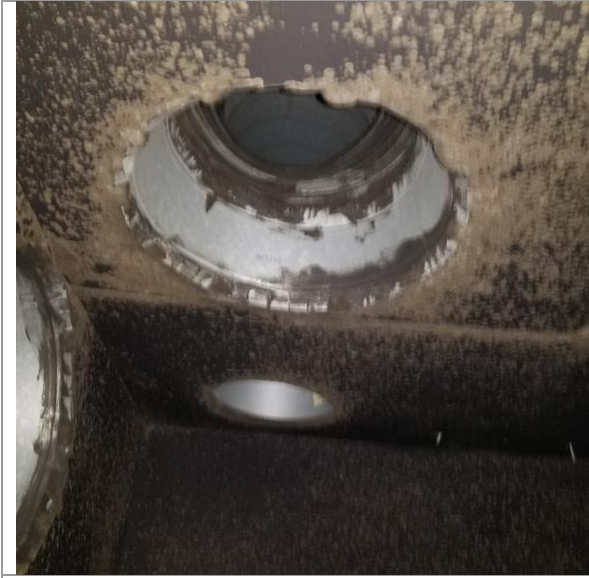
--Before--  
Plenum area with debris and organic growth

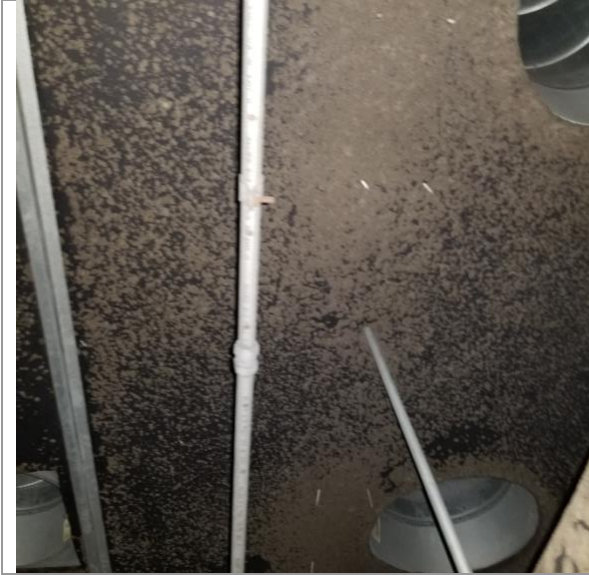
--Before--  
Plenum area with debris and organic growth

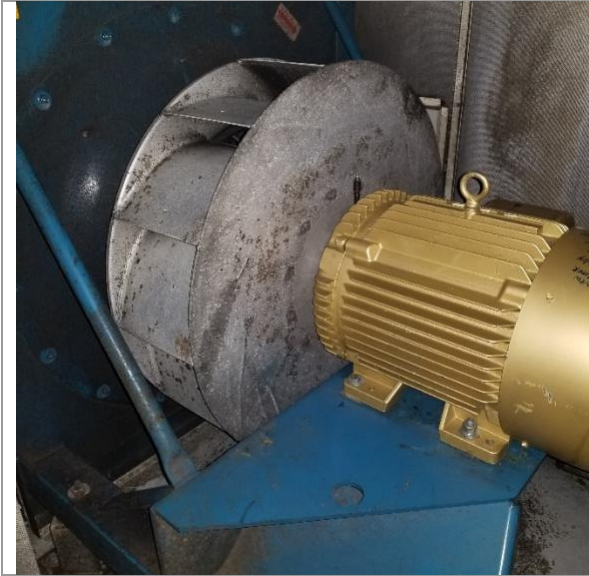
--Before--  
Fan dirty

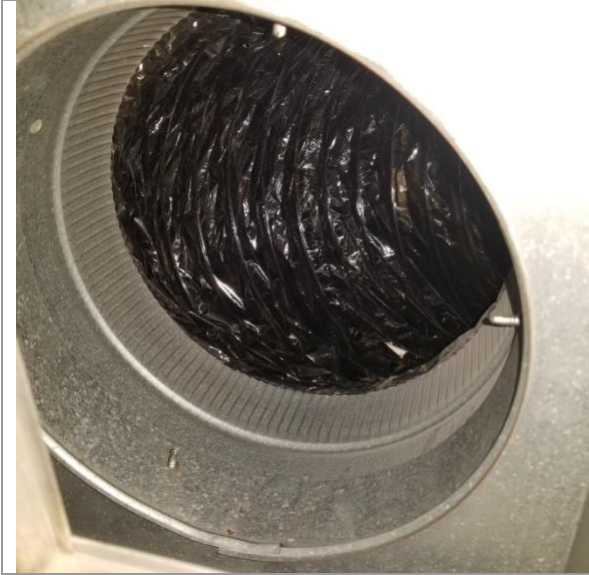
--Before--  
Dirty flex duct

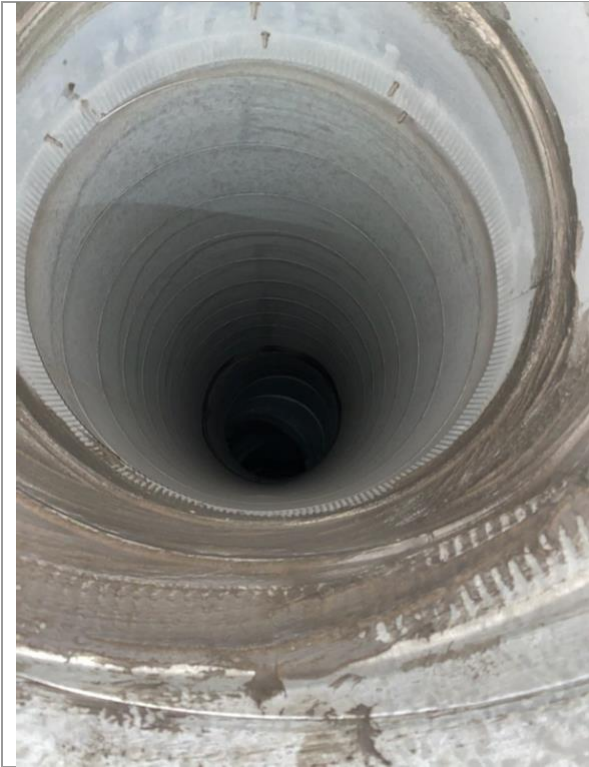
--Before--  
Dirty main duct

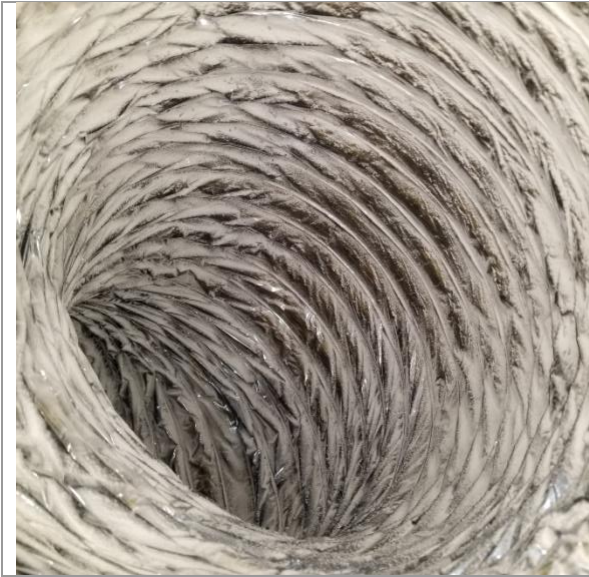
-Before-  
Dirty flex duct

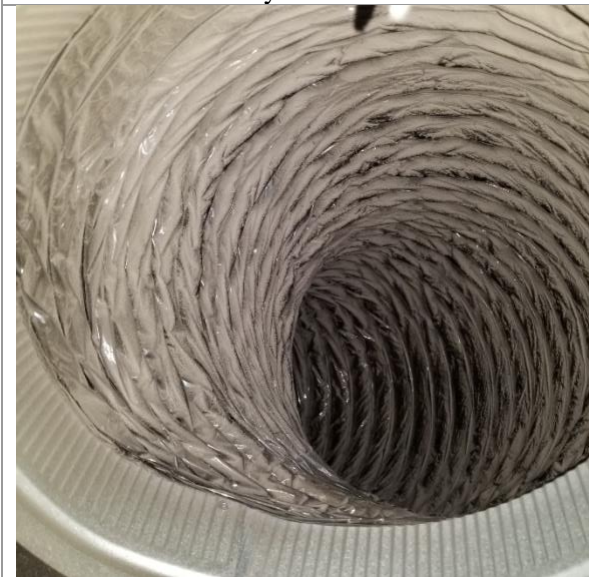
-Before-  
Dirty flex duct

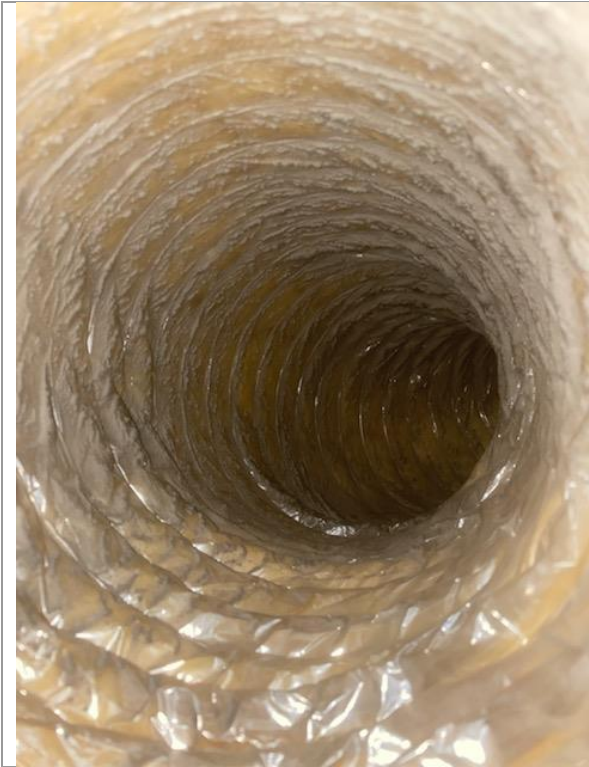
-Before-  
Dirty flex duct

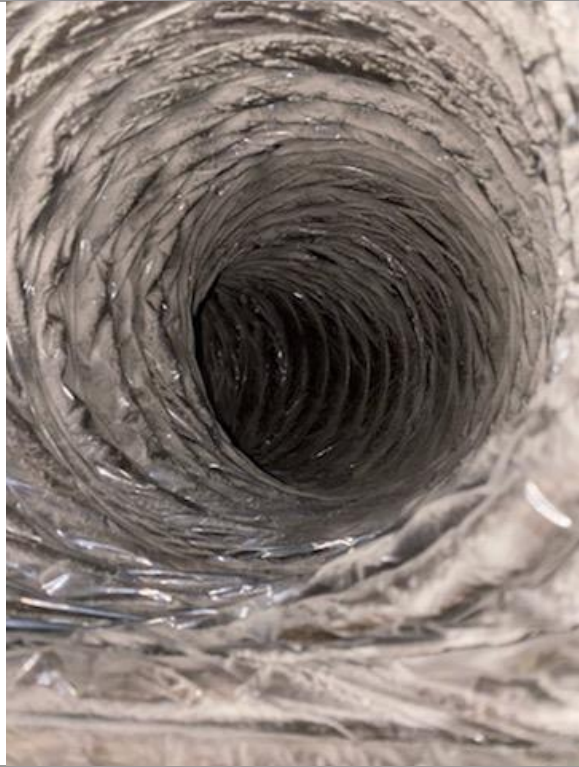
-Before-  
Dirty flex duct
