# Hospital Pharmacy HVAC Final Report

Report Approved by Alberto Amezcua  
Project Completed 07/22/22

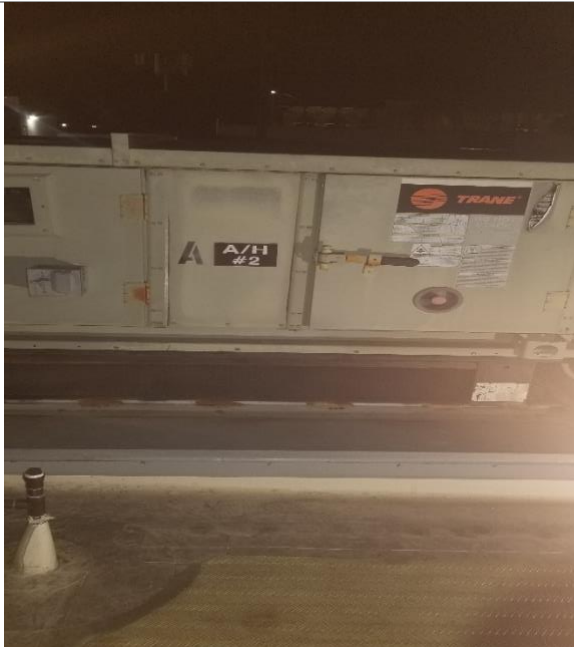
**Unit Cleaned**

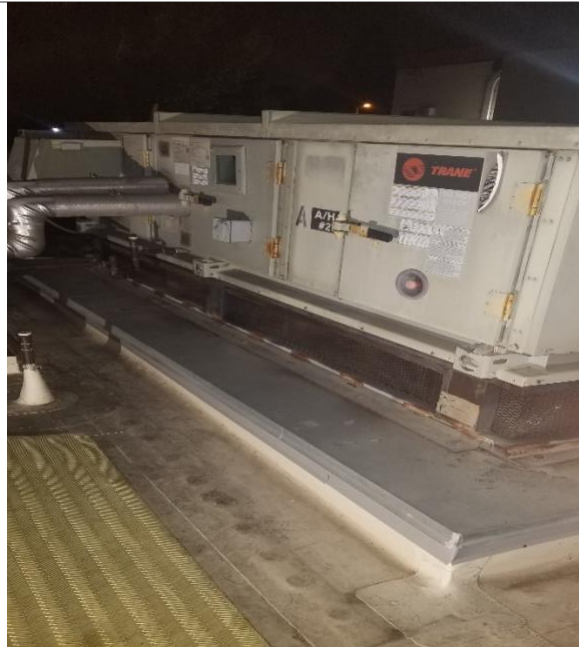
**Unit Cleaned**

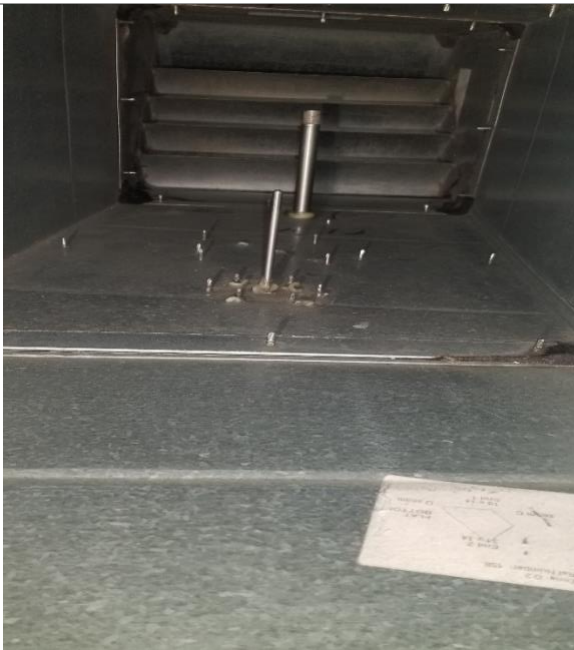
**Before  
Interior Duct with Louvers/Dampers**

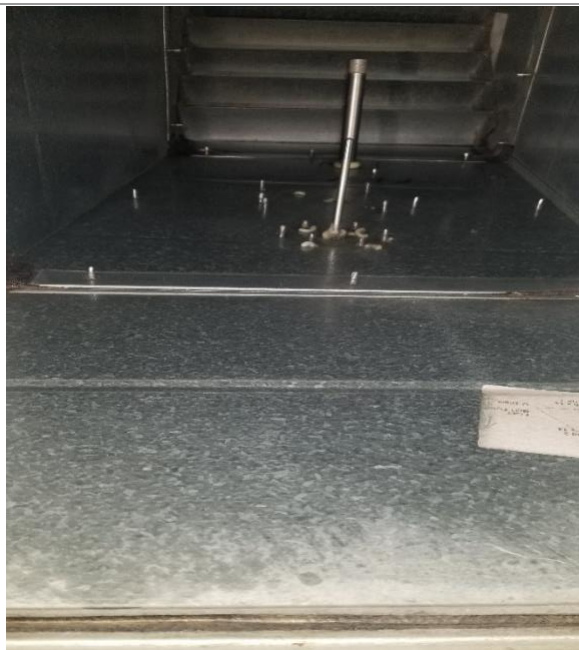
**After  
Interior Duct with Louvers/Dampers**

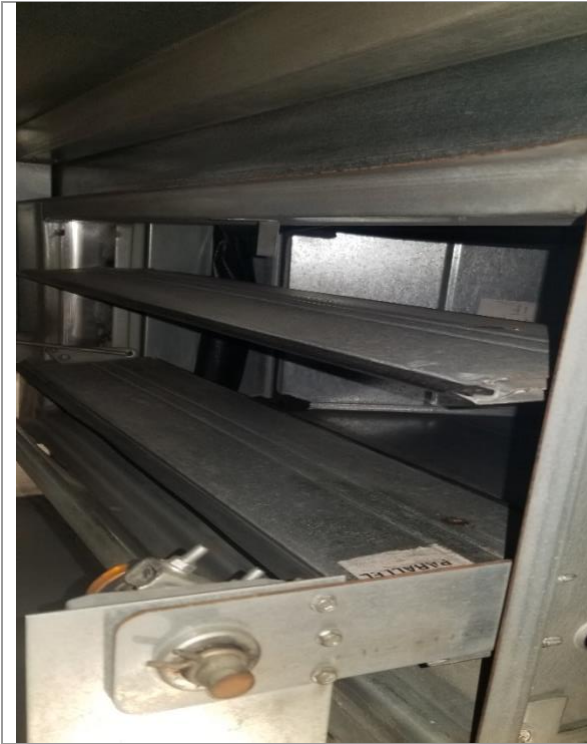
**Before  
Dampers**

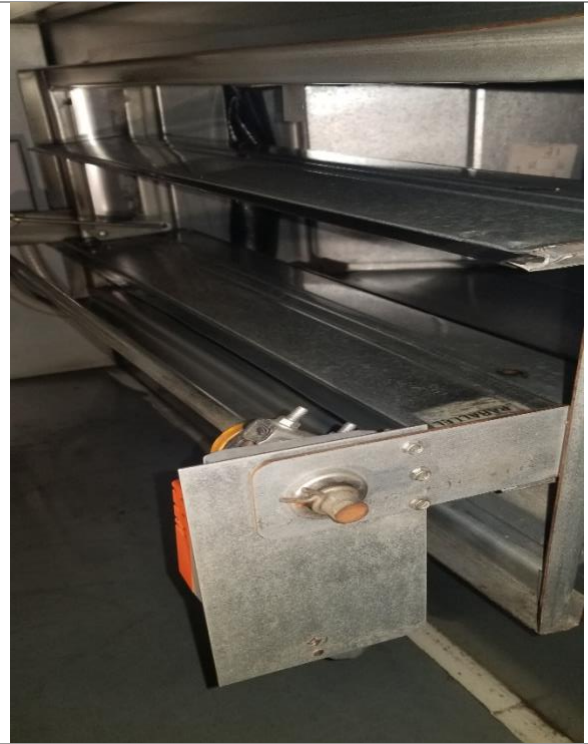
**After  
Dampers**

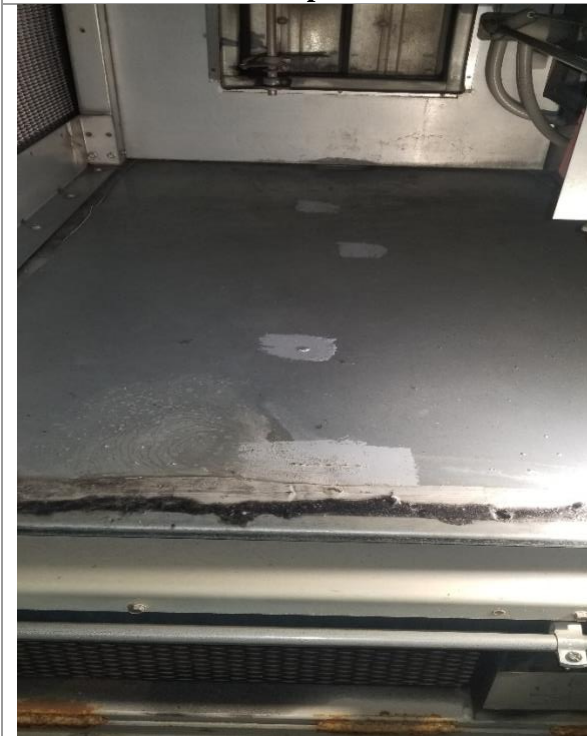
**Before  
Interior of Unit**

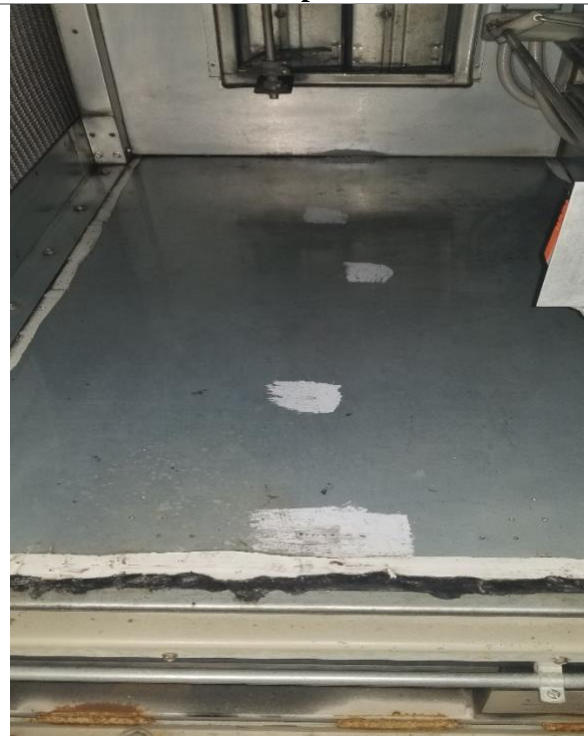
**After  
Interior of Unit**

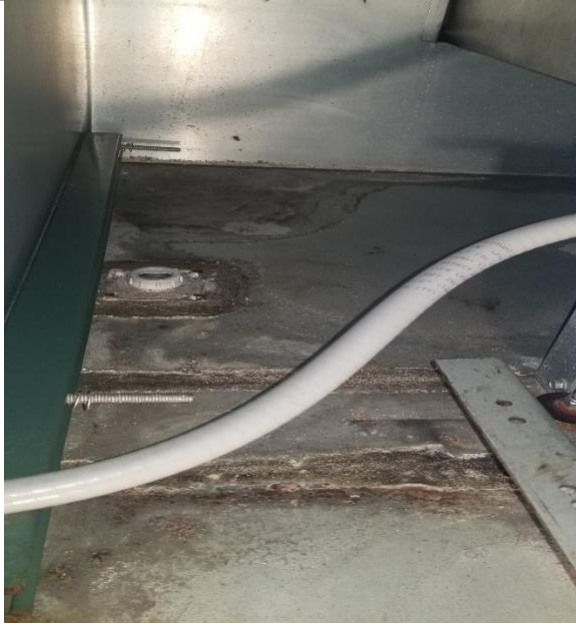
**Before**  
**Interior of unit with corrosion (Supply Side)**

Interior unit cleaned ducts and pharmacy registers. Sporicidin was added to disinfect unit, ducts, and registers. We recommend that a protective sealant be added to metal floor corroding areas to prolong life of unit integrity. Fan belt and other components in good working order

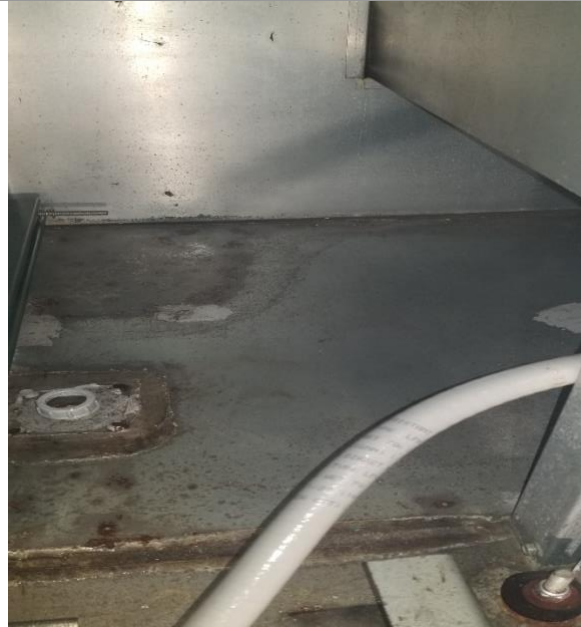
**After**  
**Interior of Unit**

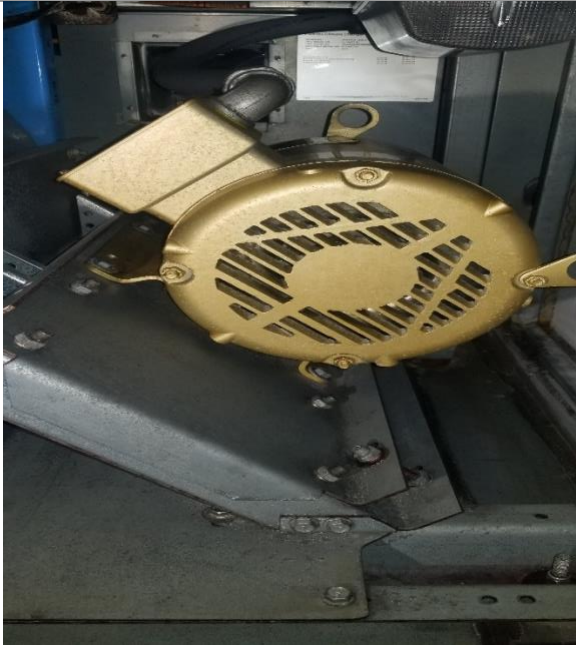
**Before**  
**Interior Fan Motor**

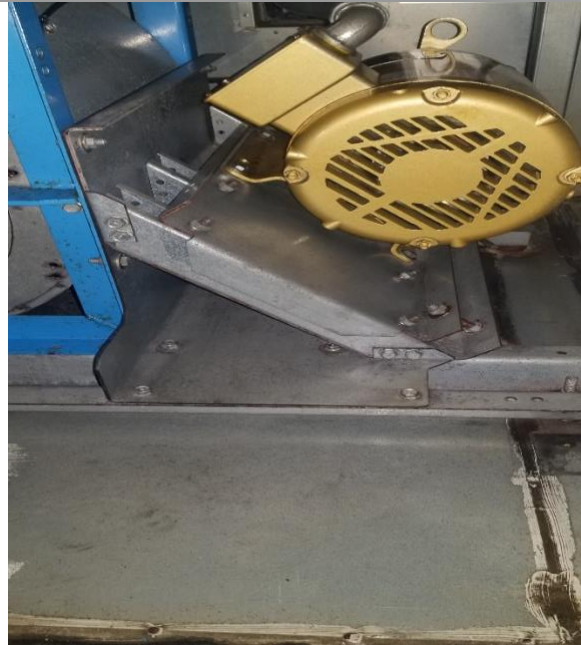
**After**  
**Interior Fan Motor**

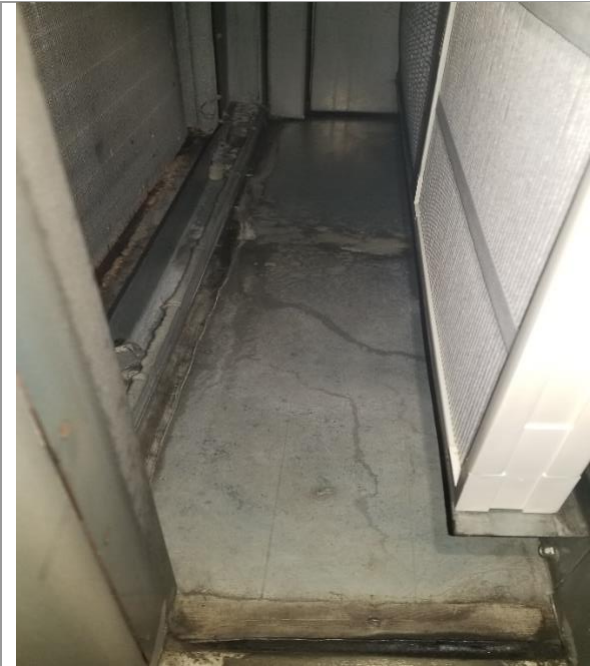
**Before  
Filter Area**

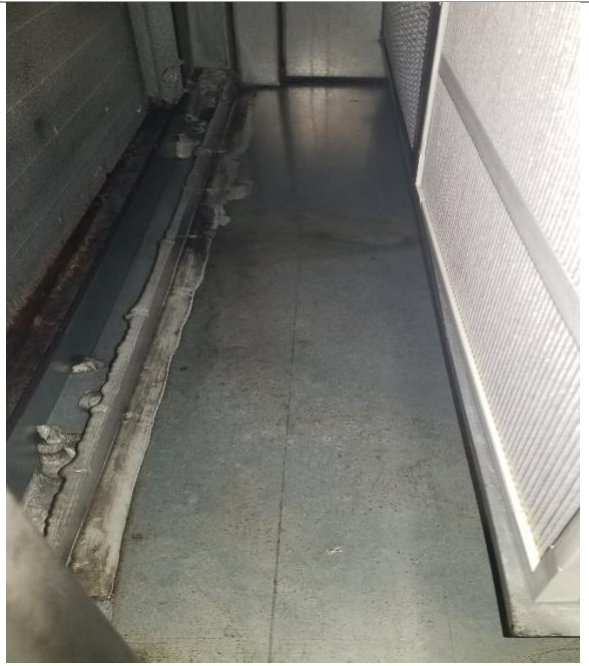
**After  
Filter Area**

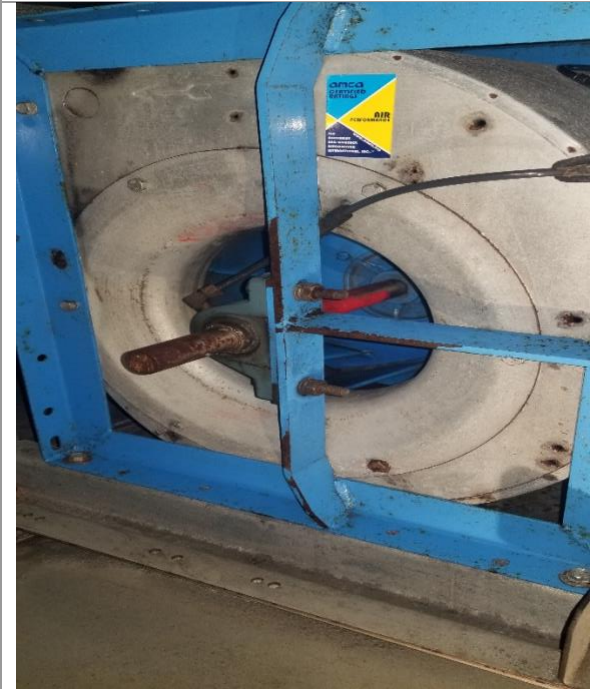
**Before  
Fan Area and Blades**

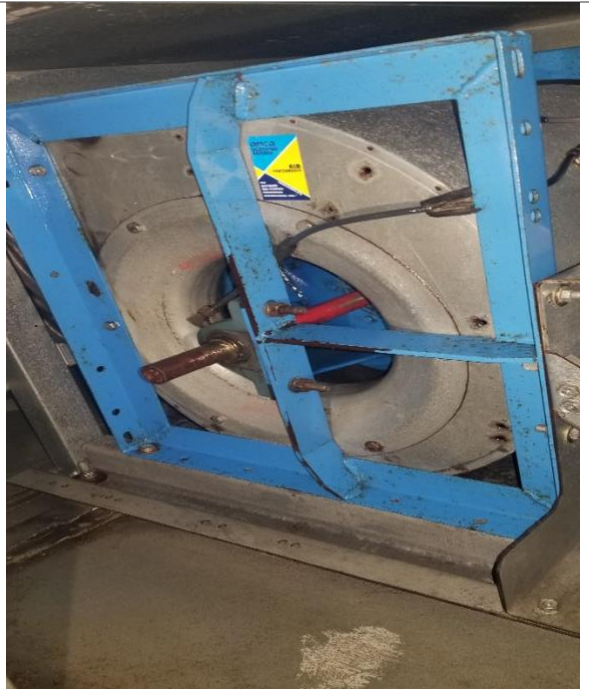
**After  
Fan Area and Blades**

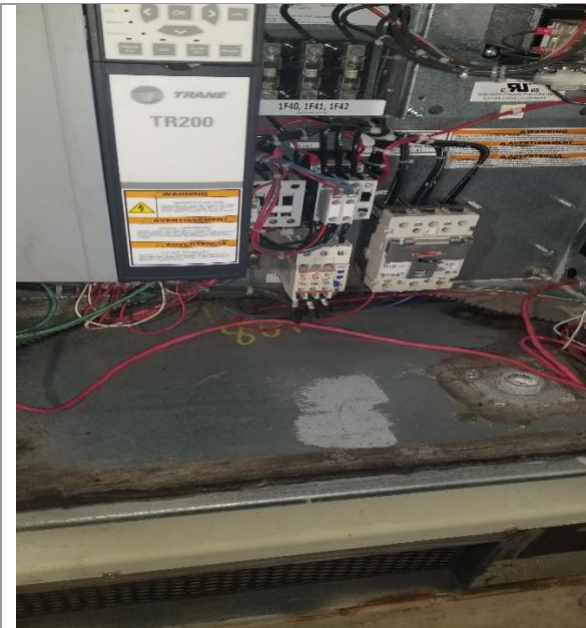
**Before  
Electrical Compartment**

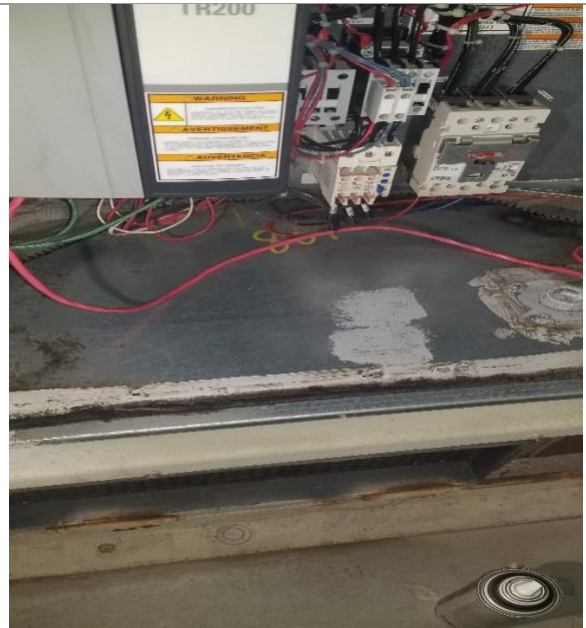
**After  
Electrical Compartment**

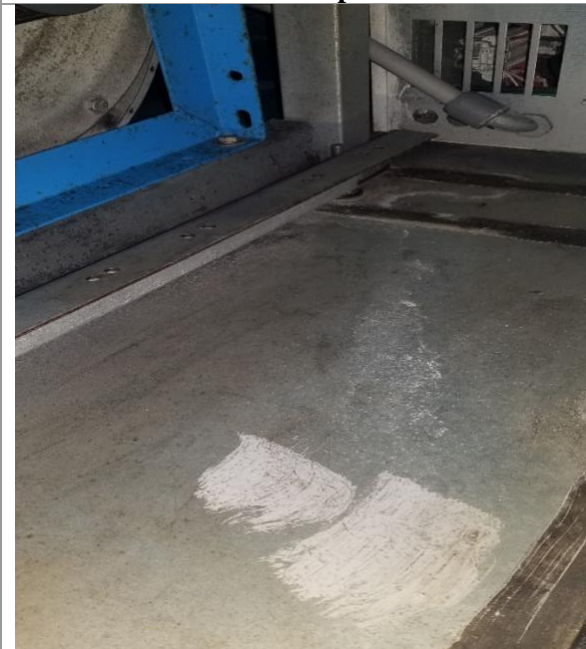
**Before  
Coil Area**

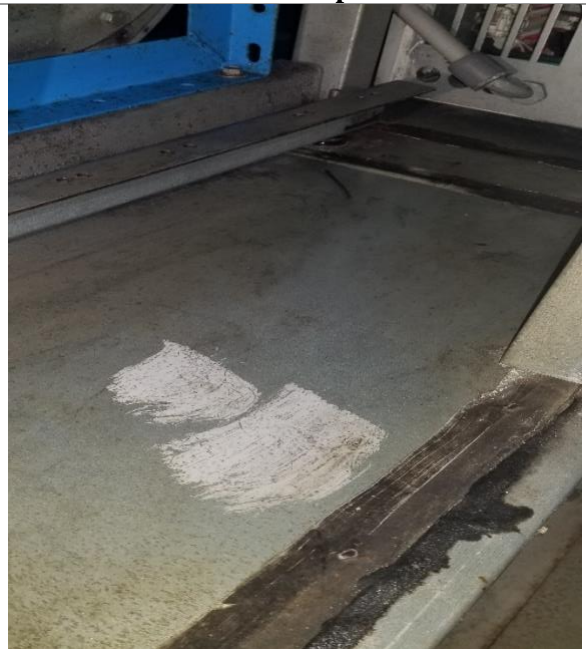
**After  
Coil Area**

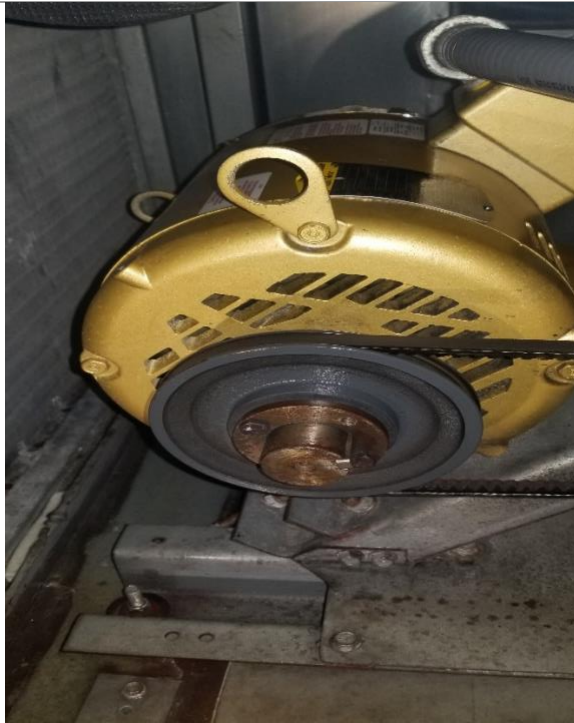
**Before**  
**Reverse Motor Area – Belt in good condition**  
**(Some corrosion observed)**

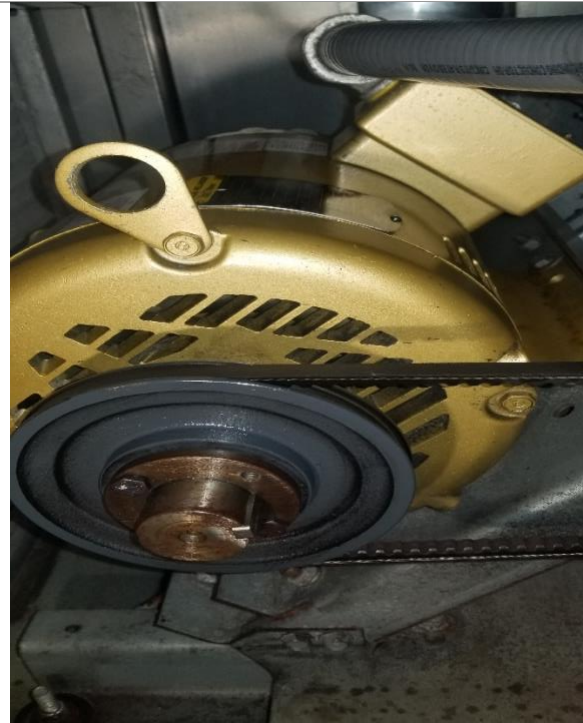
**After**  
**Reverse Motor Area – Belt in good condition**

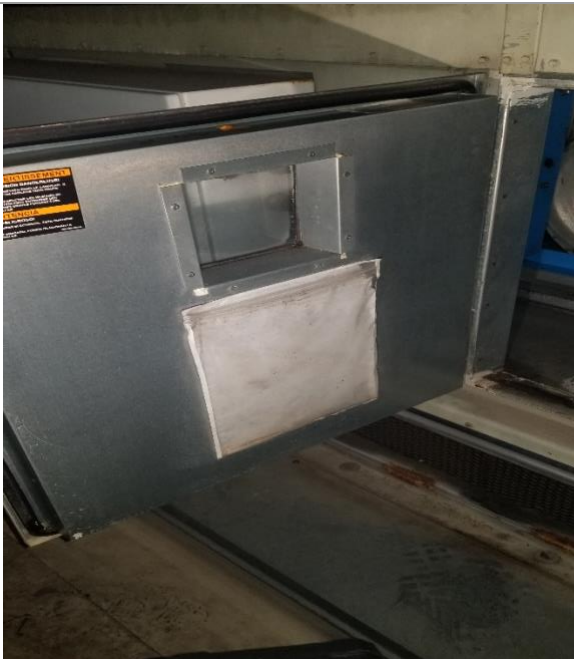
**Before**  
**Interior of access doors**

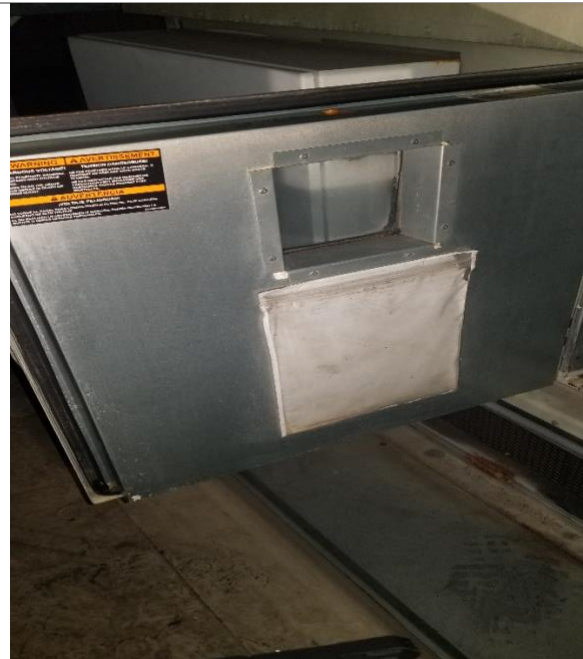
**After**  
**Interior of Access Doors**
