# Final Report

## YACHT Laundry Exhaust System & Kitchen Exhaust System

Project Performed 09/19/20  
Report Approved by Alberto Amezcua

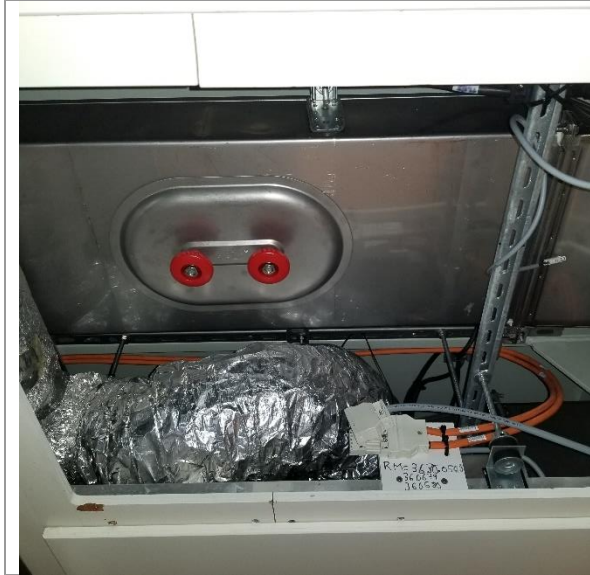
**Before  
Exhaust System Access Sealed**

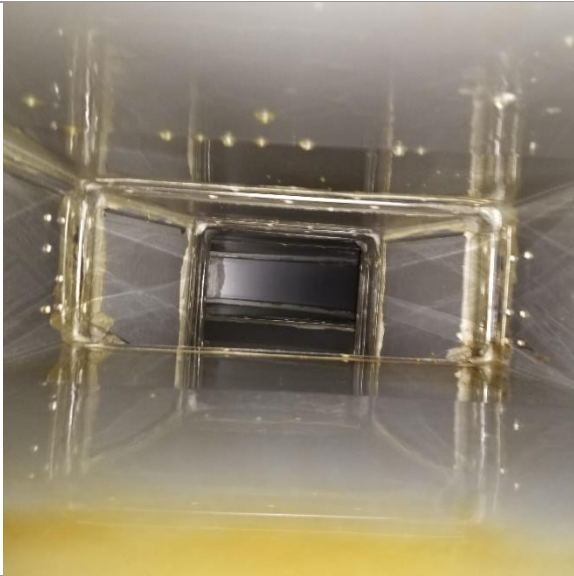
**BEFORE  
Horizontal Duct with Grease**

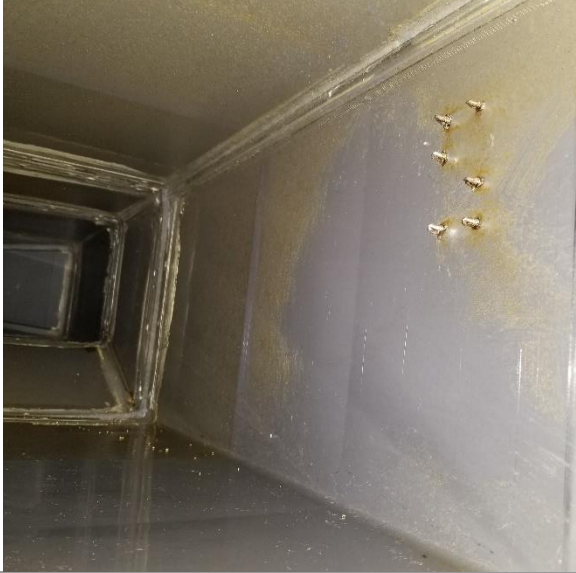
**BEFORE**  
**Walls Partially Cleaned**

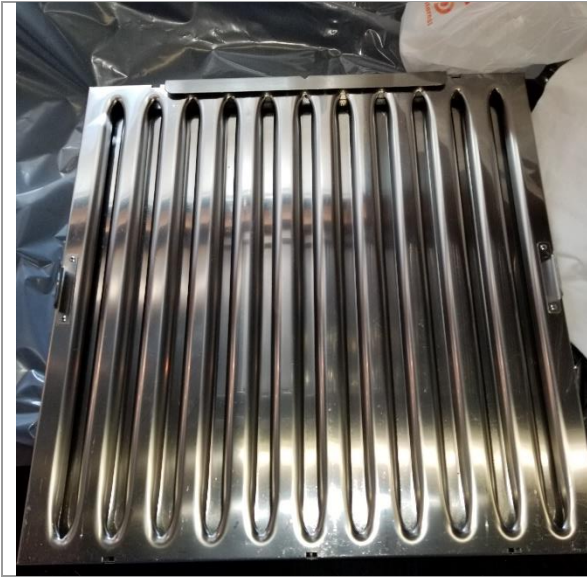
**Before**  
**Baffle Filters with Slight Grease**

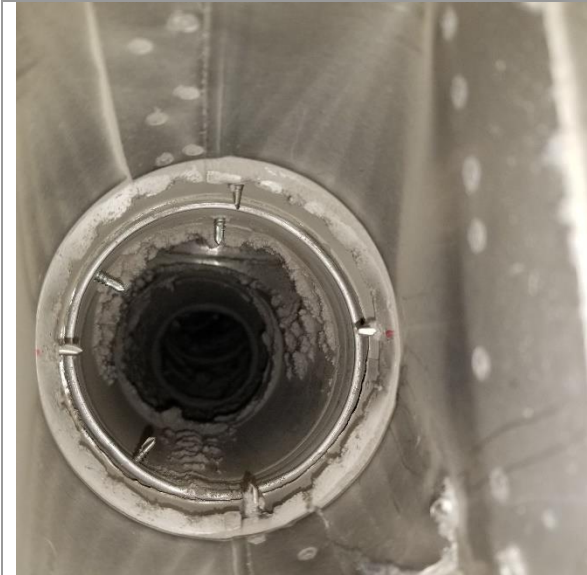
**BEFORE**  
**Typical Round Duct Dirty**

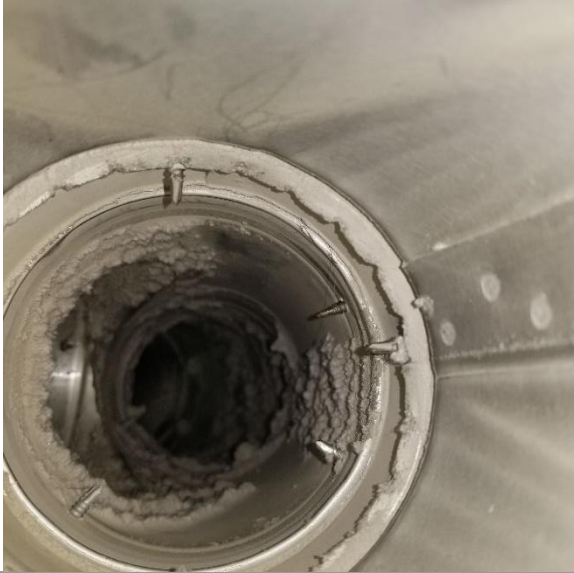
**BEFORE**  
**Typical Round Duct Dirty**

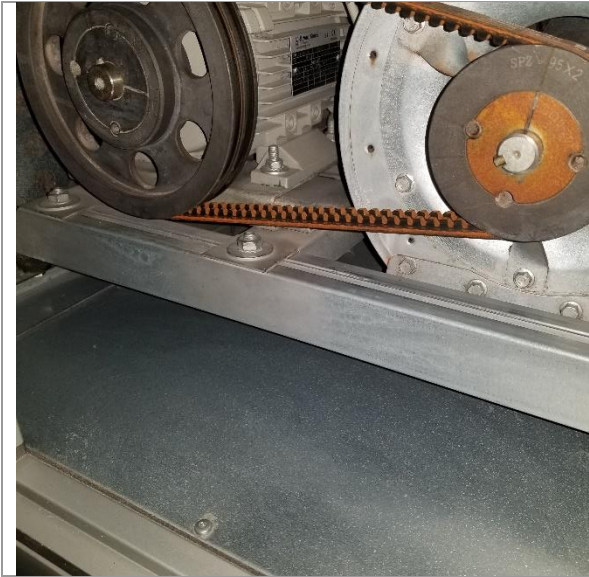
**BEFORE**  
**Unit Dirty**
