# FLOUR Silo #1 & #2 Final Report

Projects Performed 05/22/22 & 05/23/22  
Report Approved by Alberto Amezcua

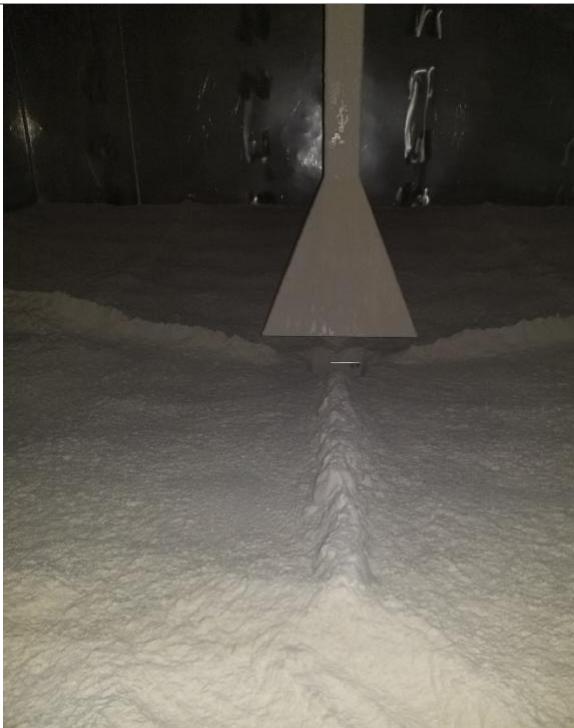
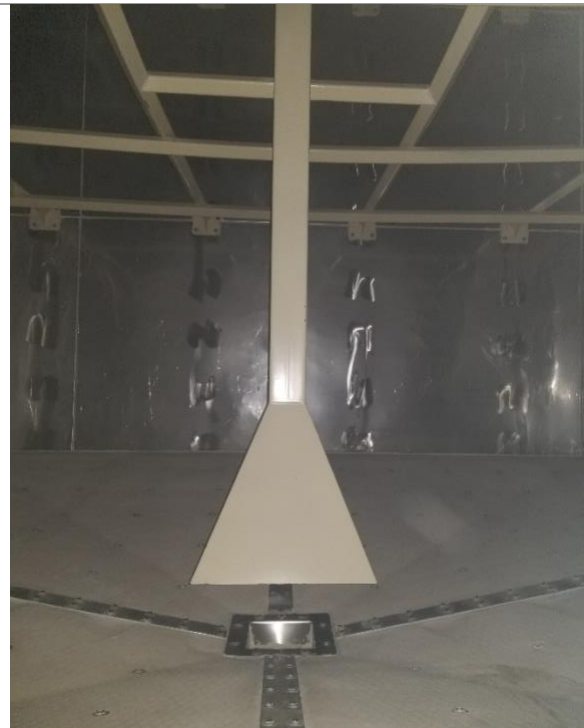
**Before  
Interior floor**

**After**

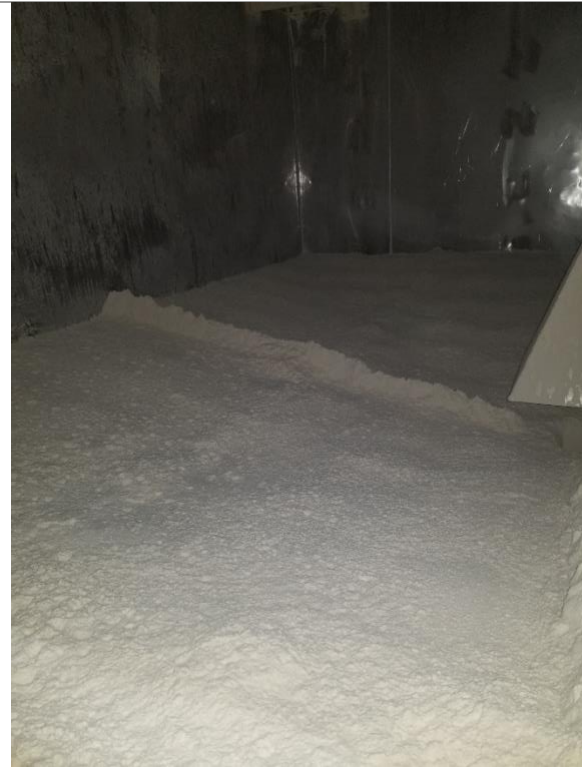
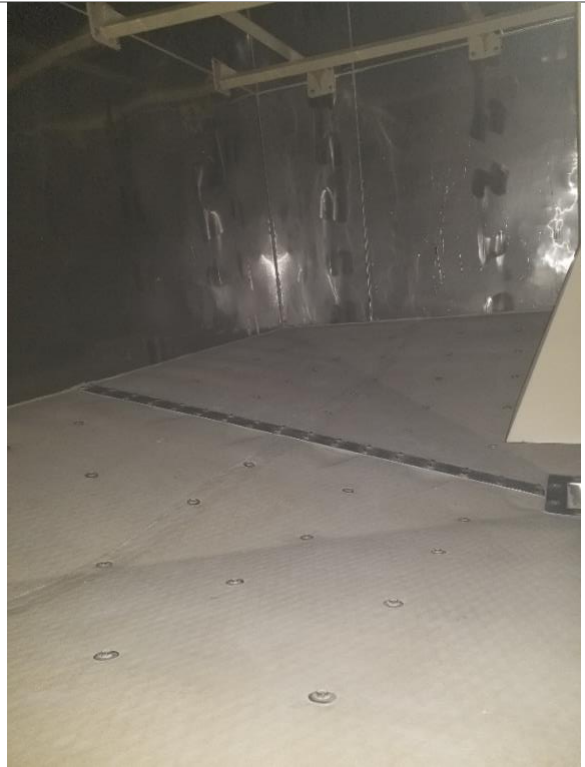
**Before  
Interior floor**

**After**

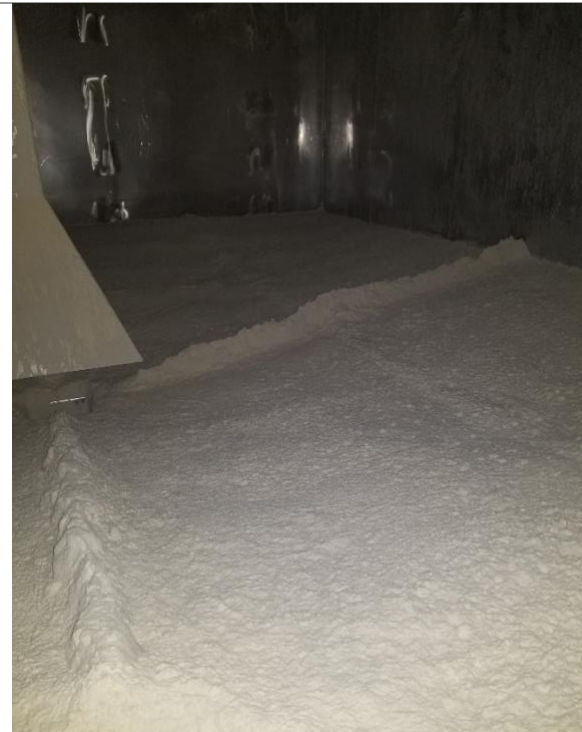
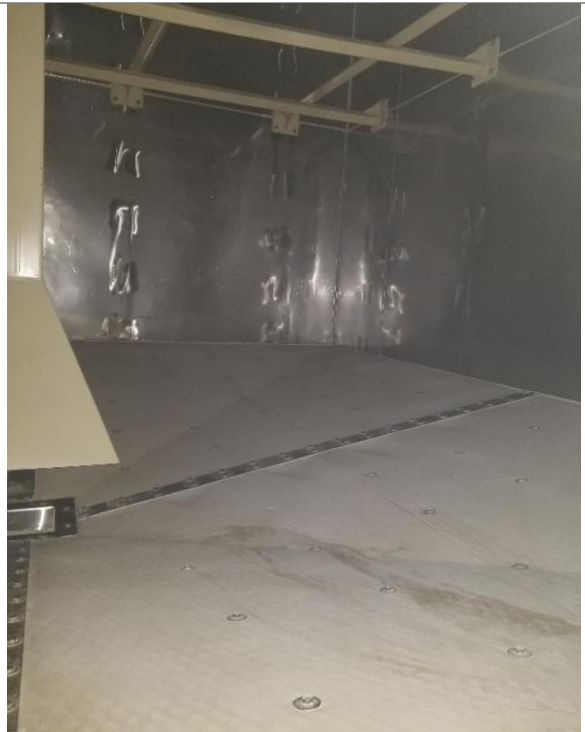
**Before  
Interior floor**

**After**

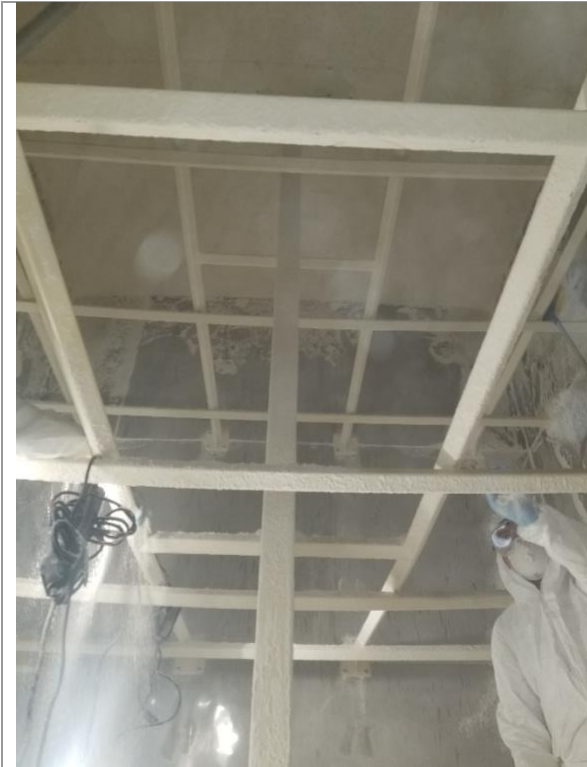
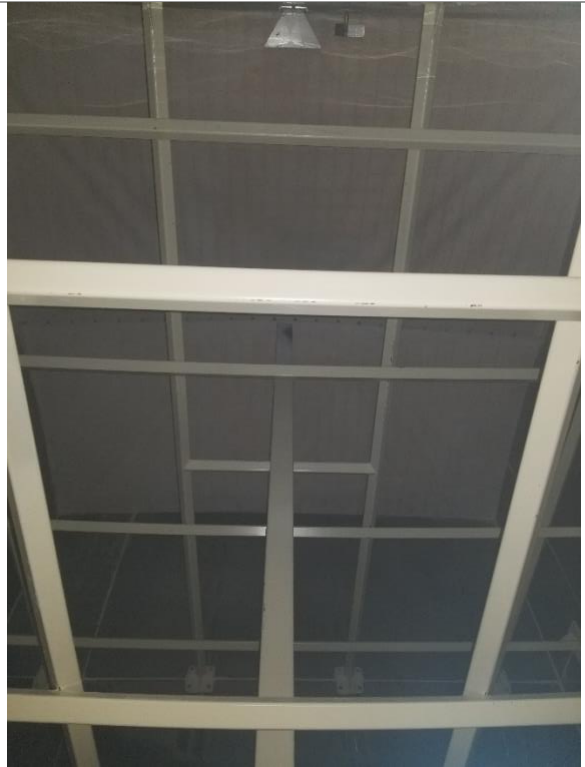
**Before  
Ceiling and bars**

**After**

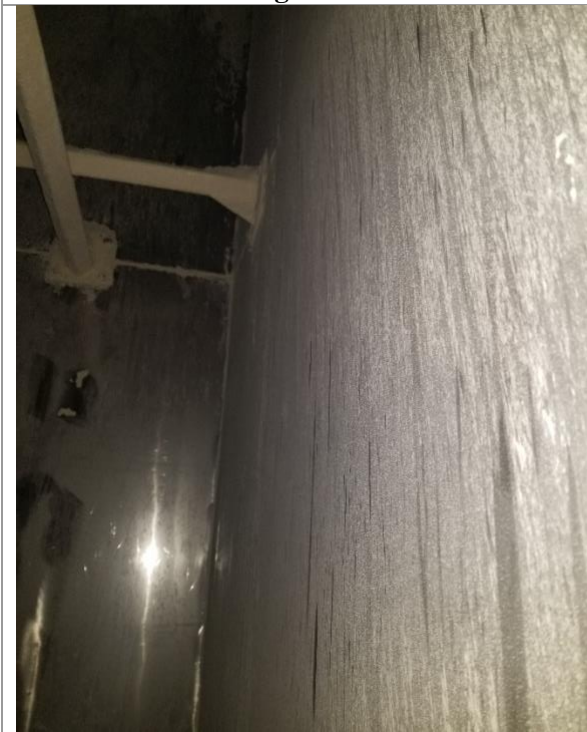
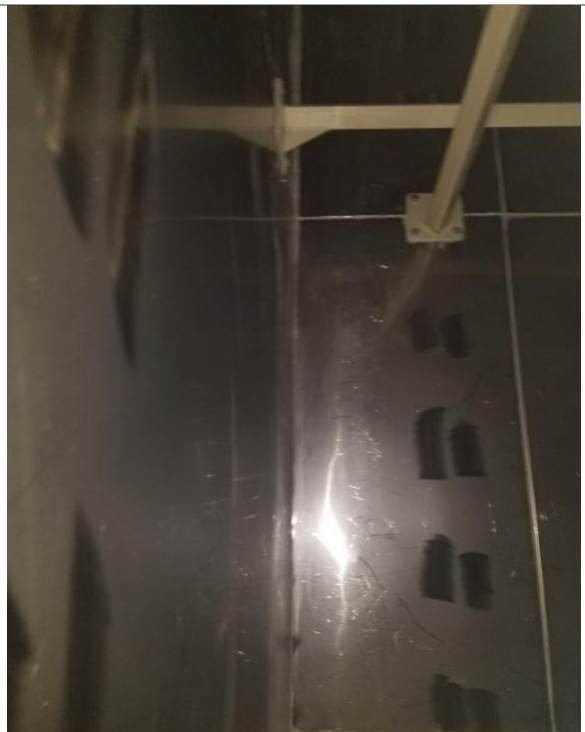
**Before  
Walls**

**After**

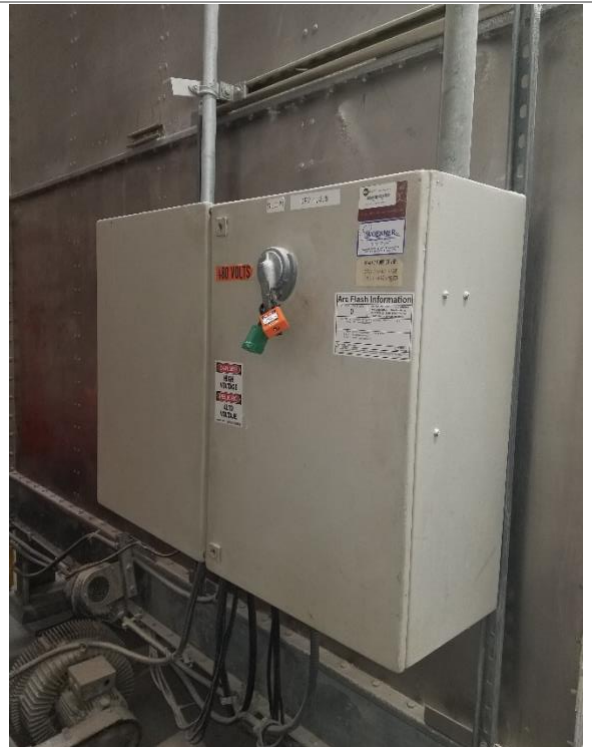
**Lock out (Bimbo)**

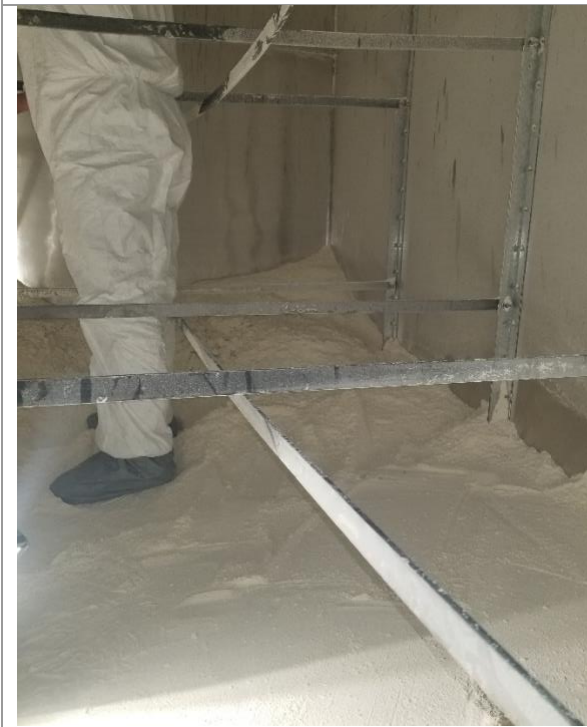
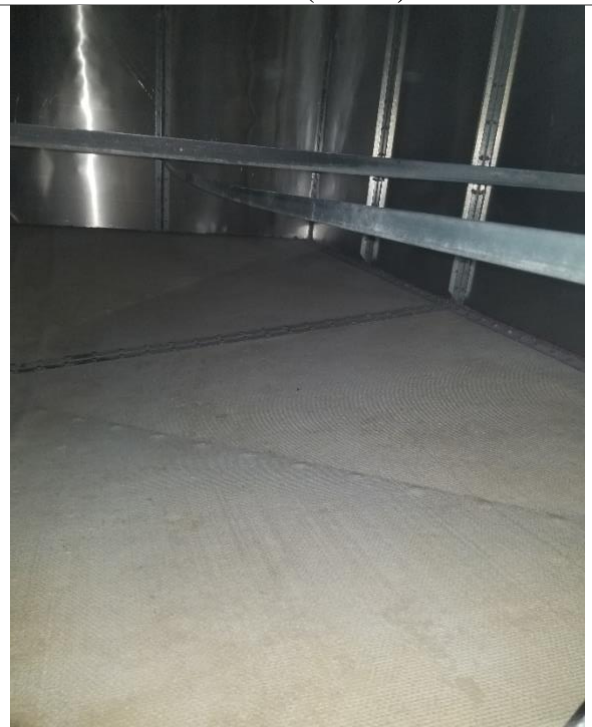
**Before  
Interior floor**

**After**

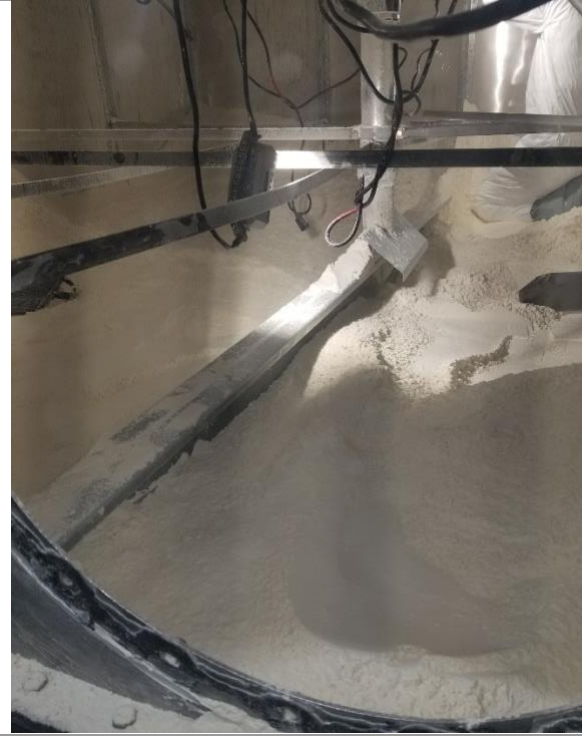
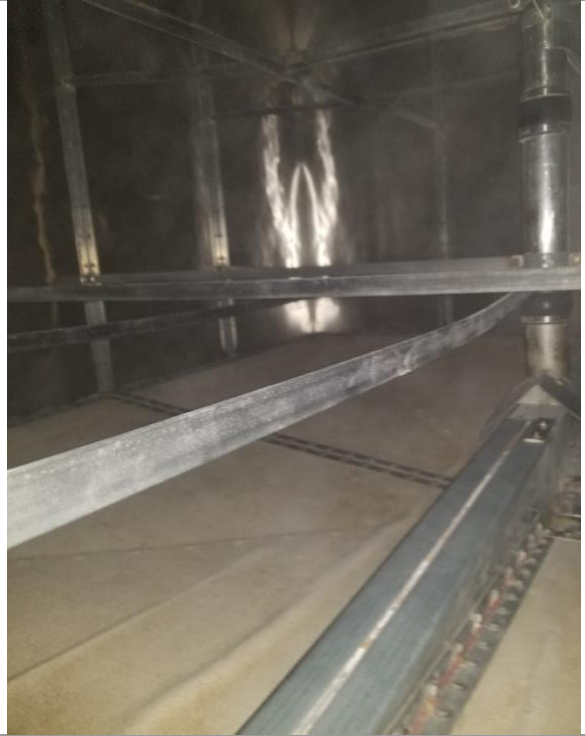
**Before  
Interior floor**

**After**

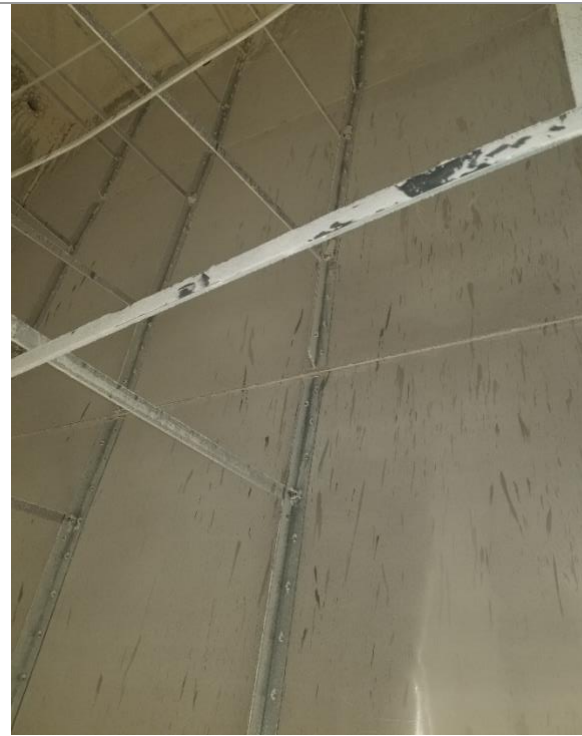
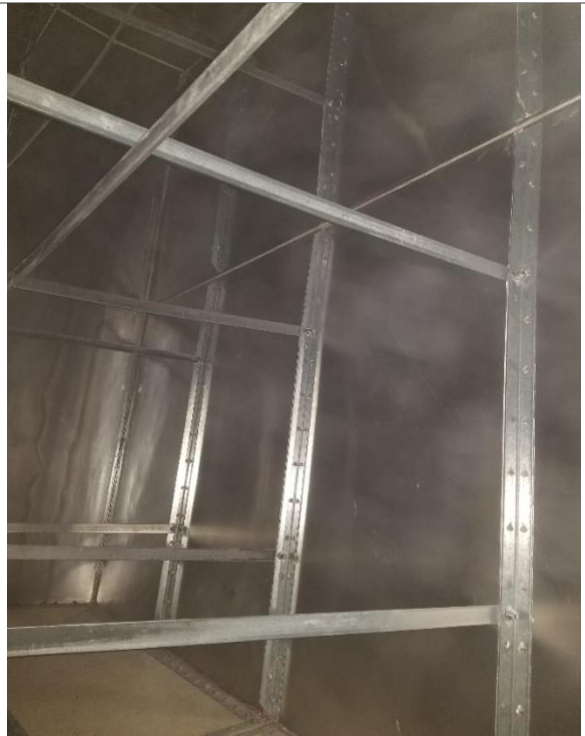
**Before  
Interior walls**

**After**

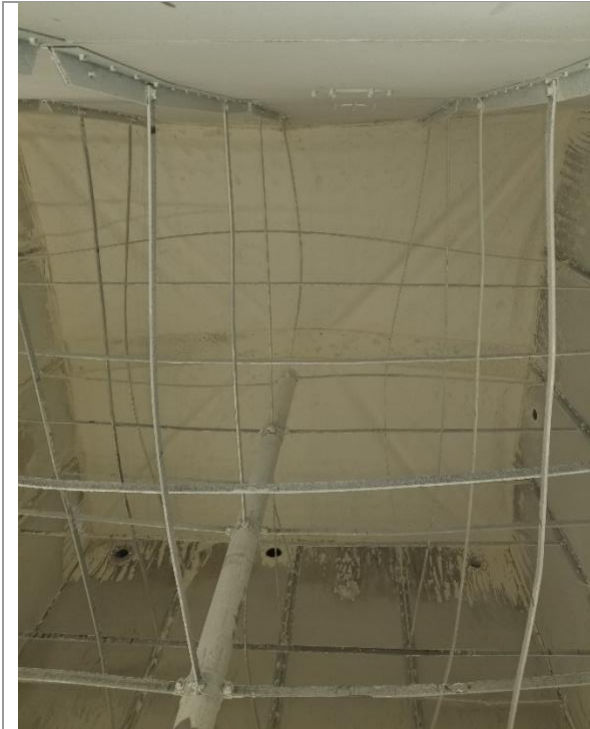
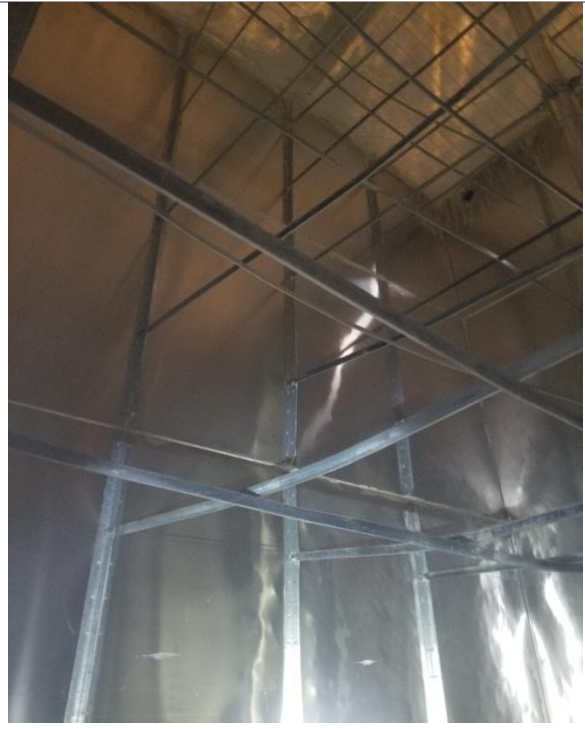
**Before  
Ceiling and bars**

**After**

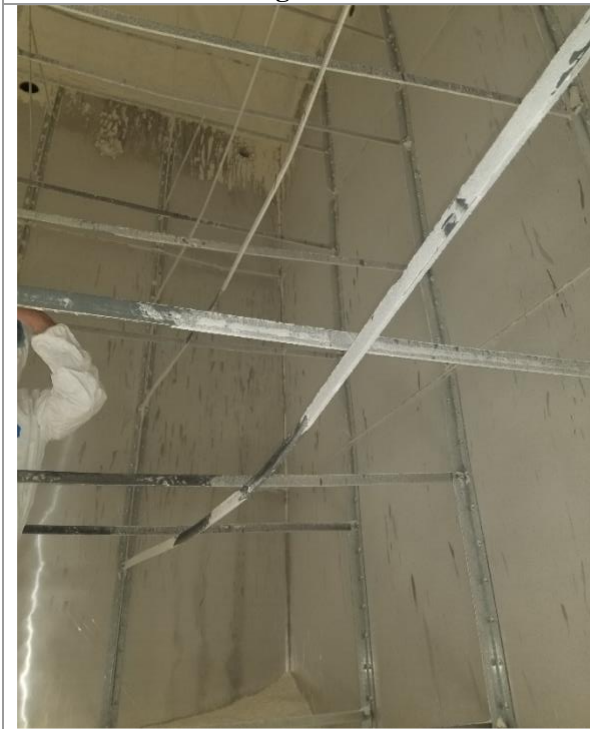
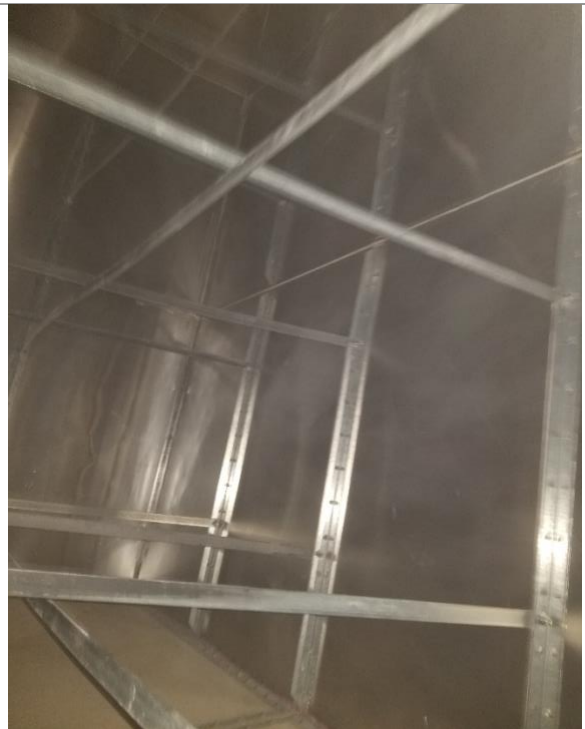
**Before  
Walls and bars**

**After**

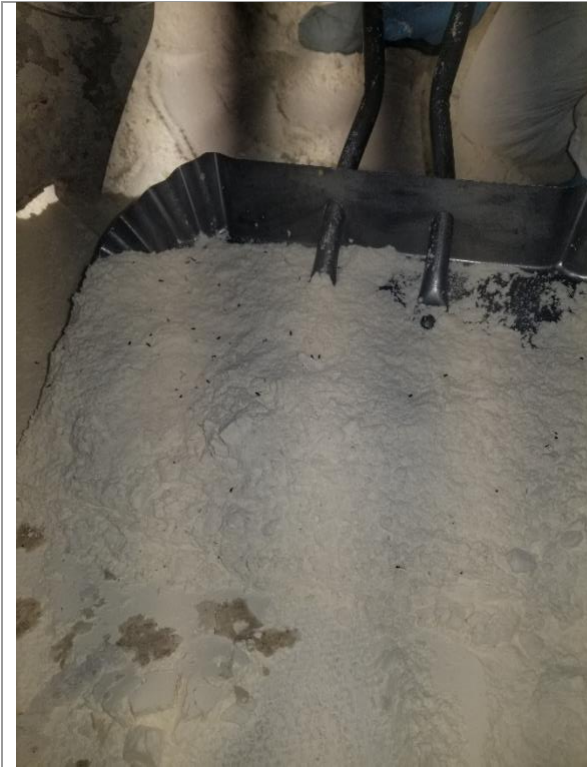
**Black dots are beetles**

***Techs did not observe any organic debris, including insects such as beetles in silo #2. However, Silo #1 had some contamination of organic debris. These seem to derive from the metal interior seams of the silo. Our recommendation is to have interior seams resealed with food grade sealant.***

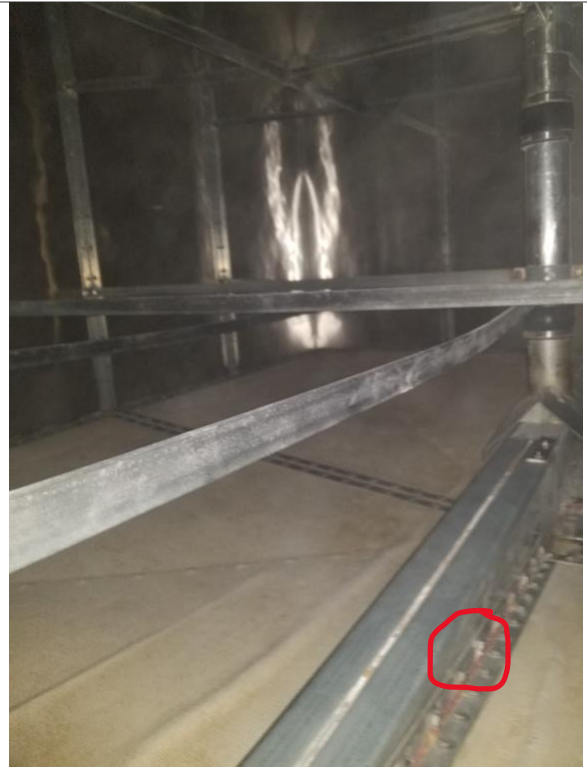
**Observes beetles coming out of seams, floor, and walls**
