Café Restaurant Final Report

System Cleaned per NFPA Standards

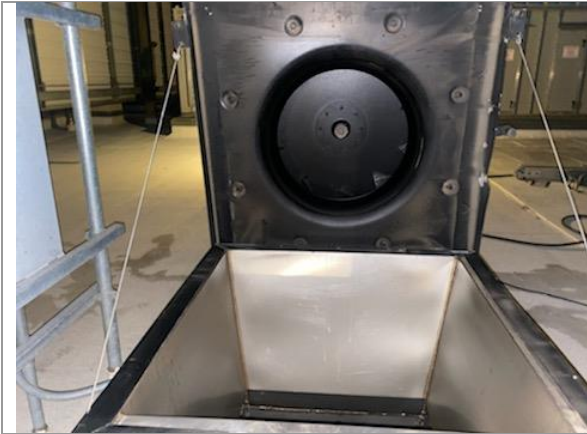
**Before
Exhaust Fan**

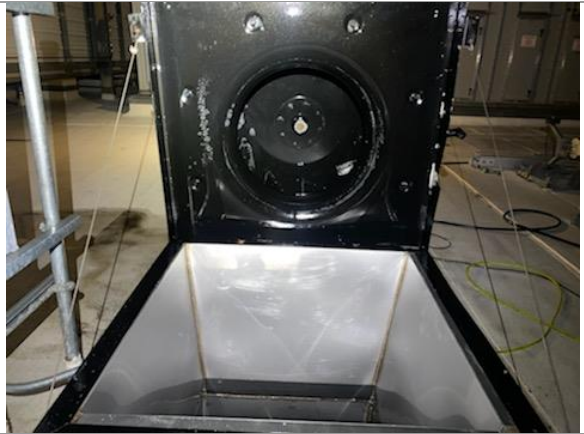
**After
Exhaust Fan**

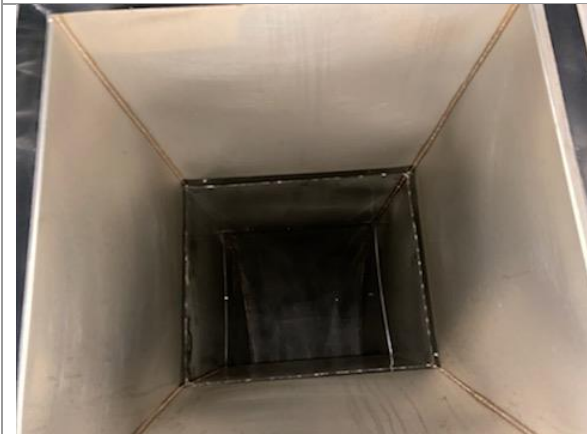
**Before
Drop**

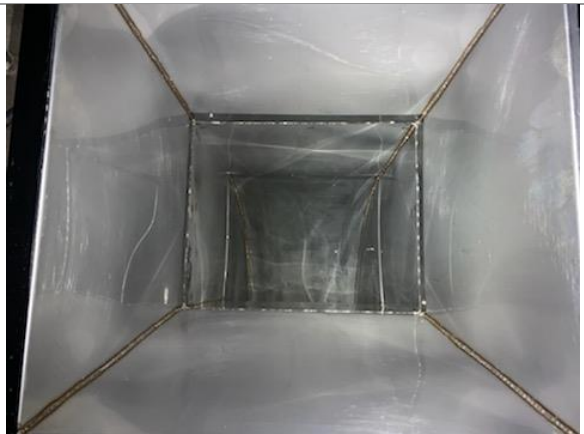
**After
Drop**

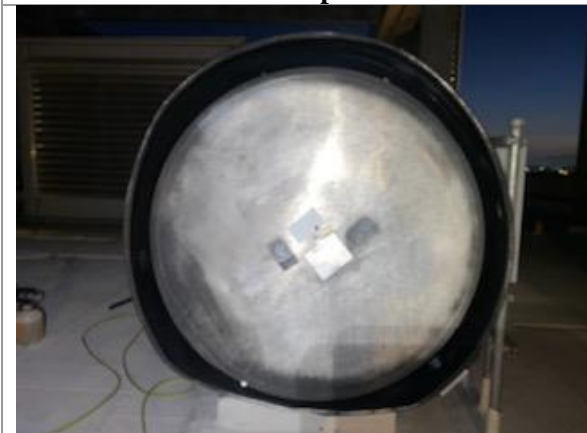
**Before
Fan**

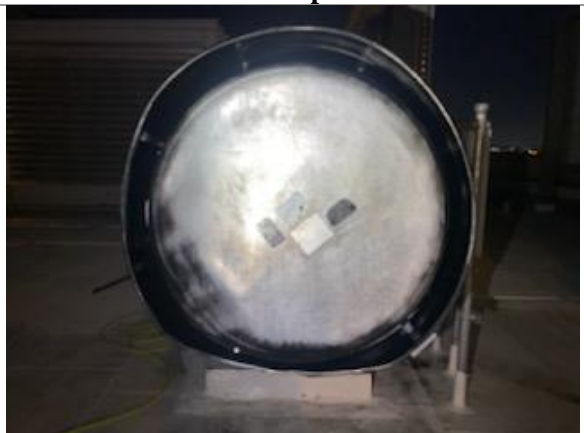
**After
Fan**

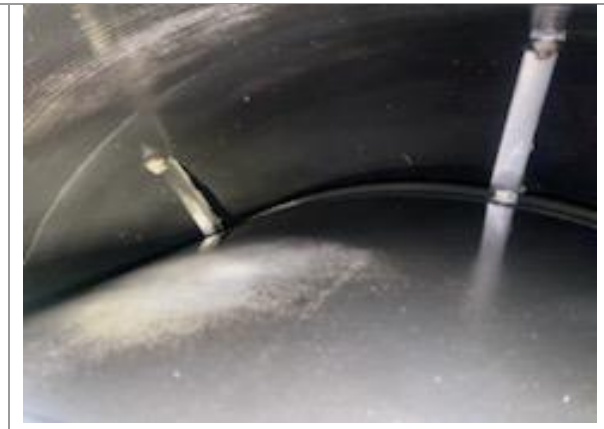
<p align="center">Before Interior of fan</p>	<p align="center">After Interior of fan</p>

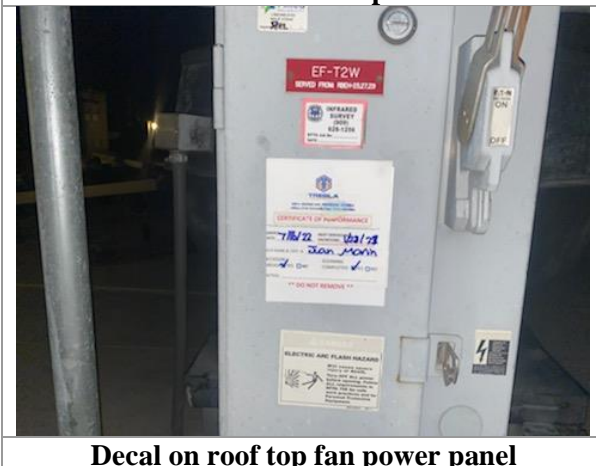
<p align="center">Decal on roof top fan power panel</p>
