**TREBLA**  
INDUSTRIAL RESOURCES, INC.

# DUCT CLEANING FINAL REPORT

## First Floor

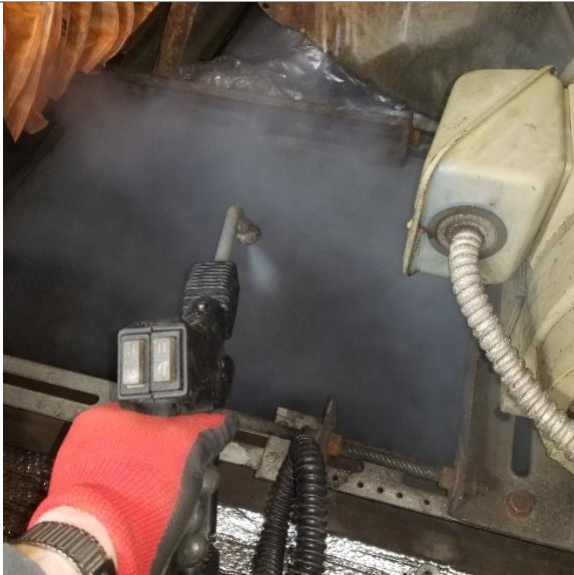
1<sup>st</sup> Floor AHU #1

Unit scrubbed and steamed cleaned. Process also eliminates organic growth

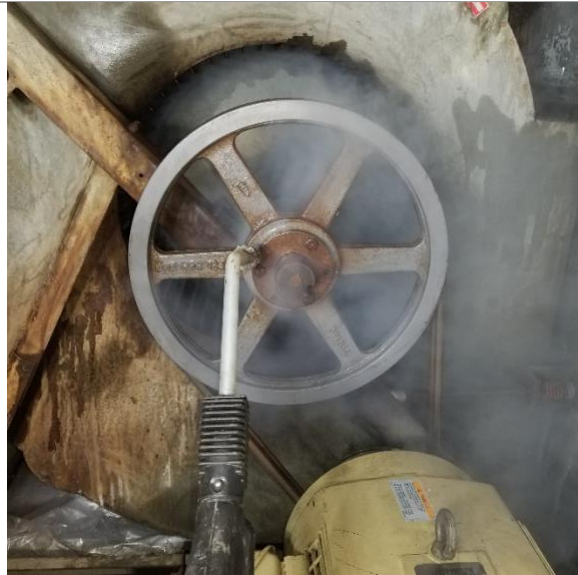
Unit steamed cleaned. Process also eliminates organic growth

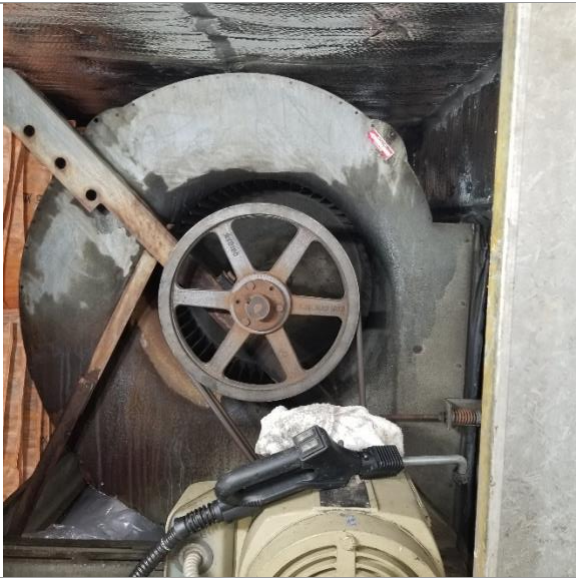
Steam cleaning in progress

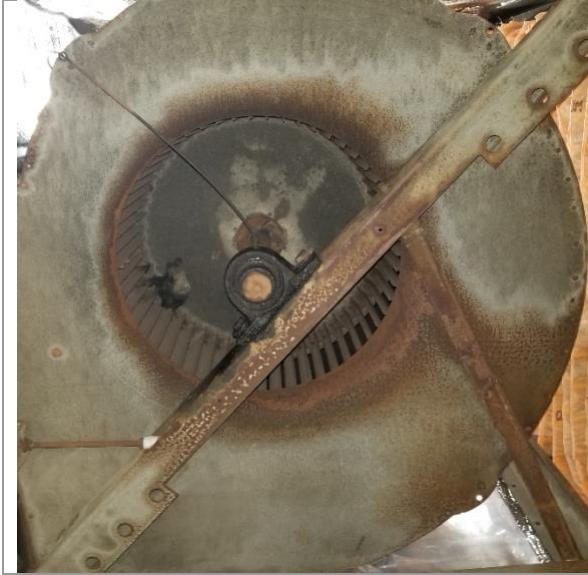
--Before--  
Unit with heavy debris and organic growth

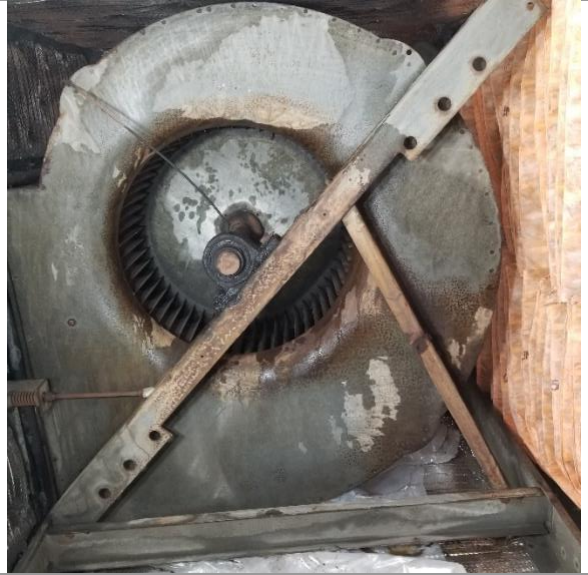
---After---  
Unit cleaned

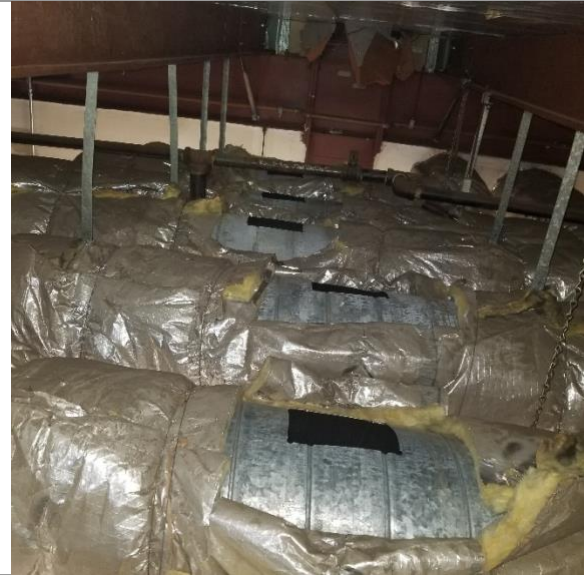
Access created to inspect and clean

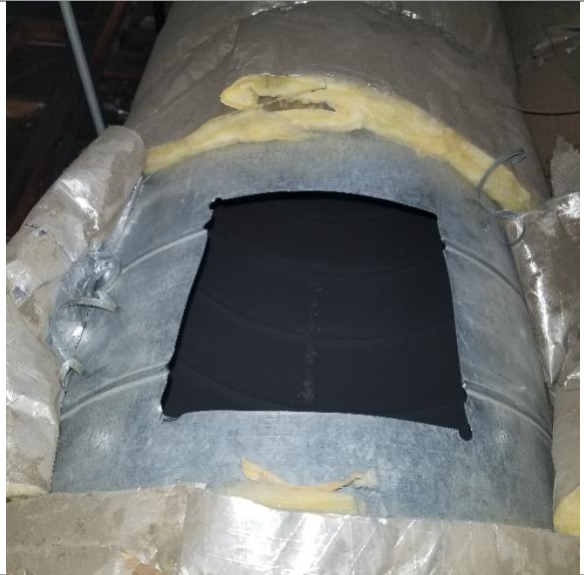
Access created to inspect and clean

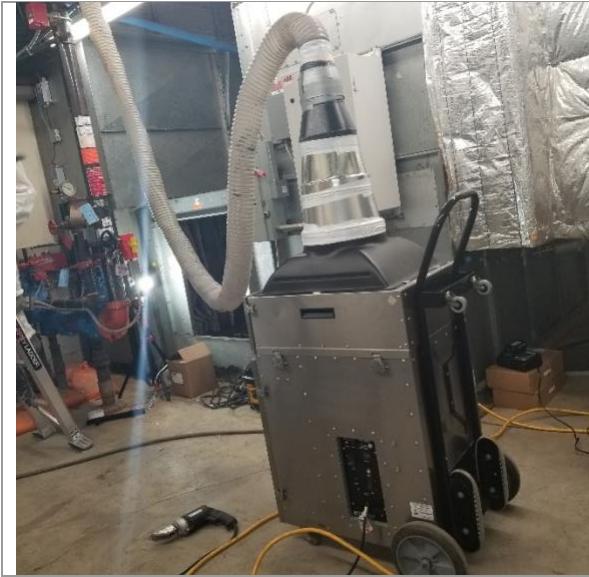
HEPA negative air used to clean mechanical area

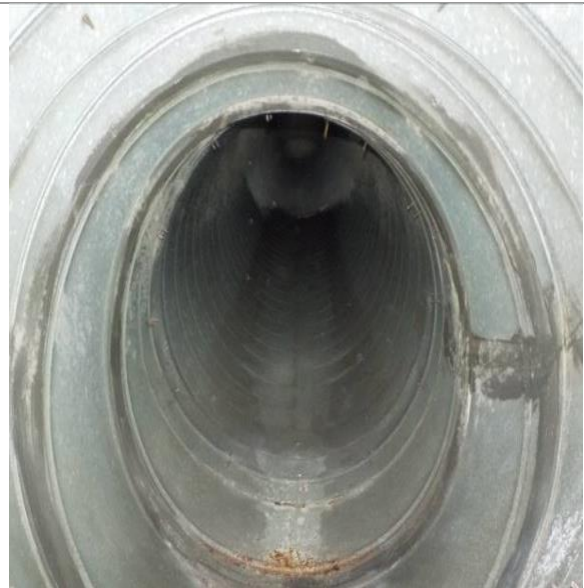
---After---  
Sample of Mechanical Area Ducts

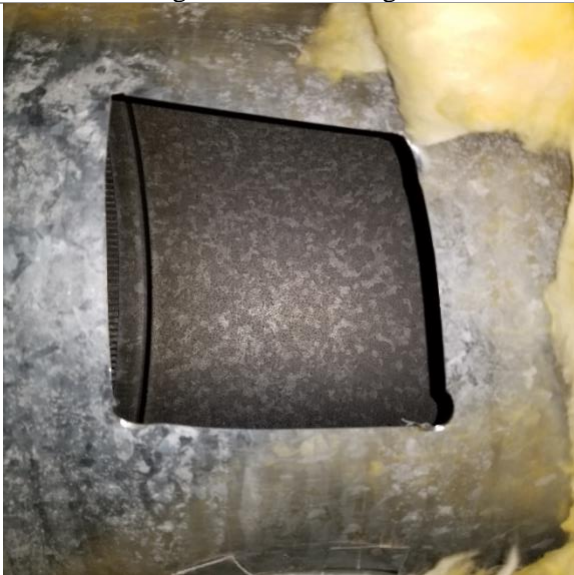
--Before--  
Access to main ducts (Typical for all access  
points)

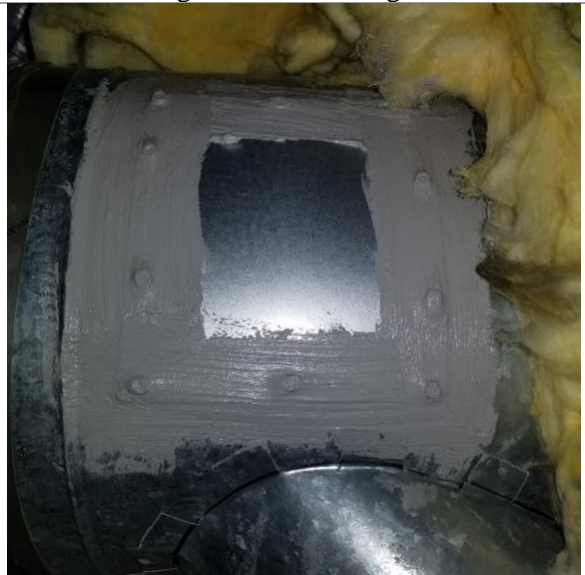
---After---  
Sealed (Typical for all access points)

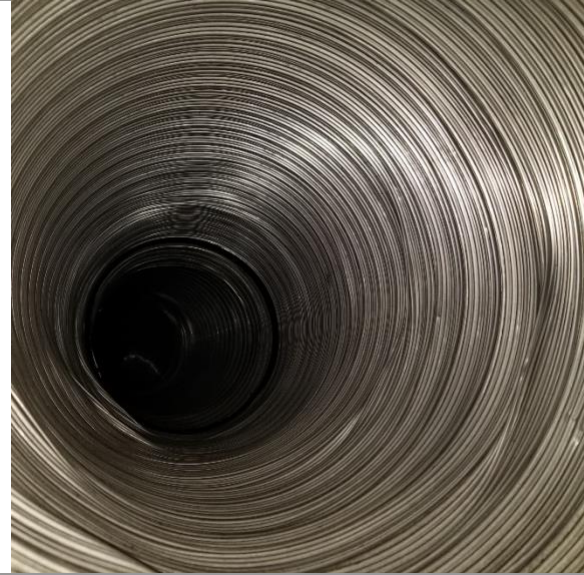
--Before--  
Main Duct

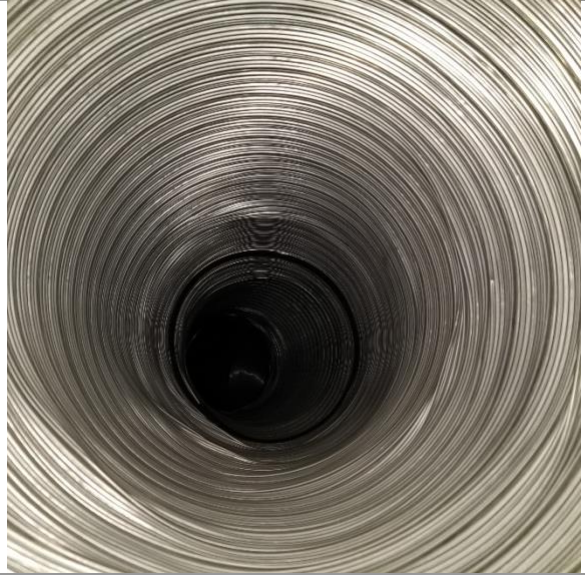
--After--  
Main Duct

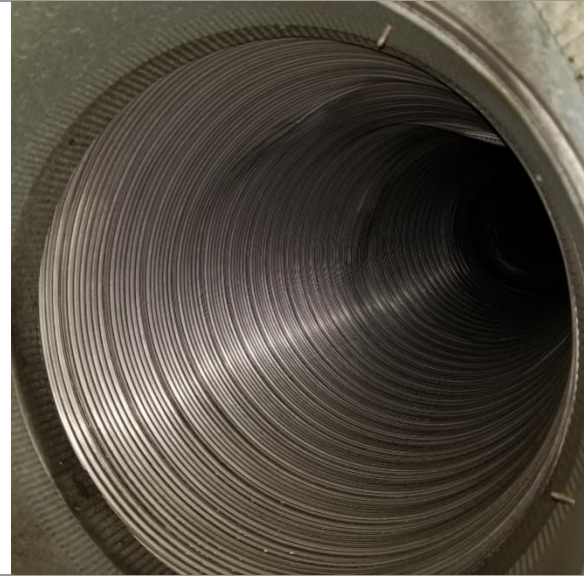
--Before--  
Main Duct

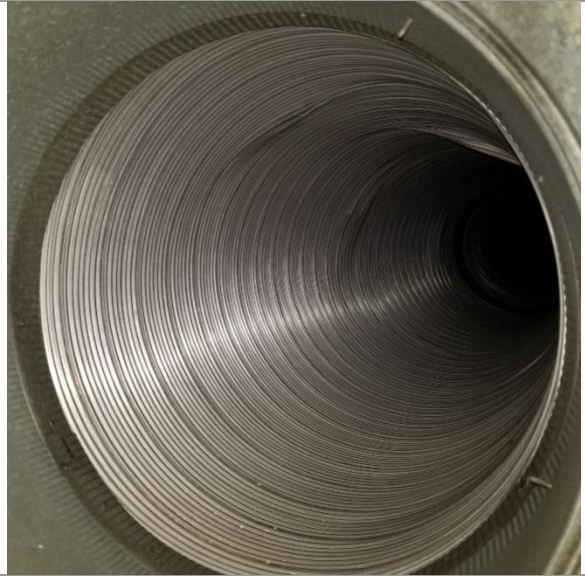
--After--  
Main Duct

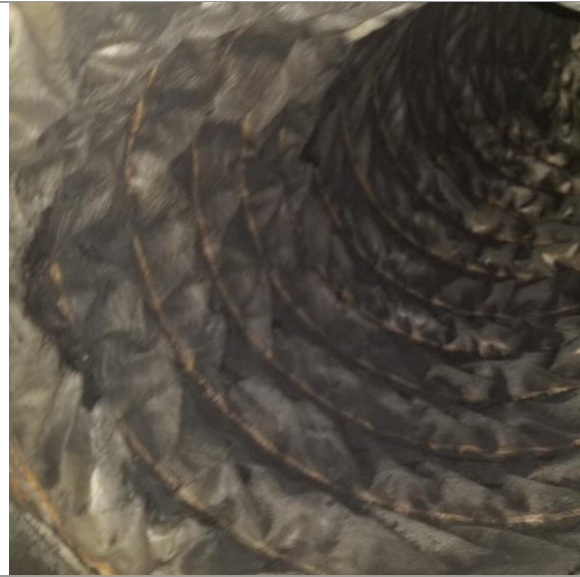
--Before--  
Flex duct with heavy debris

--After--  
Difficult to remove debris from these interior fabric flex ducts. Should consider they be replaced. Mostly found in 1<sup>st</sup> floor offices

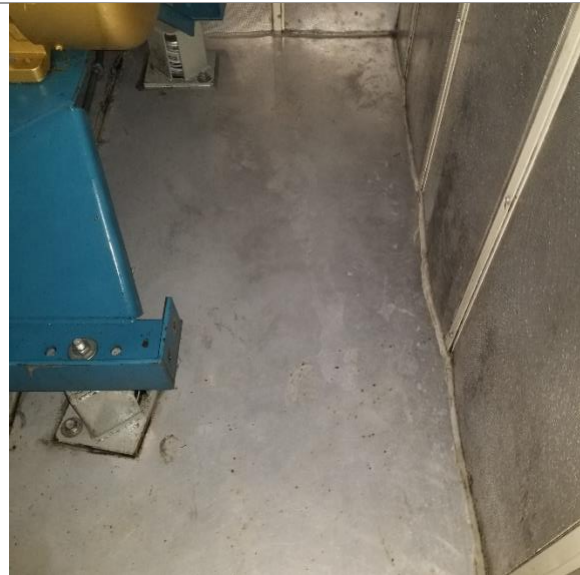
-Before-  
Fan with debris and organic growth

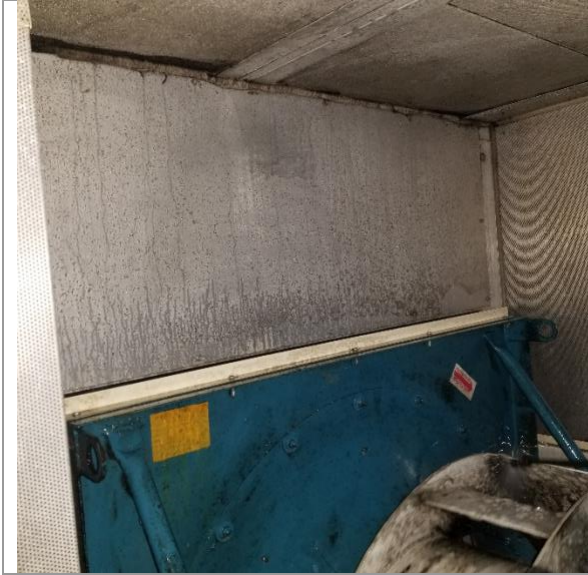
--Before--  
Fan area with debris and organic growth

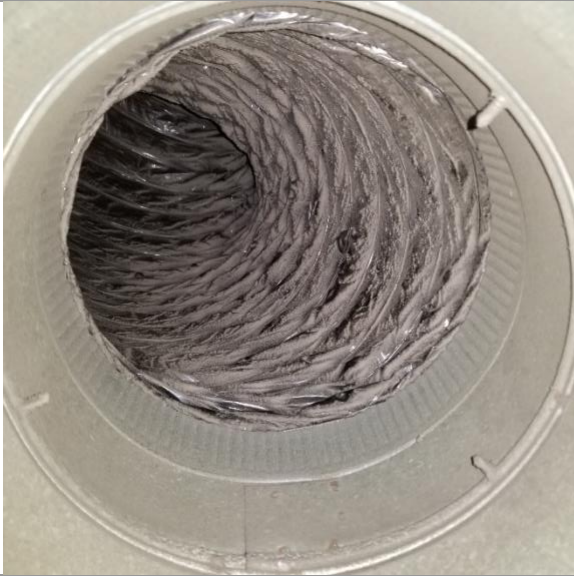
--Before--  
Dirty flex duct

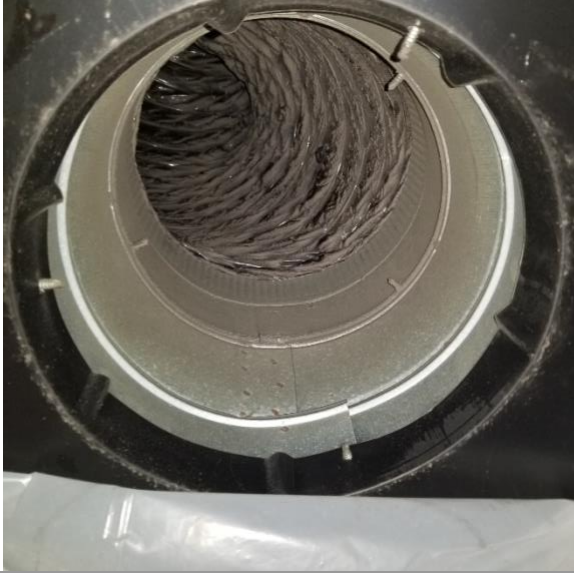
--Before--  
Dirty flex duct

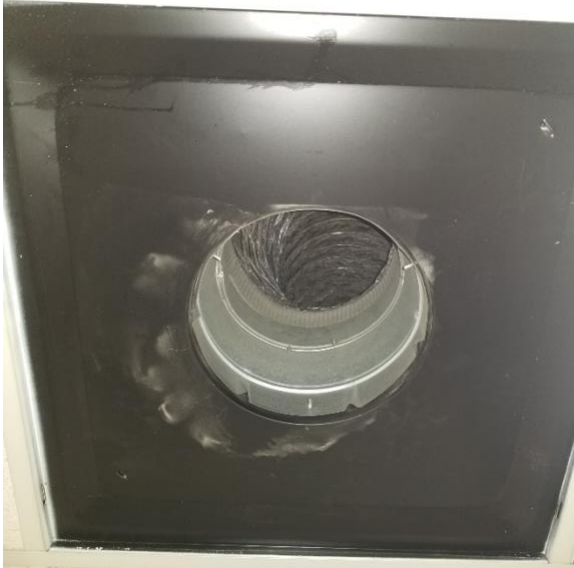
--Before--  
Dirty flex duct

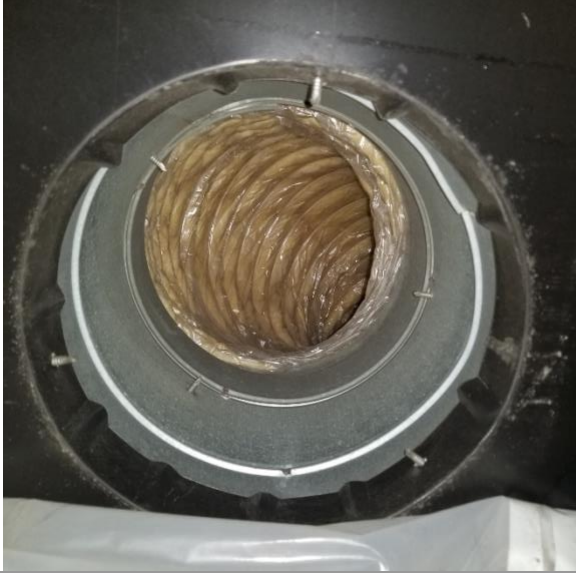
--Before--  
Dirty flex duct

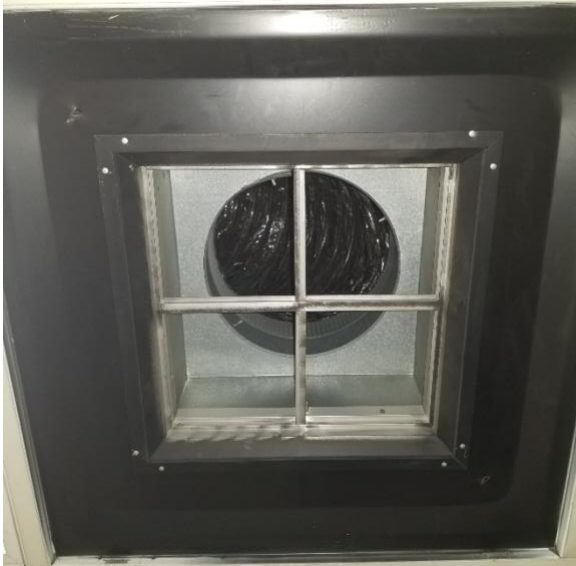
--Before--  
Dirty flex duct

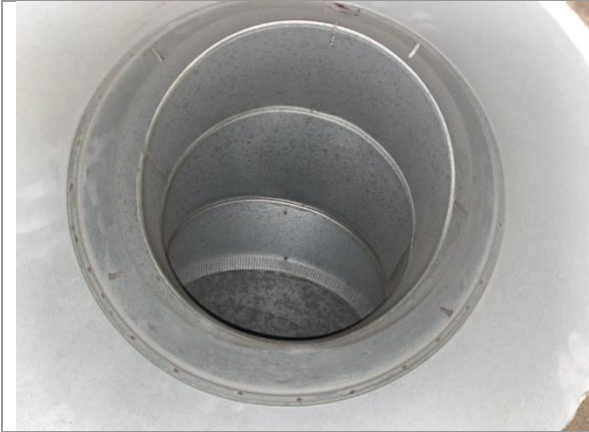
-Before-  
Dirty duct

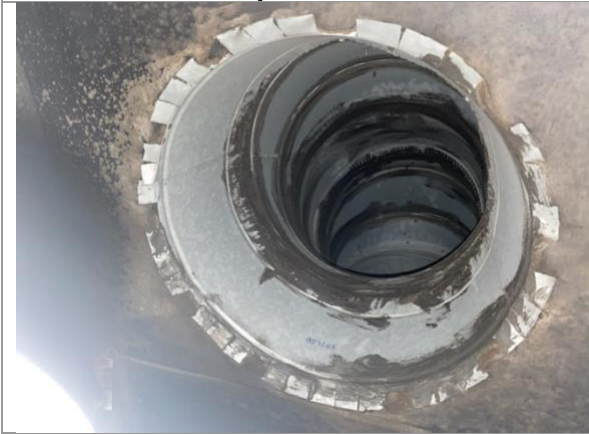
--Before--  
Dirty main duct

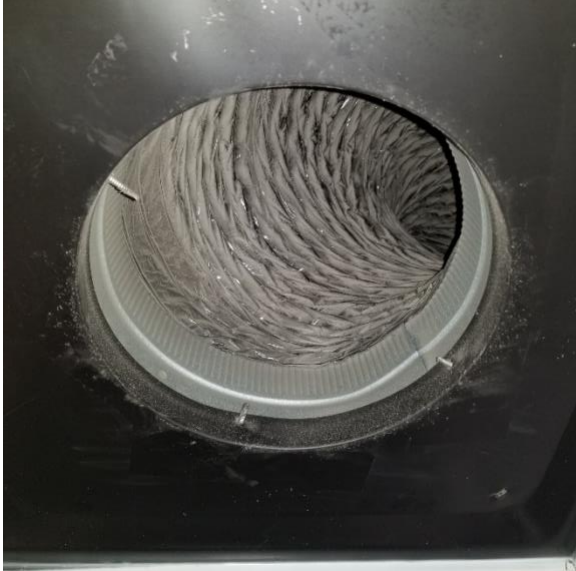
-Before-  
Dirty flex duct

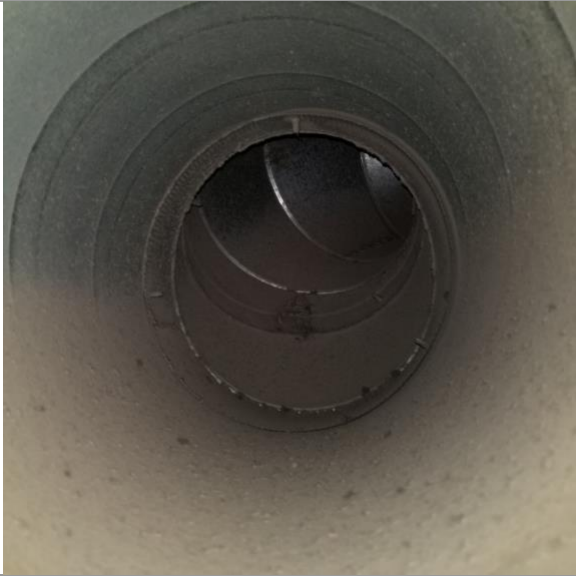
-Before-  
Dirty main duct

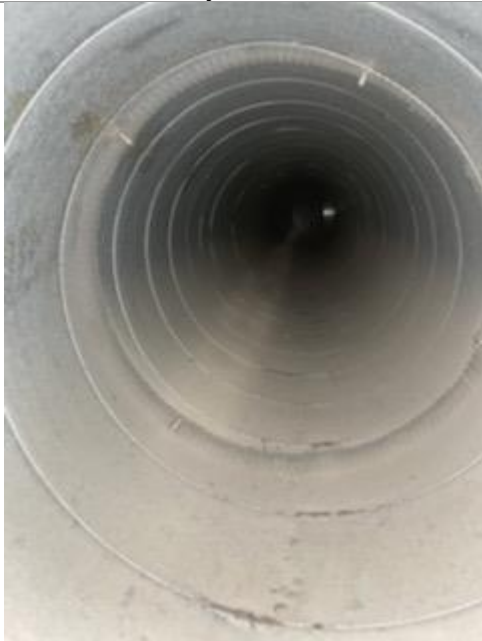
-Before-  
Dirty main duct

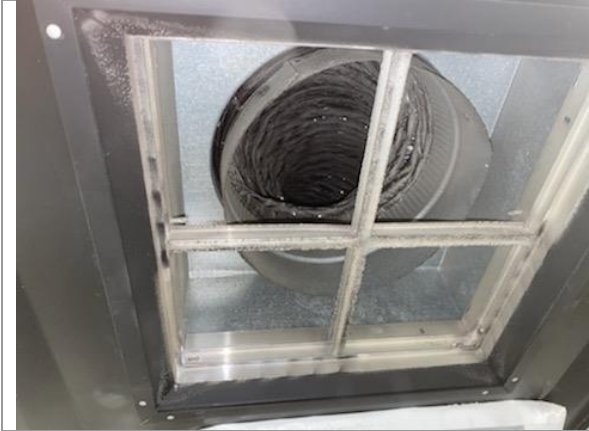
-Before-  
Dirty flex duct
