**TREBLA**  
INDUSTRIAL RESOURCES, INC.

# DUCT CLEANING FINAL REPORT

## First Floor

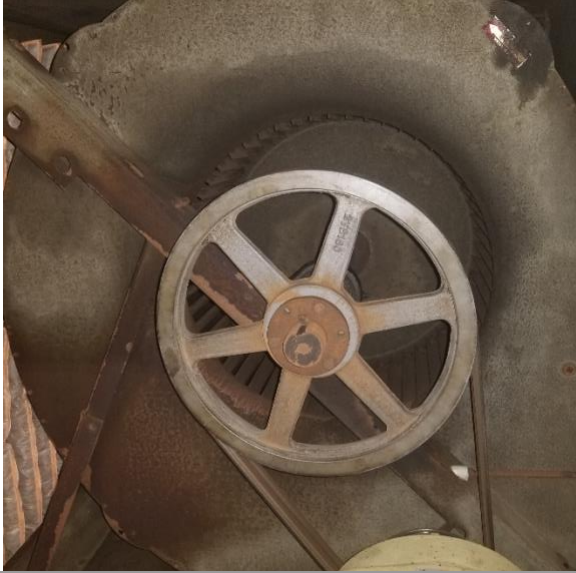
--Before--

Unit with heavy debris and organic growth

1. Origin of black debris was from unit insulation deterioration. AstroShield was added to interior of unit to resolve this issue.
2. Flex ducts in common meeting area and conference room were switched out for new ducts. These old flex ducts with fabric interior are notorious for retaining and spreading old debris, please review pics on report. It is recommended they be changed. Approximately 60 of these flex ducts are located on the first floor and none on second floor.
3. We will have a team return approximately a month from today to remove media filter from registers.

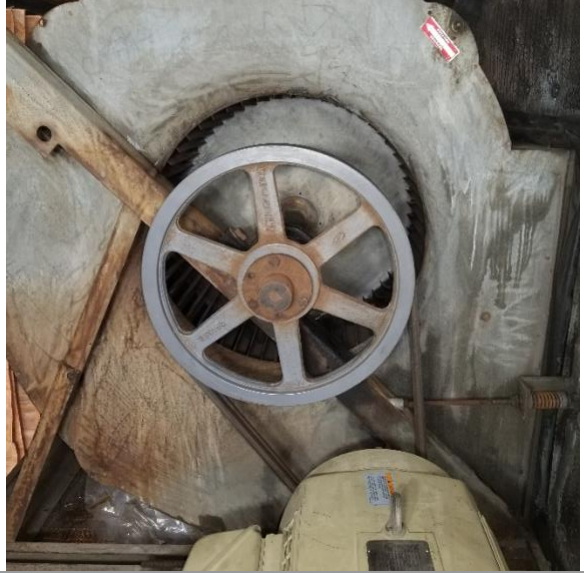
---After---

Unit steamed cleaned. Process also helps kill organic growth

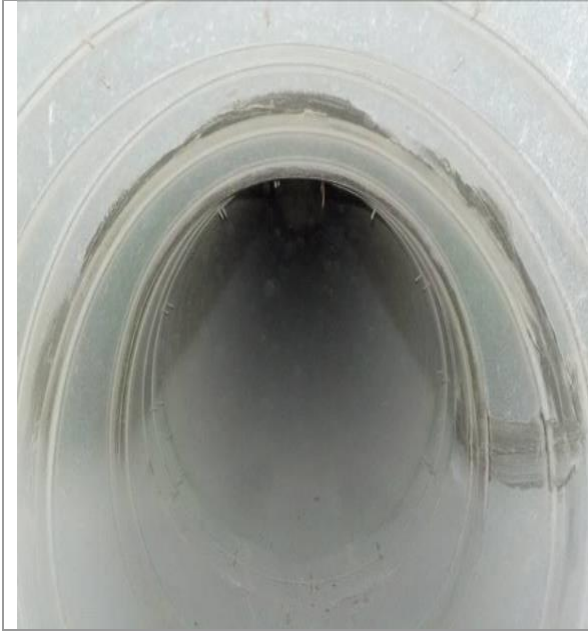
--Before--  
Sample of Mechanical Area Ducts

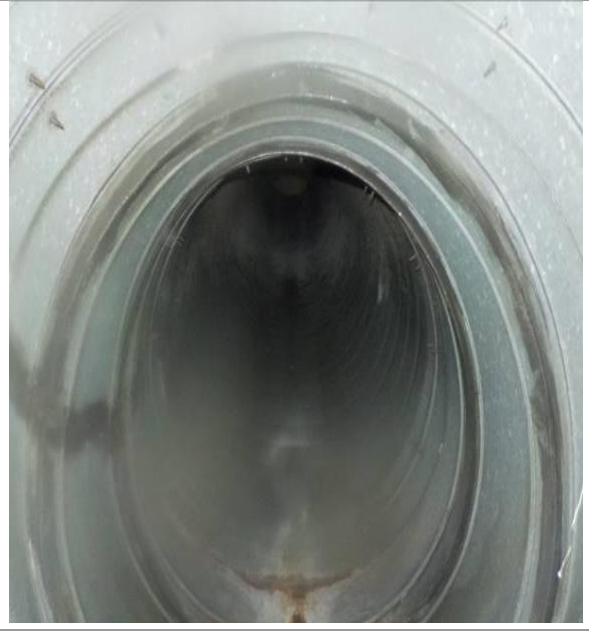
---After---  
Sample of Mechanical Area Ducts

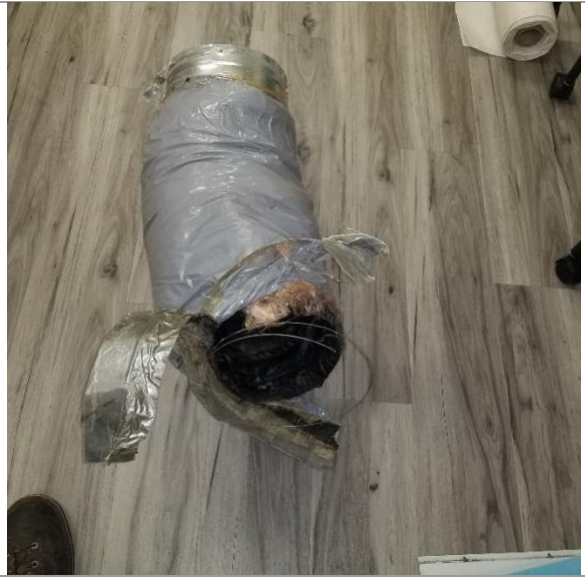
Taking down, location meeting room, 1<sup>st</sup> floor

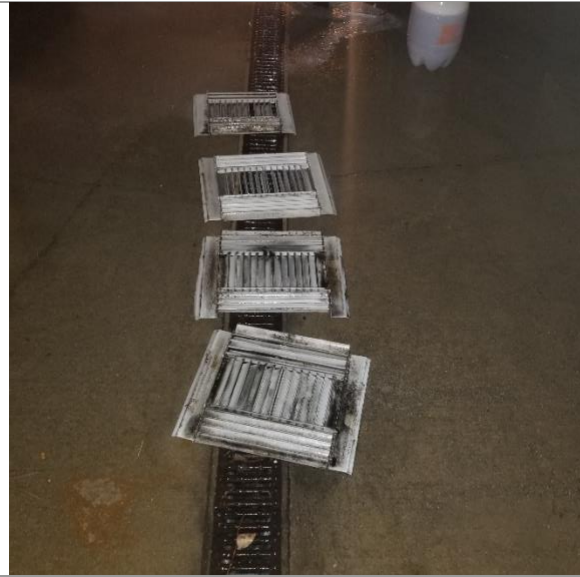
--Before--  
Registers dirty

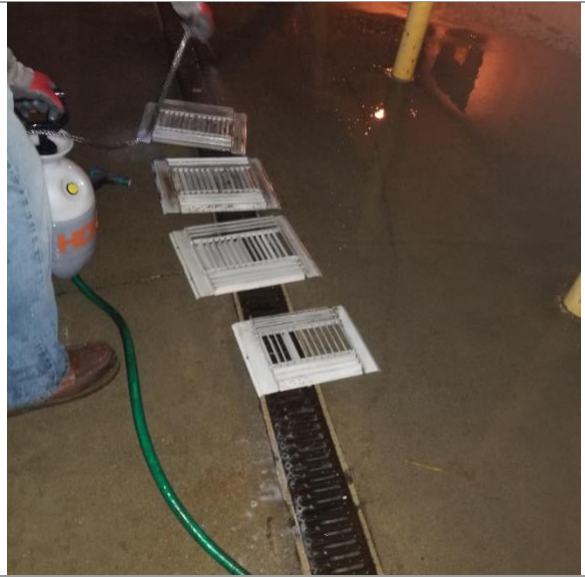
--After--  
Registers cleaned

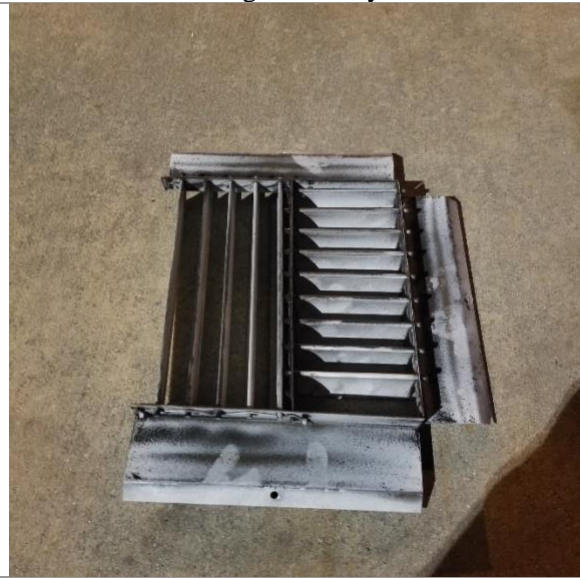
--Before--  
Registers dirty

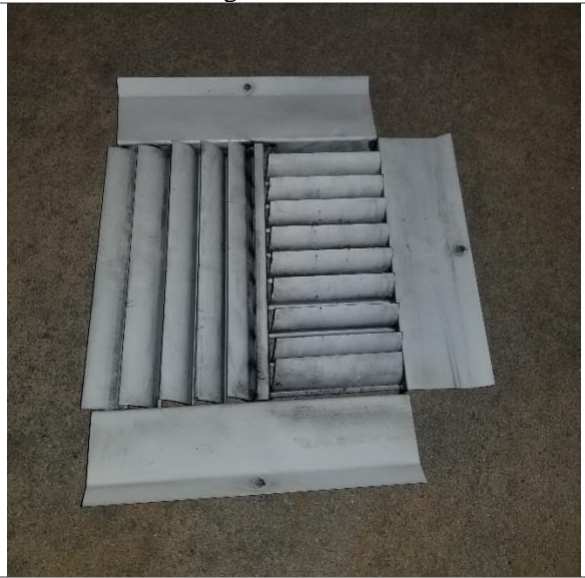
--After--  
Registers cleaned

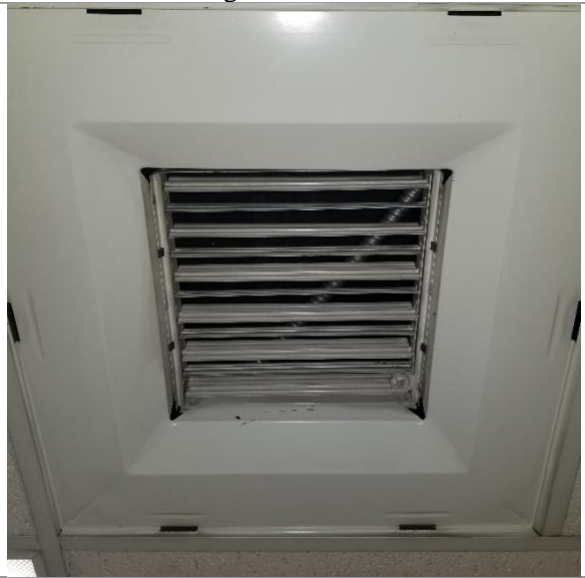
--After--  
Clean

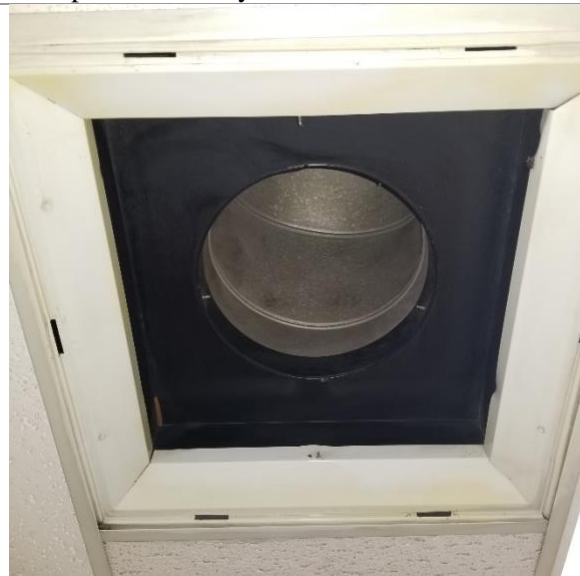
--After--  
Cleaned

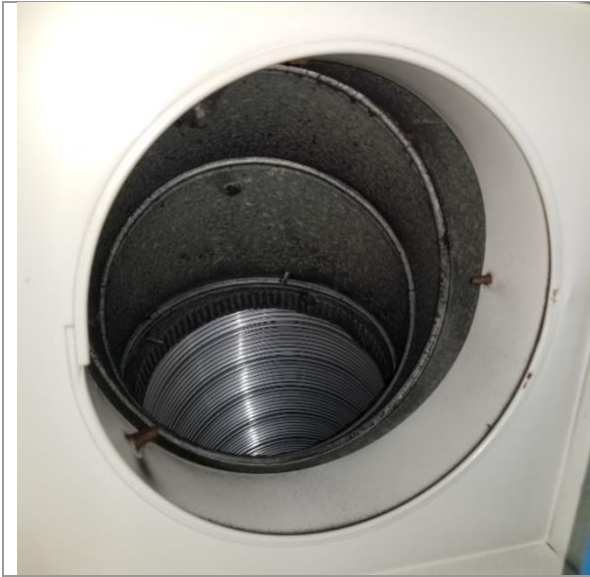
--Before--

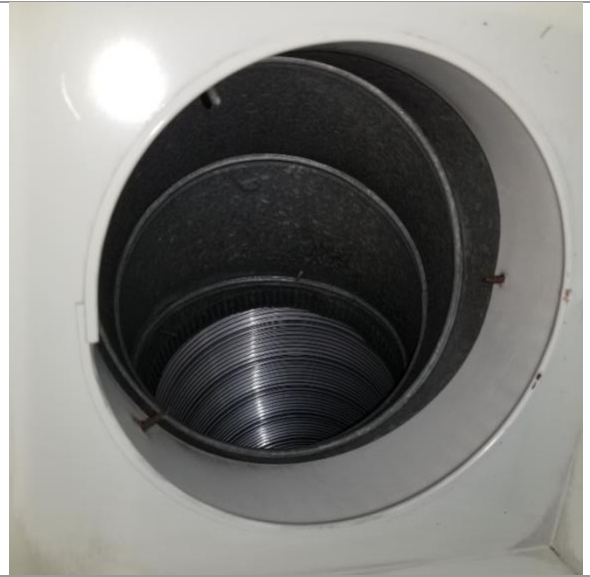
--After--

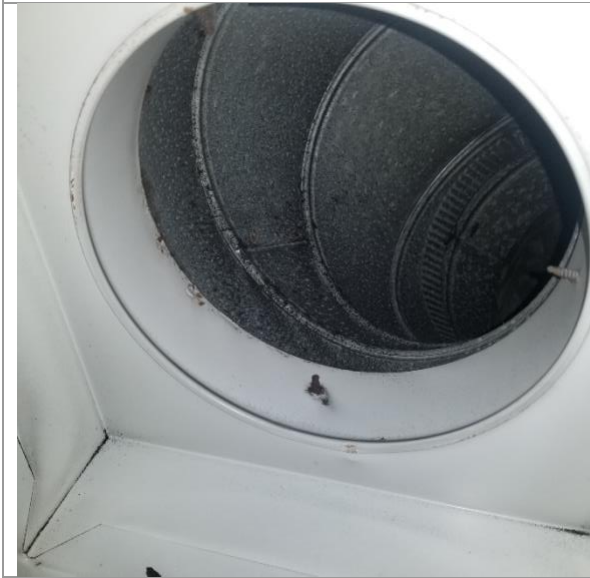
--Before--

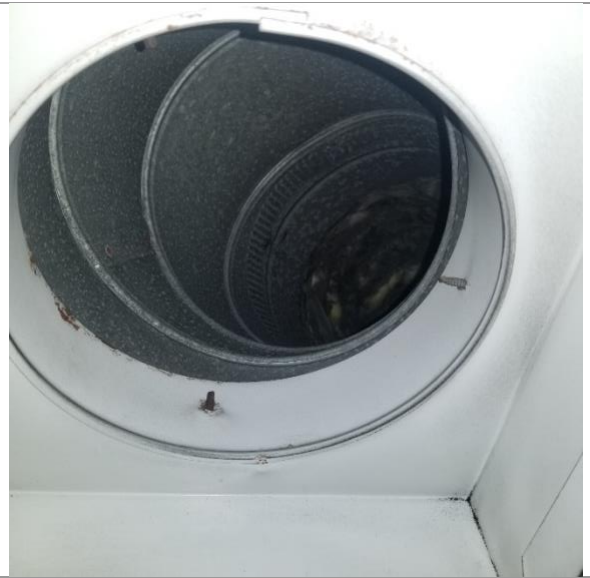
--After--

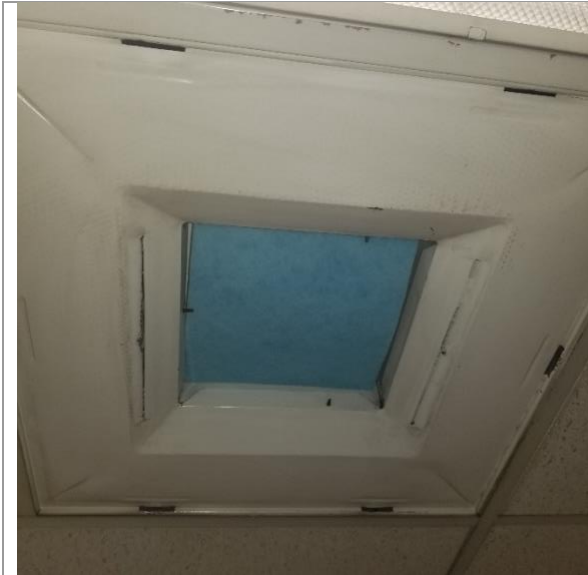
--After-- cleaning filter media added

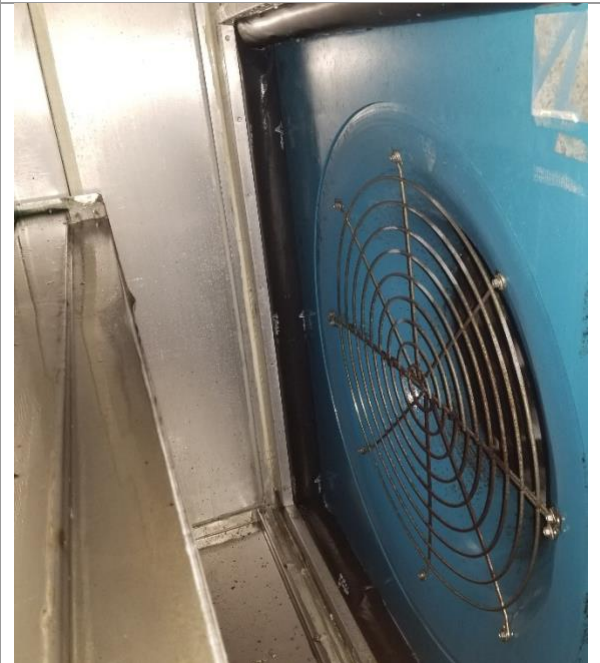
--After--  
Cleaned

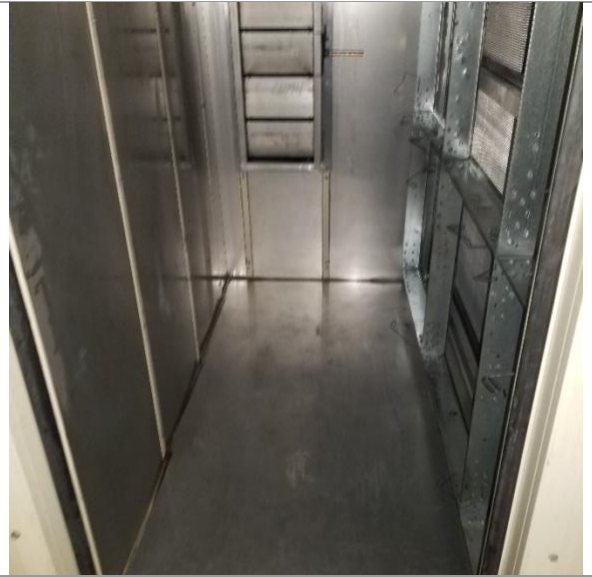
--After--  
Cleaned

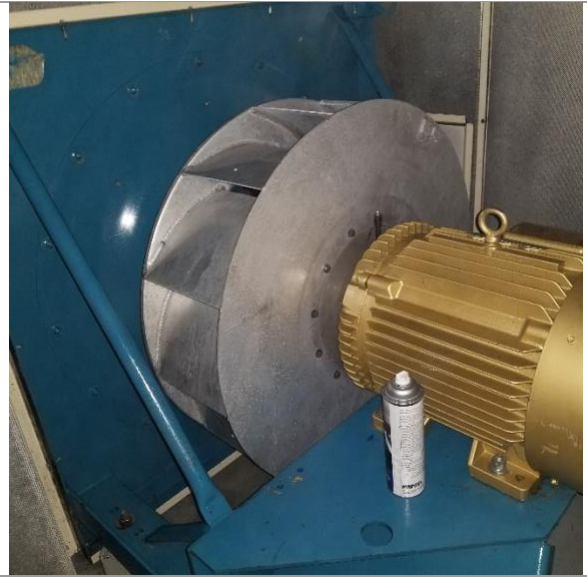
--After--  
Cleaned

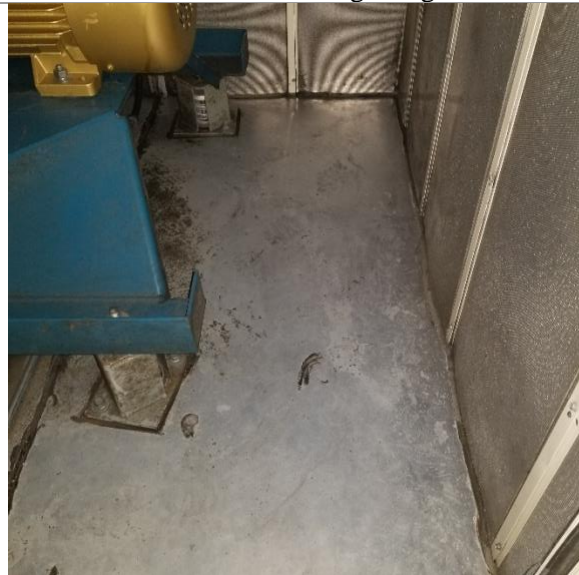
--Before--  
Fan area with debris and organic growth

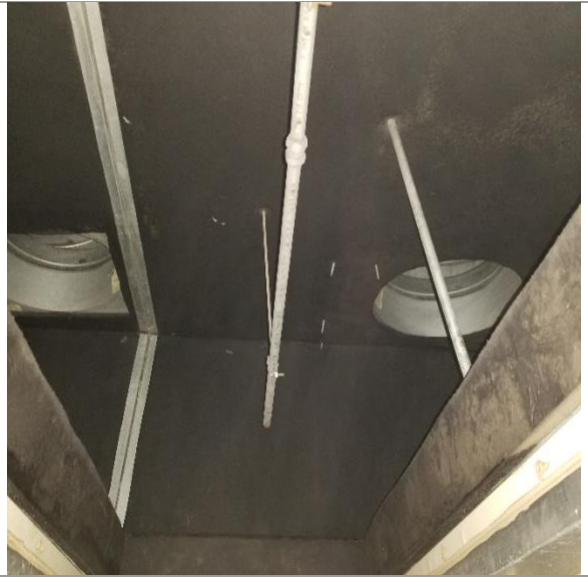
--After--  
Cleaned

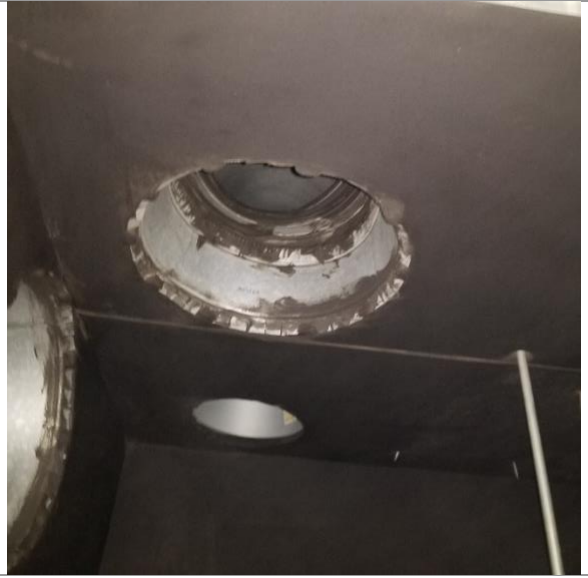
--After--  
Cleaned

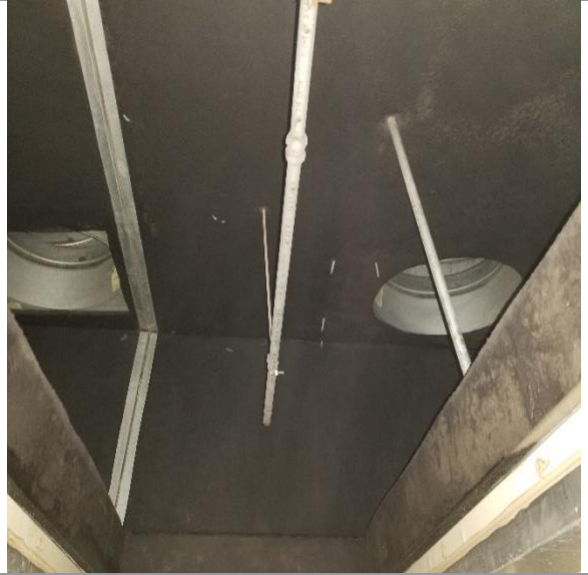
--After--  
Cleaned

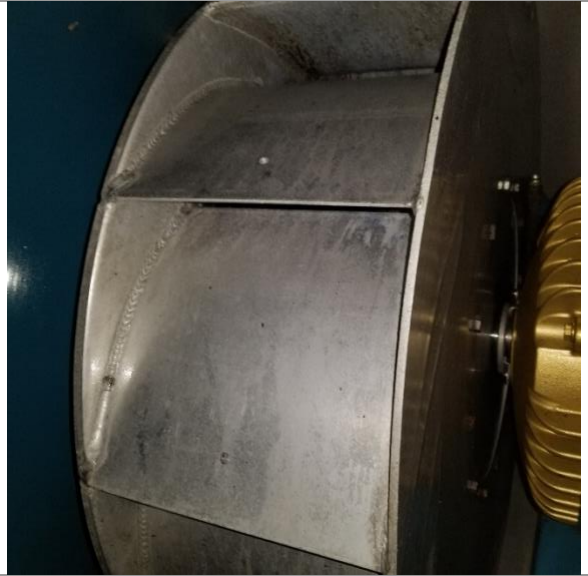
--After--  
Cleaned

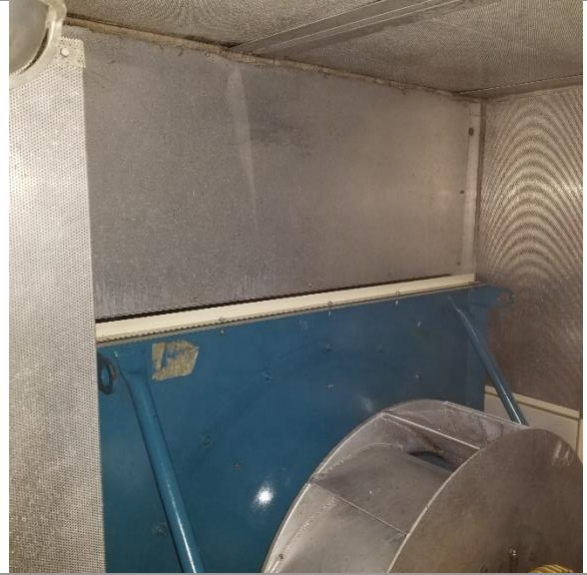
--After--  
Cleaned

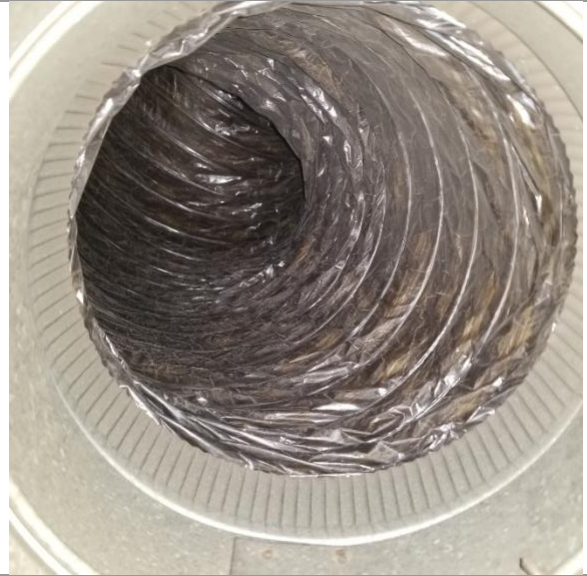
--After--  
Cleaned

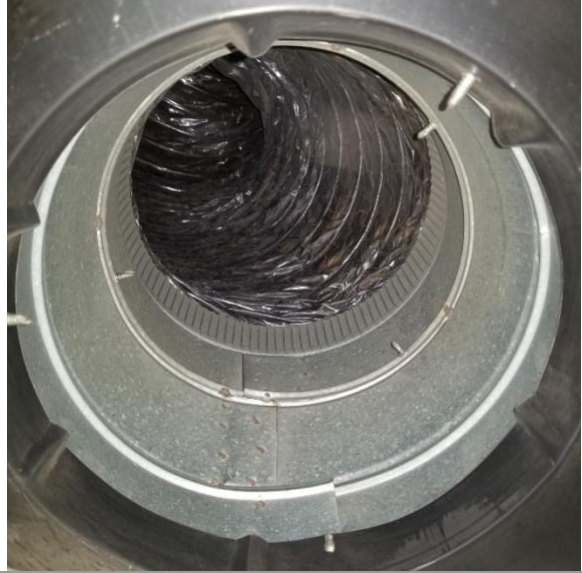
--After--  
Cleaned

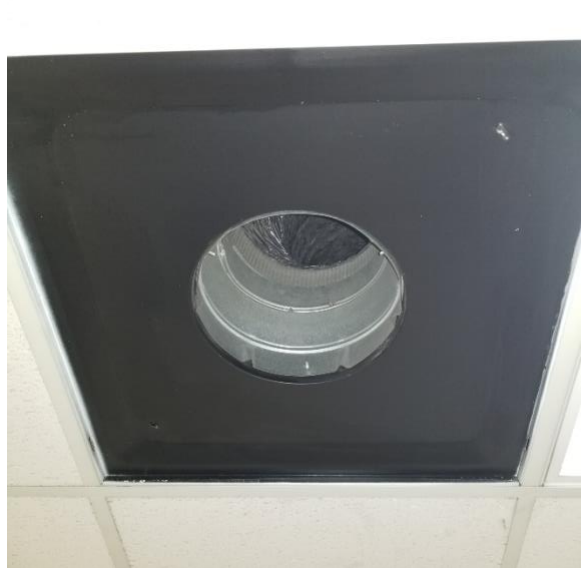
--After--  
Cleaned

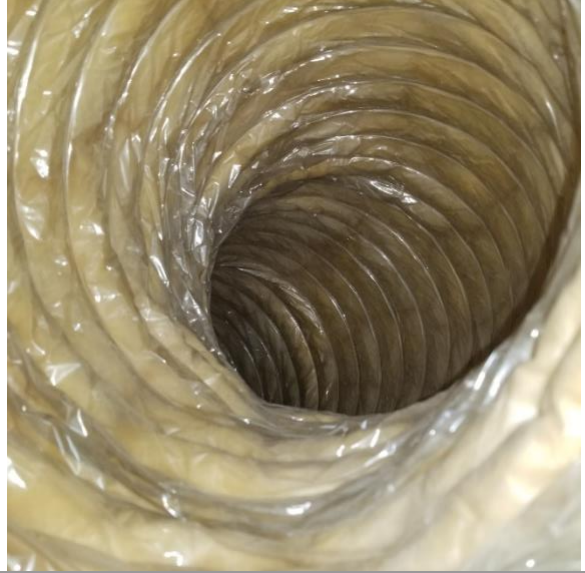
--After--  
Cleaned

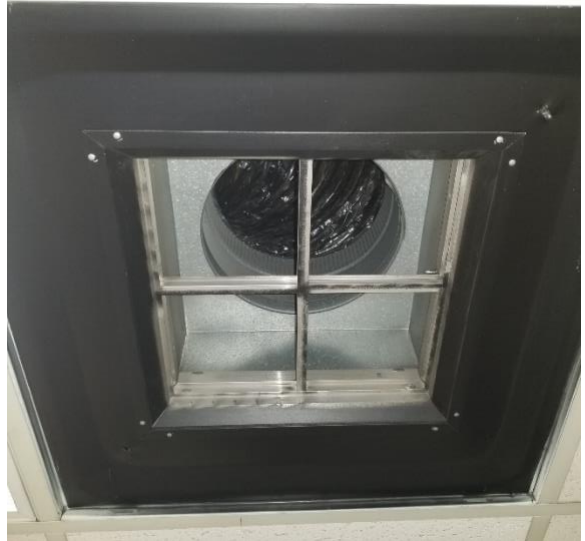
--After--  
Cleaned

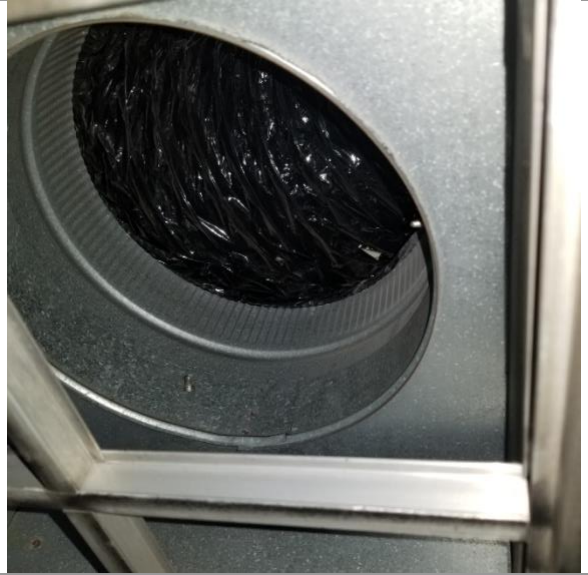
--After--  
Cleaned

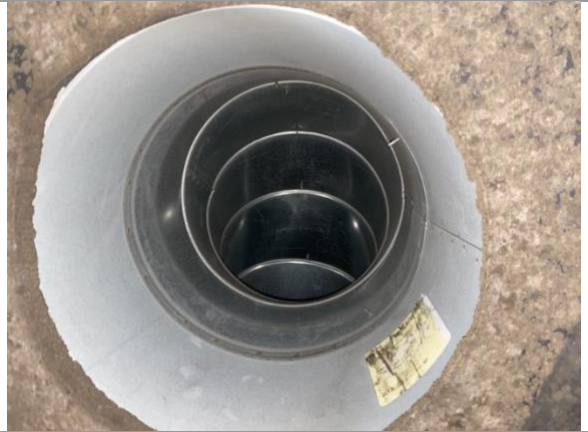
--After--  
Cleaned

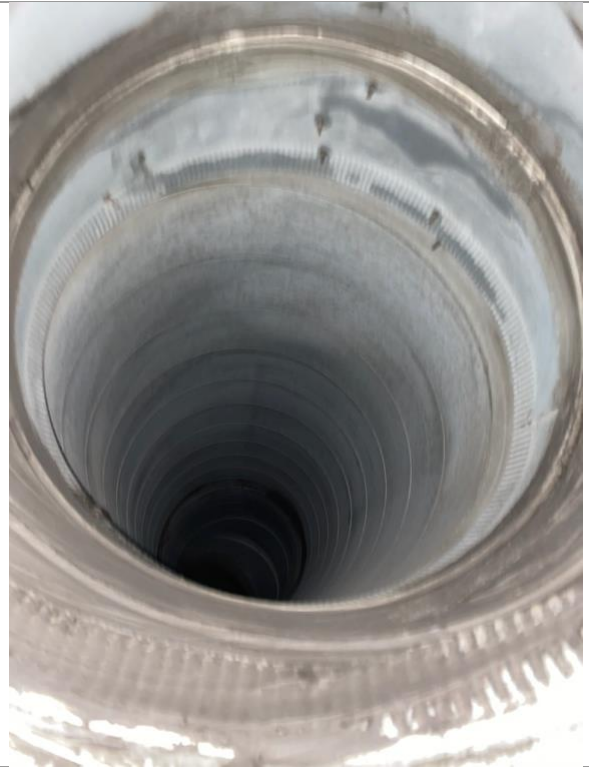
--After--  
Cleaned

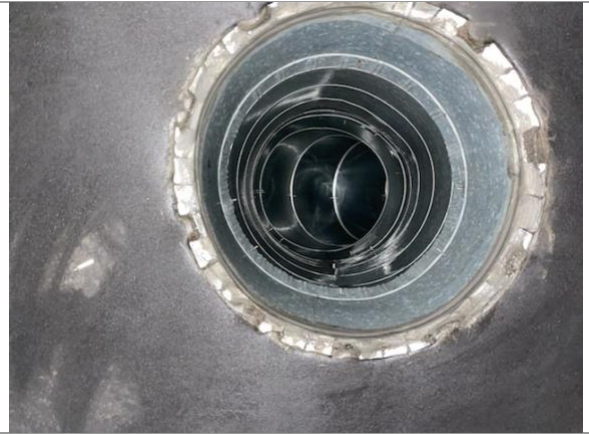
--After--  
Cleaned

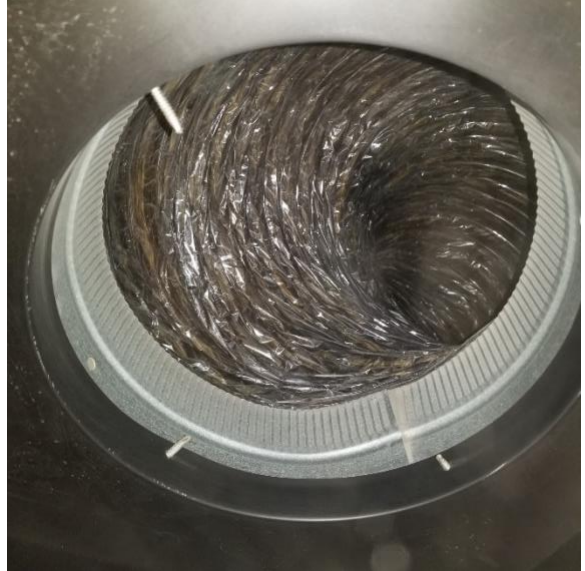
--After--  
Cleaned

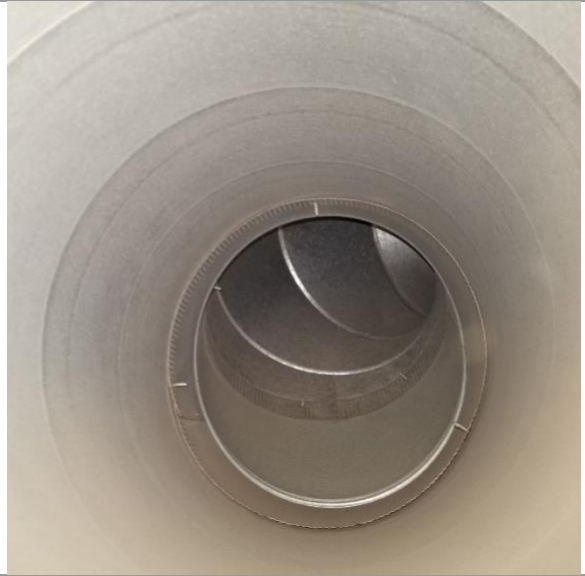
--After--  
Cleaned

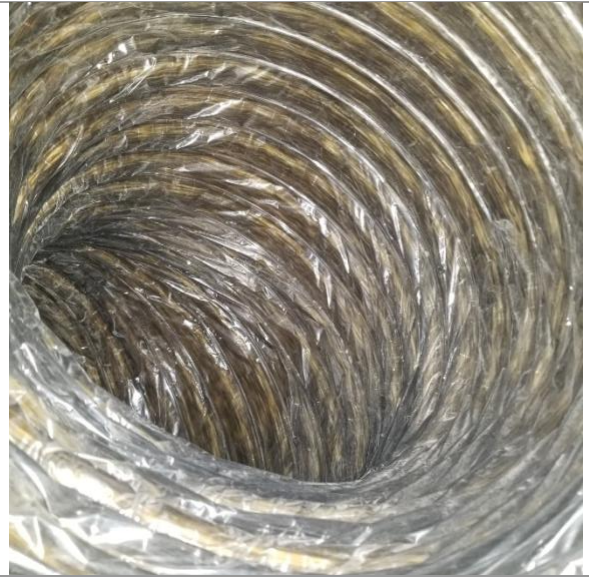
--After--  
Cleaned

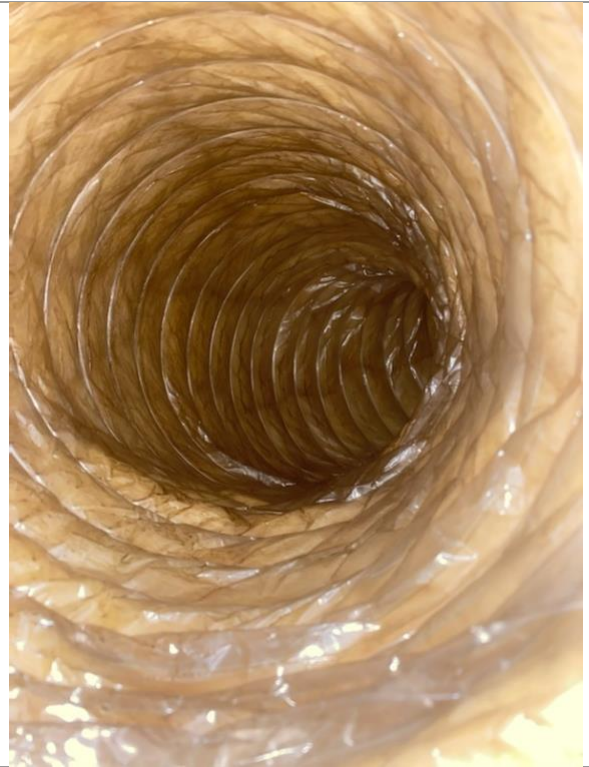
--After--  
Cleaned

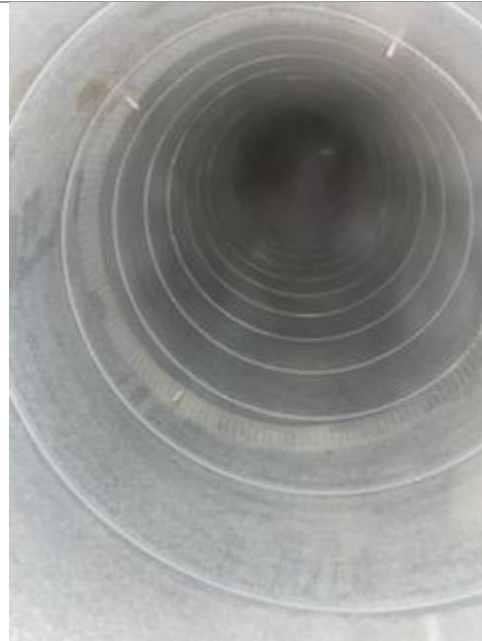
--After--  
Cleaned

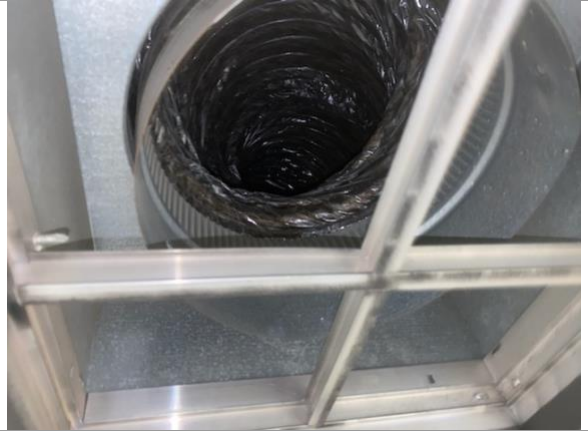
--After--  
Cleaned

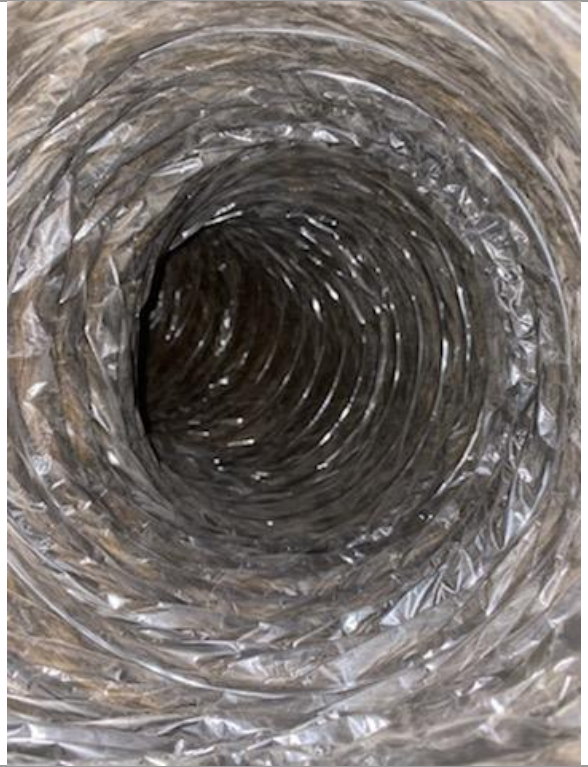
--After--  
Cleaned
